NMSU Alcalde Sustainable Agricultural Science Center

BOOK 2 OF 12

FACILITIES MASTER PLAN REPORT

Executive Summary | July 2023

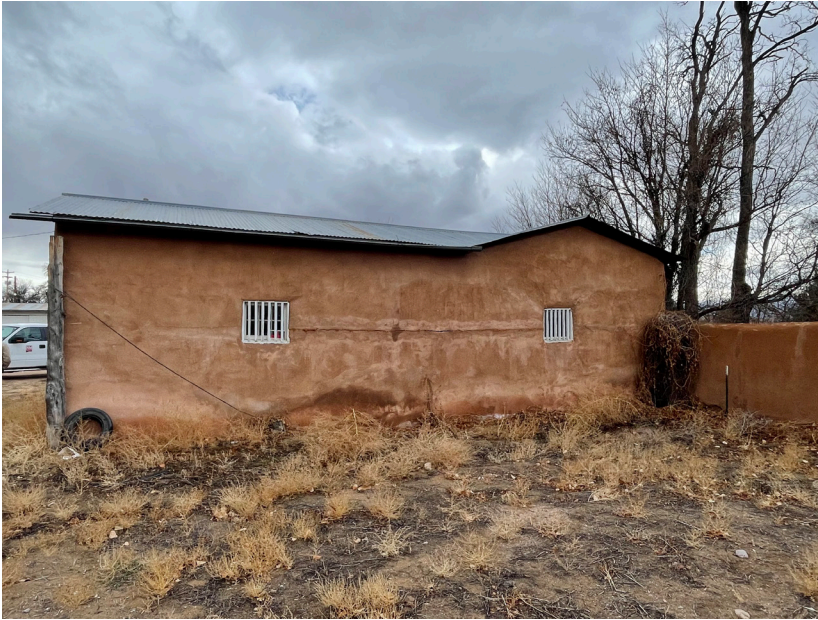
STORAGE 350E

The building has extensive eroded foundations and damaged load bearing walls. The building also has negative water drainage from site and street towards the building. It's a prime candidate for removal and replacement.

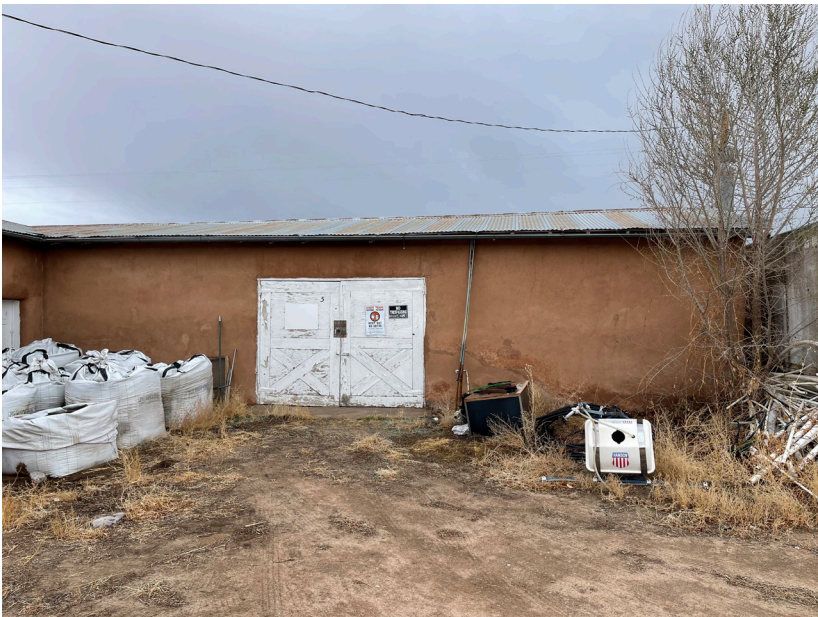
STORAGE 350D

The building has extensive eroded foundations and damaged load bearing walls. The building also has negative water drainage from site and street towards the building. It's a prime candidate for removal and replacement.

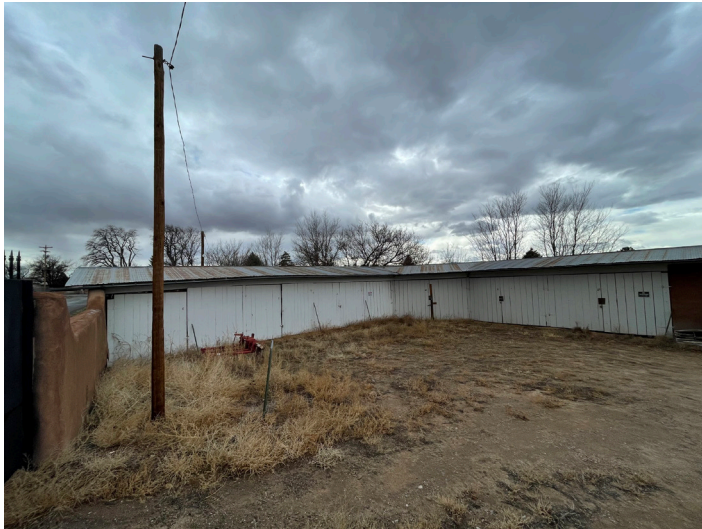
STORAGE 350C

The building has extensive eroded foundations and damaged load bearing walls. The building also has negative water drainage from site and street towards the building. It's a prime candidate for removal and replacement.

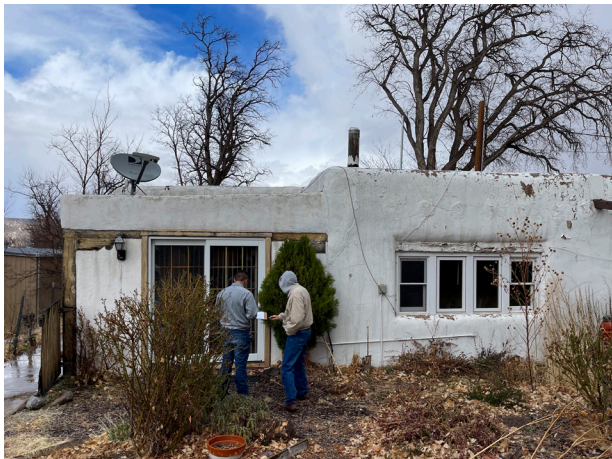
RESIDENCE 350G

The stucco around living room window (south) and east wall is cracked additionally loose around living room window (south) and east wall. The window header at the living room window has extensive rot and is visibly deflecting and the rotted canales on West elevation needs to be replace. The door header into mechanical room and window headers along East elevation is rotted. Need down-leaders drains from canales to stop water from running along sidewalk. Needs a new concrete apron all around the building and regrade for positive drainage along all sides. The house is not ADA accessible and the entry door it needs a ramp. The stucco along the South and East elevations needs to be removed to evaluate the adobe for erosion, wood columns at back porch need resealing along with fascia, Southwest corner of house has exposed wood that requires resealing, stucco cracks at other elevations need repair and repainting, all windows need to be resealed, sidewalk leading to the porch entry needs retaining walls as its being undermined.

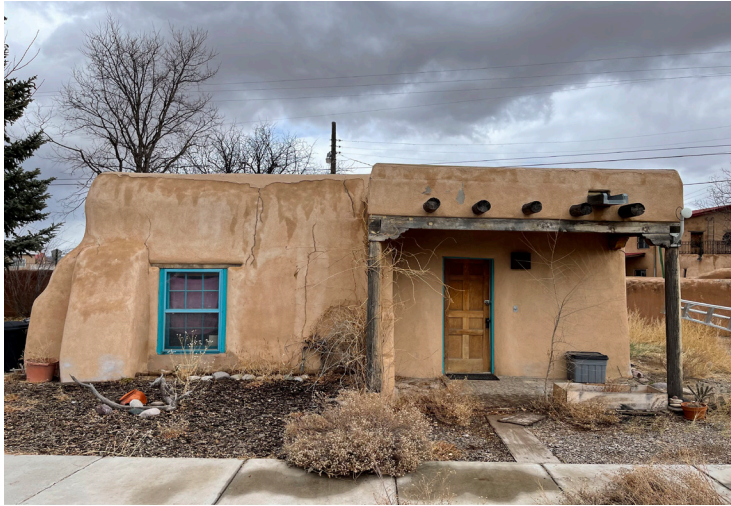
GUESTHOUSE 350F

Cracked stucco along the walls needs repairs and repainting, concrete apron all around need to be regraded for positive drainage away from house, replace rotted wood canales, exposed wood columns and vigas at entry porch needs resealing. Need to seal around the viga extensions at entry porch, and windows need to be replaced with double pane. The wood front door needs to be refinished, the roof is leaking around canales at kitchen, the bathtub drain is leaking and is not connected to septic tank (safety). The floor at the restroom needs reconstruction as it is wet and mushy (possible mold), all exterior window vigas need sealing, all parapets need refinishing at transition between roof cap sheet and stucco, house needs ADA access ramp.

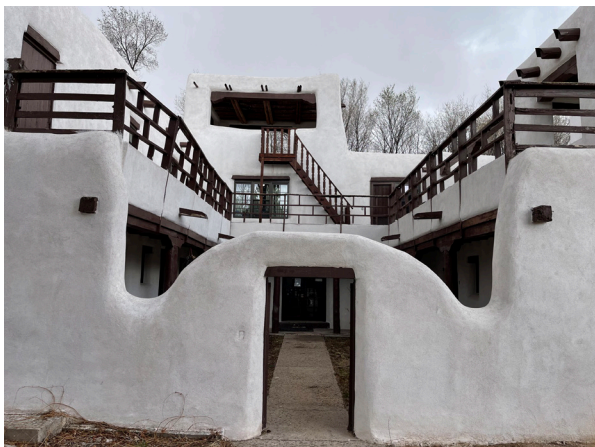
OFFICE 350H

The railings at the entry courtyard are rotted, the roof needs re coating around entry courtyard over the veranda, the wood bases at columns need metal caps, and wood stairs to higher roof areas need repair. Existing wood splits needs re coating, and existing dirt roof over lookout tower needs to be replaced with new roof to match all others. The garden wall along arroyo has collapsed and needs to be rebuilt, downleaders and rotted wood jambs at door by the staircase need to be replaced. The soffit around veranda is rotted/ water damaged, the patio entry doors rotted out and need replacing, building requires ADA parking and ramp. The concrete apron around perimeter walls and along East needs regrading for positive flow away.

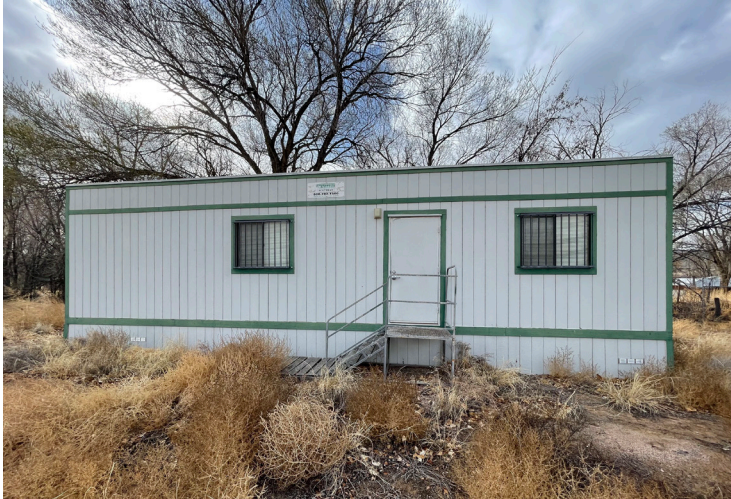
LAB TRAILER 641

Repair roof leak over restroom, repaint exterior walls, building needs ADA ramp-deck, needs ADA parking complete with signage, etc. All interior lights need to be replaced with LED fixtures, gutters and downleaders are needed, repaint exterior doors, reseal all moldings, concrete apron and regrade all around the facility.

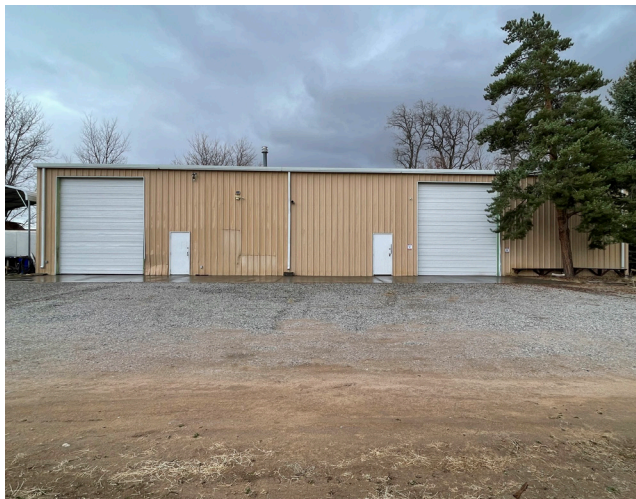
STEEL BUILDING 350A

Repair metal wall panels, and provide ADA hardware at main entrance doors. The concrete apron at South and East sides needs to be regraded to provide positive flow away from building. The facility needs to have all gutters cleaned, reroute East downleaders toward South side, and repair roof leaks (replace roof screws and washers). There is need to repaint HM doors and frames, repaint overhead door jambs, need bollards at overhead doors jambs, need concrete apron repairs, need new weatherstripping and kits at all doors and overhead doors, seal AC unit wall penetration at Northeast corner.

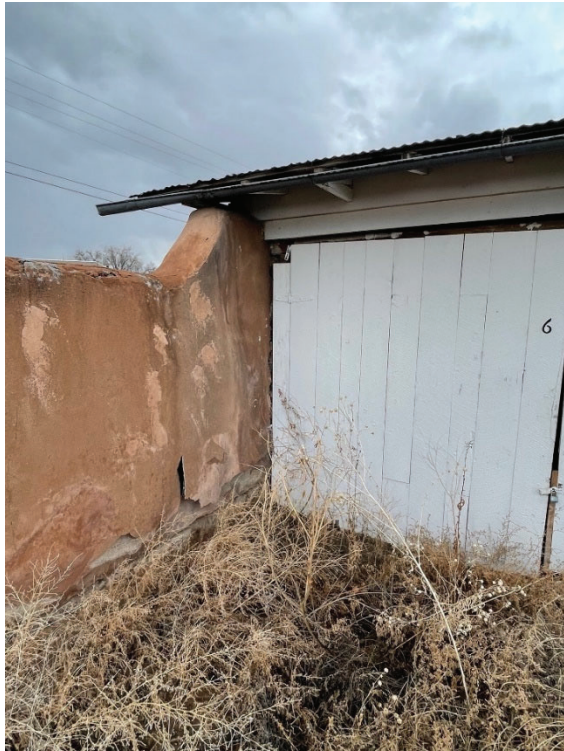
View of water damage to the adobe walls and adobe erosion below the stucco surface. This is typical.

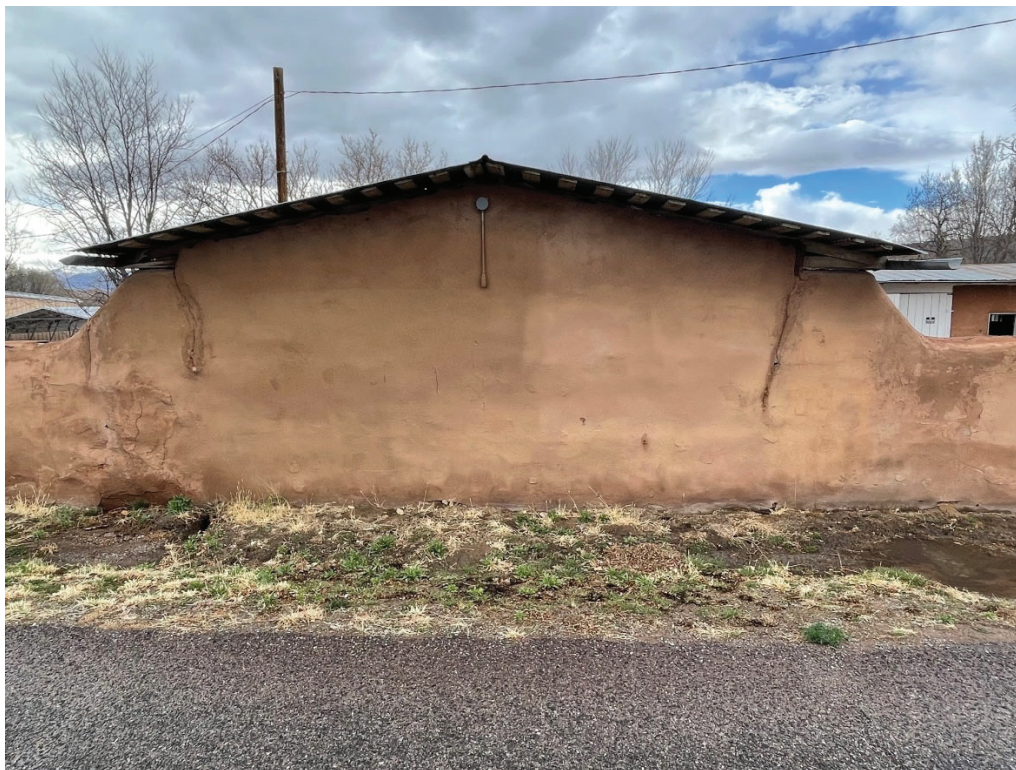
View of through-wall cracks, street runoff water infiltrating building at base of wall and differential settlement.

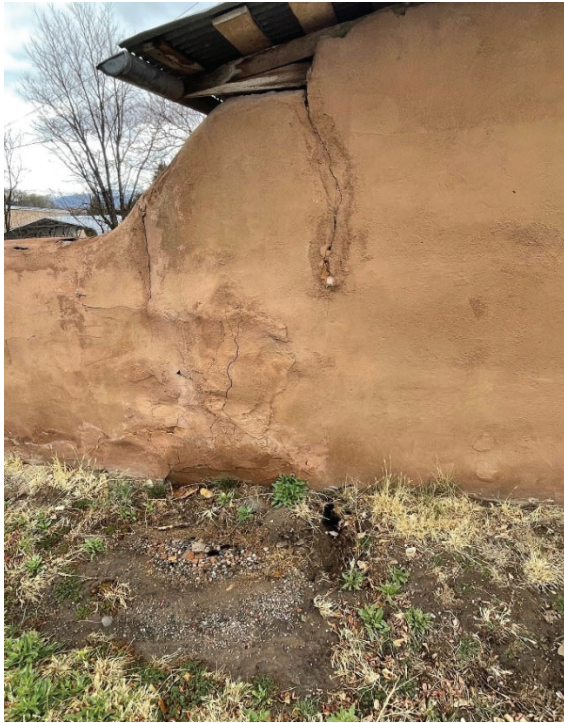
Upclose view of street water runoff cutting through adobe wall and undermining the adobe foundation causing differential settlement.

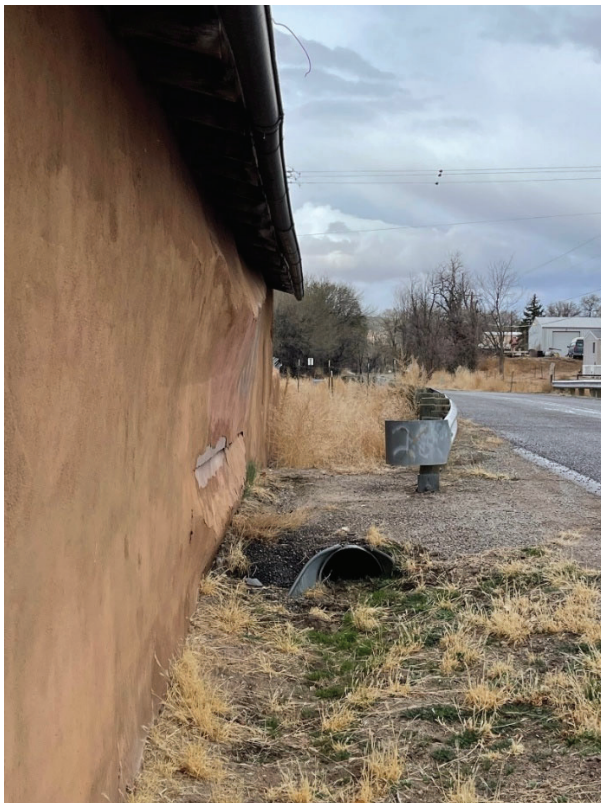
View of adobe erosion below stucco surface. This condition is typical.

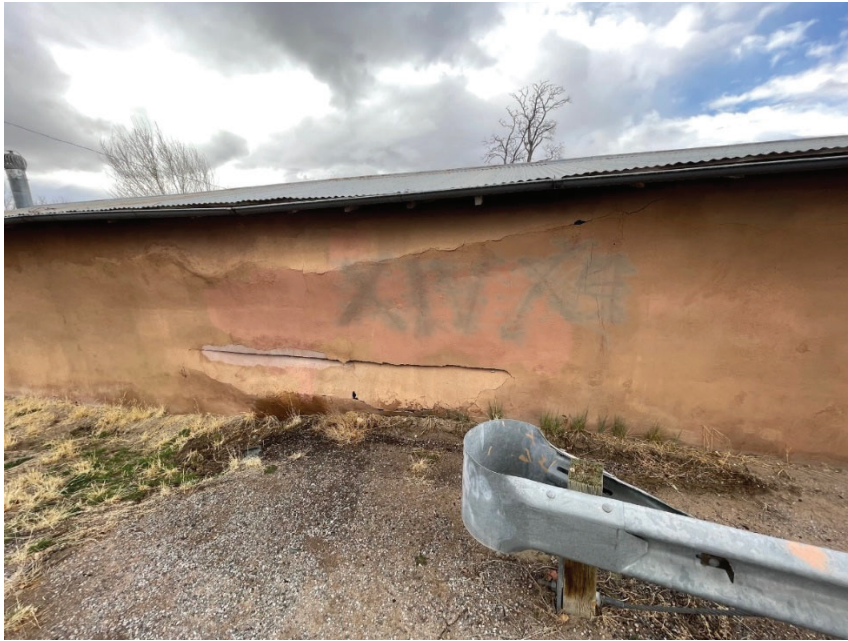
View of adobe erosion below stucco surface. This condition is typical.

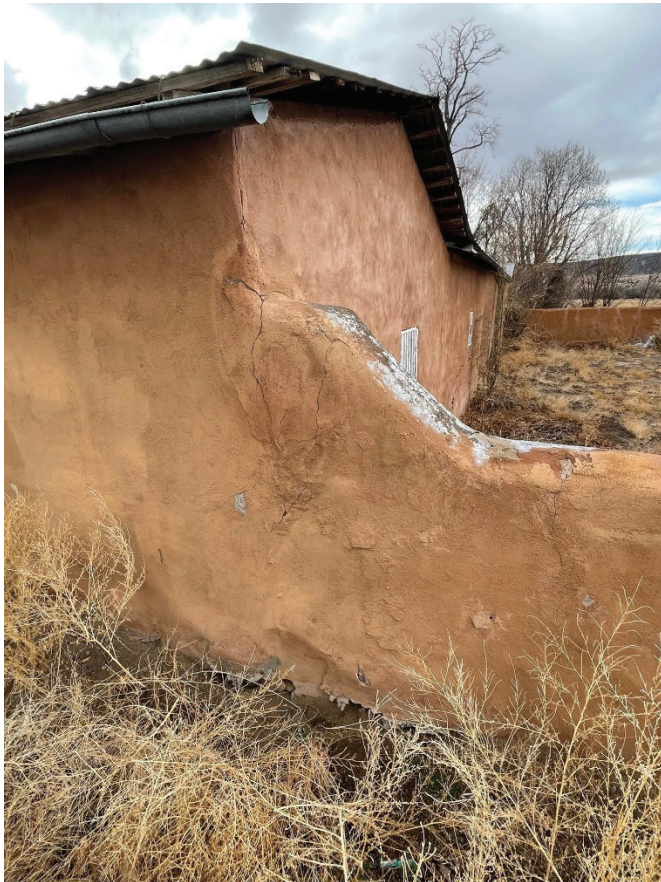
Up close view of street water runoff cutting through adobe wall and undermining the adobe foundation causing differential settlement of second building along roadway.

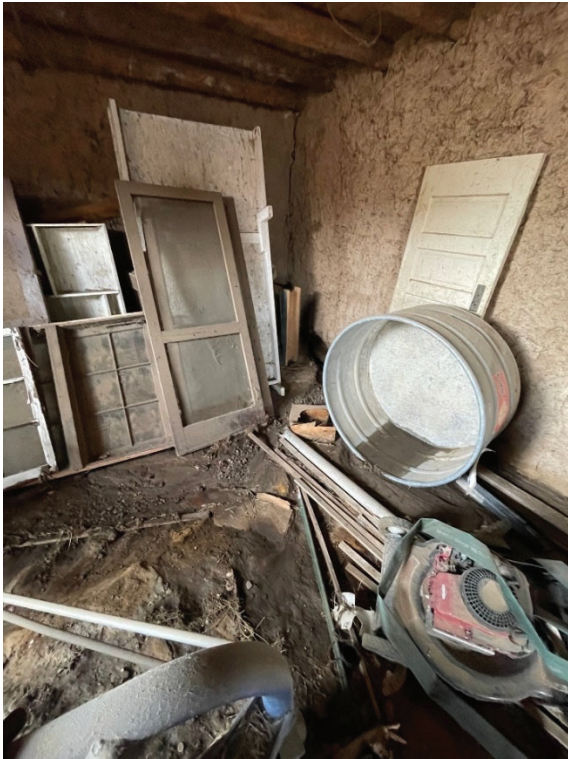
Interior view of water coming in through bottom of adobe wall and flooding the building.

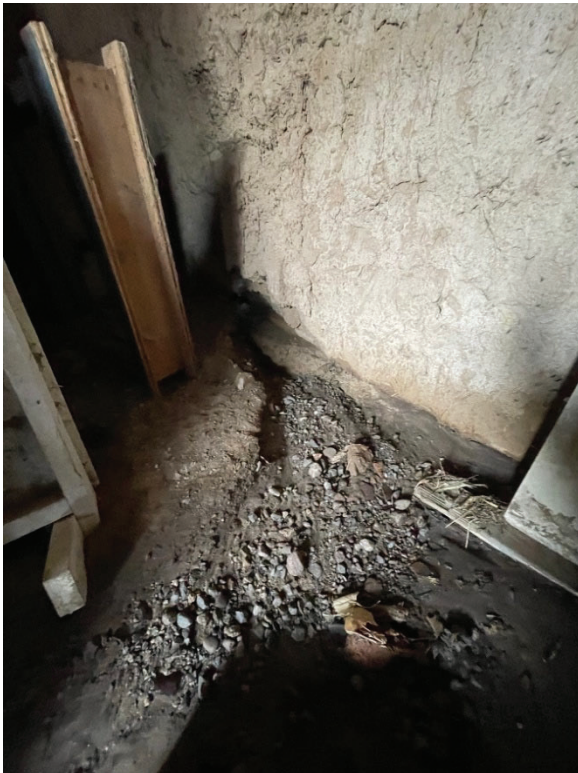
Interior view of water coming in through bottom of adobe wall eroding the base of wall and causing differential settlement.

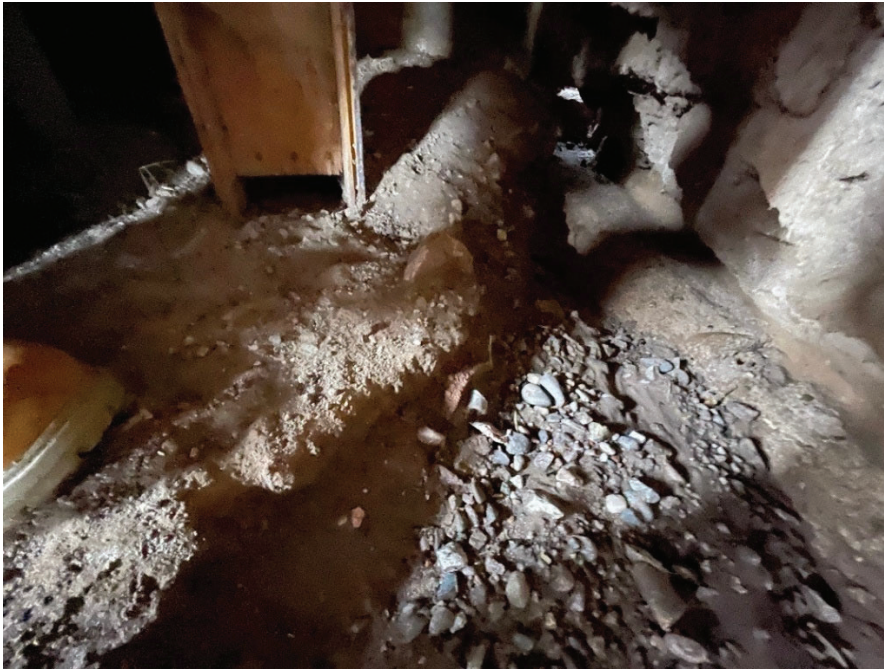
Interior view of water coming in through bottom of adobe wall eroding the base of wall.

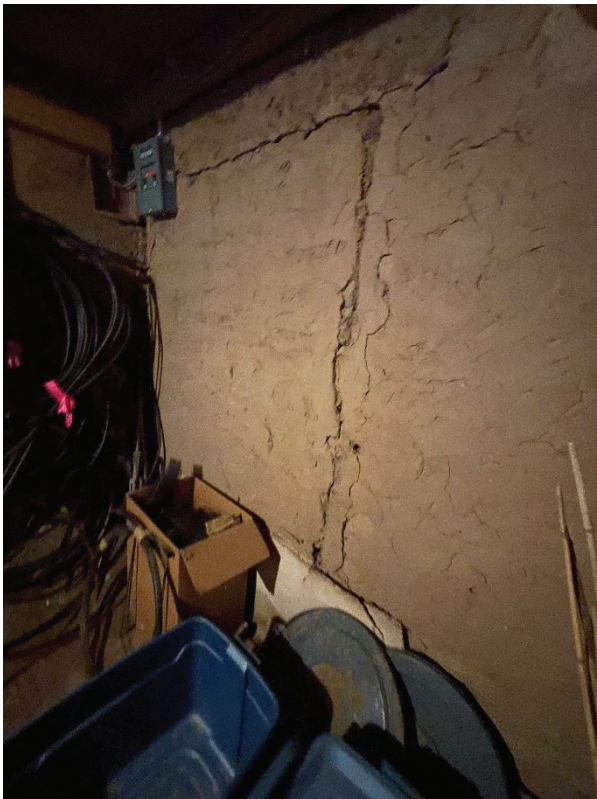
Interior view of thru-wall cracking at storage building due to water erosion of adobe wall base and differential settlement. This condition is typical.

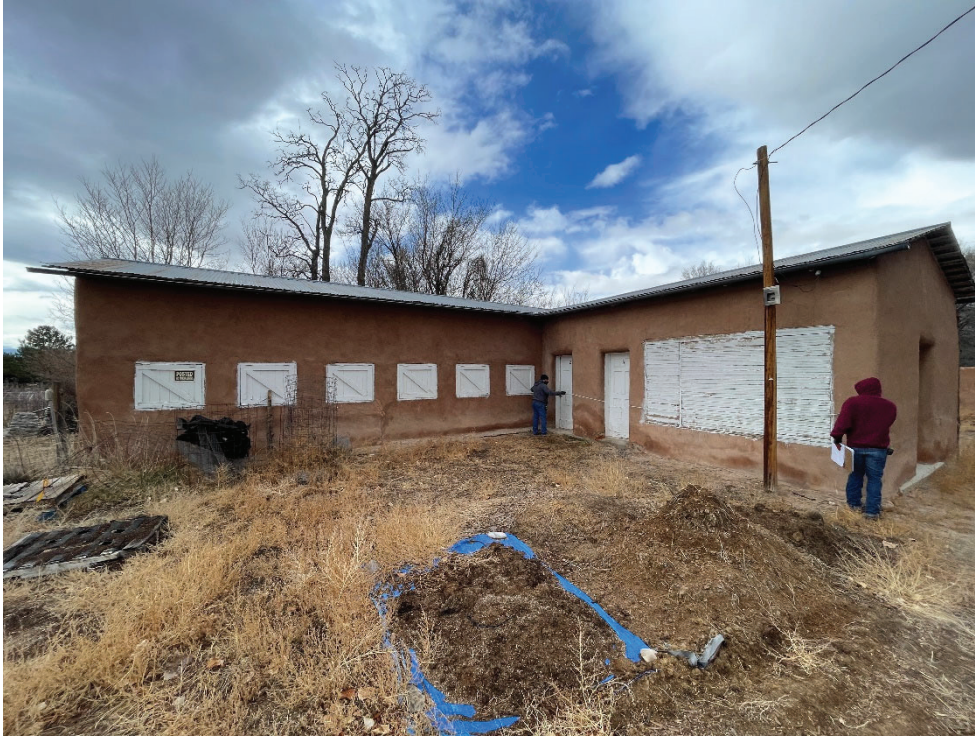
View of storage building that is condemned.

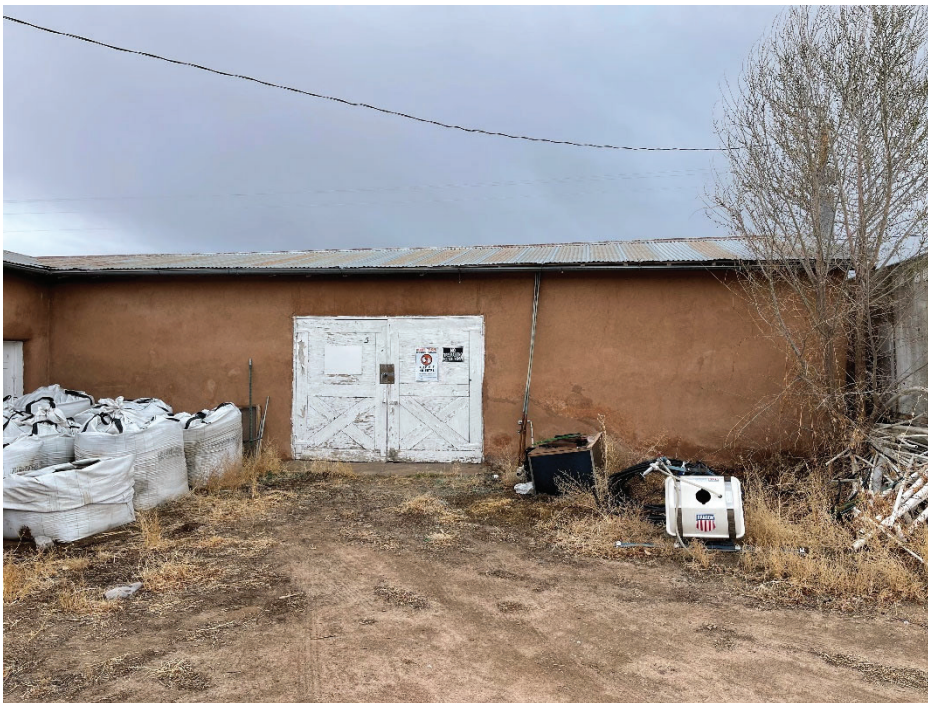
Seed storage structural problems. Building beyond feasible repair

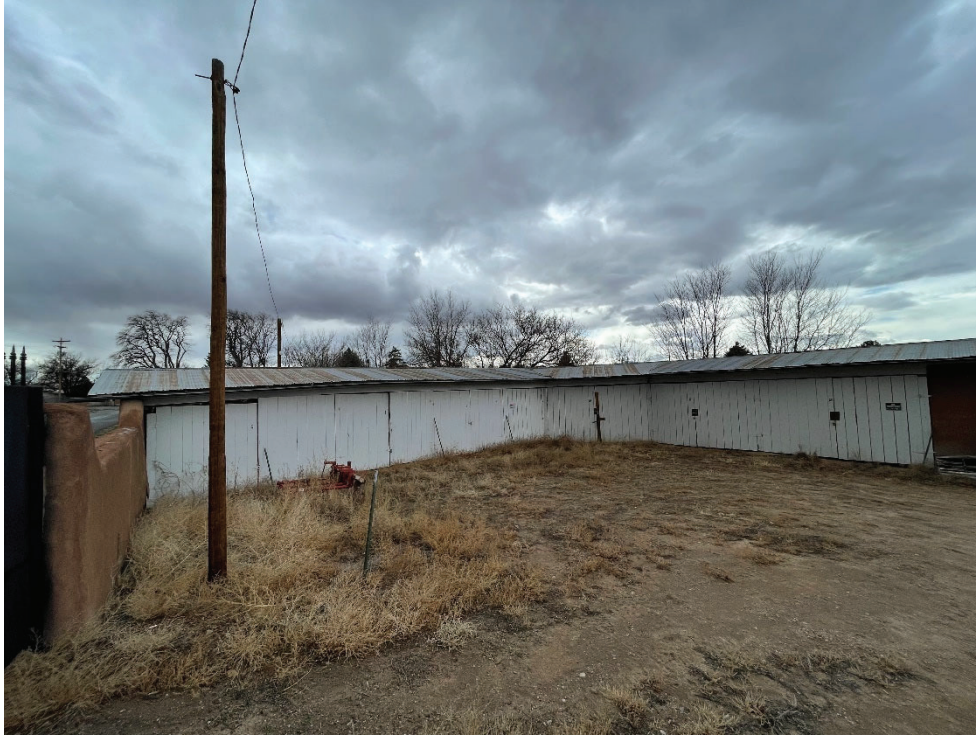
Implement storage structural problems. Building beyond feasible repair

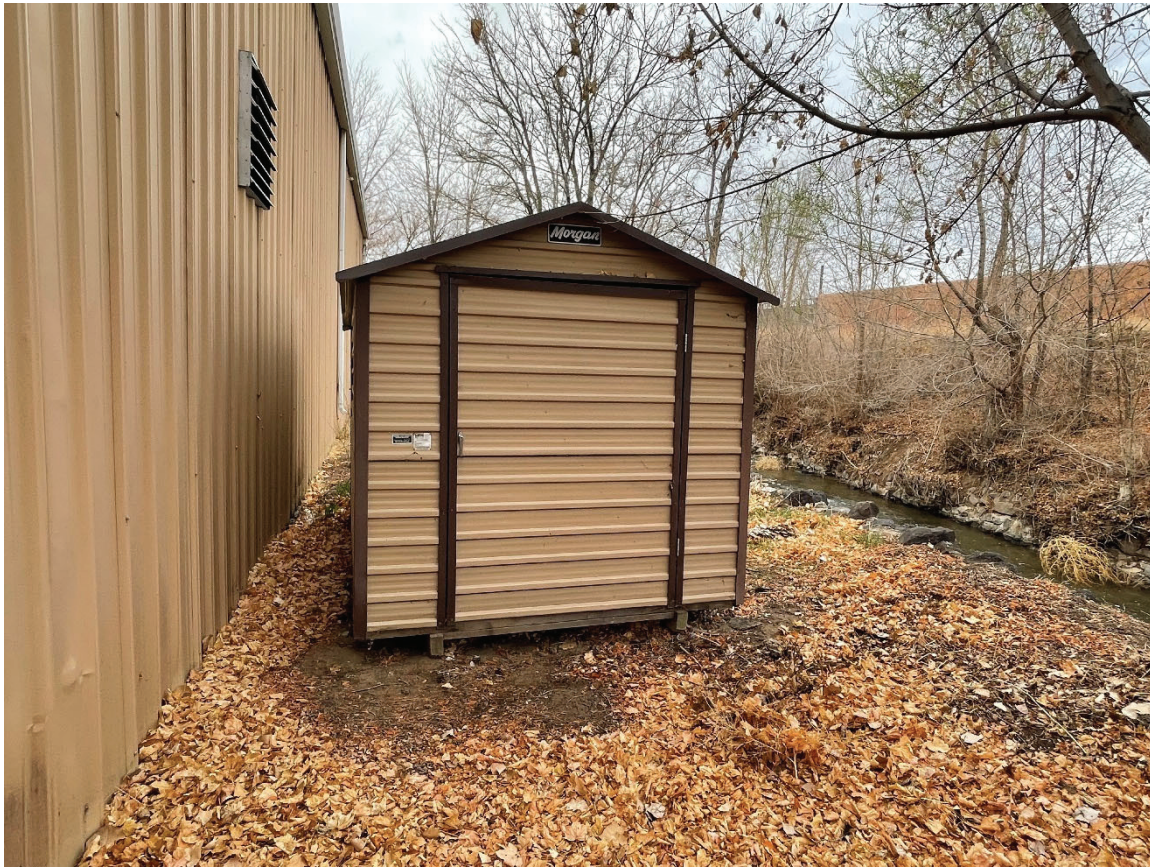
Storage Shed by acequia:

Needs: Entry stoop, rain gutters and down leaders, level structure, pull away from shop building.

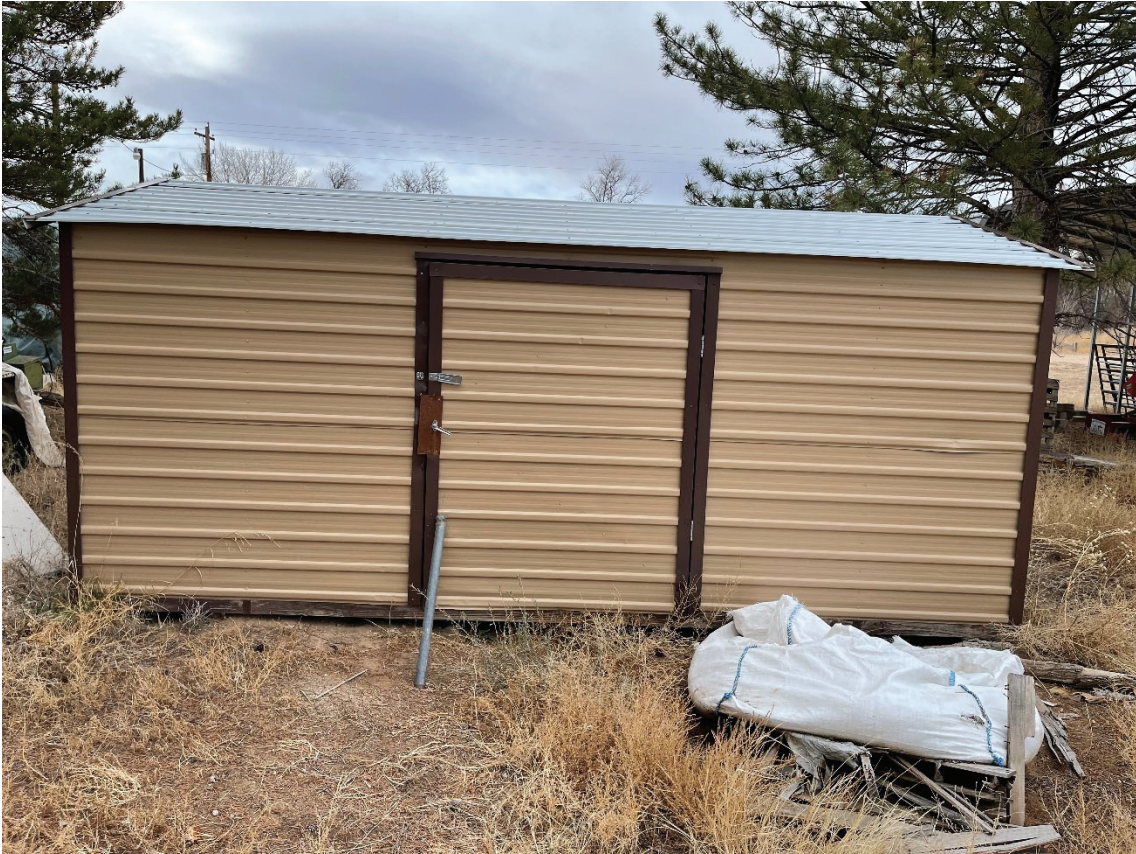
Storage Shed by acequia:

Needs: Entry stoop, rain gutters and down leaders, regrade around building.

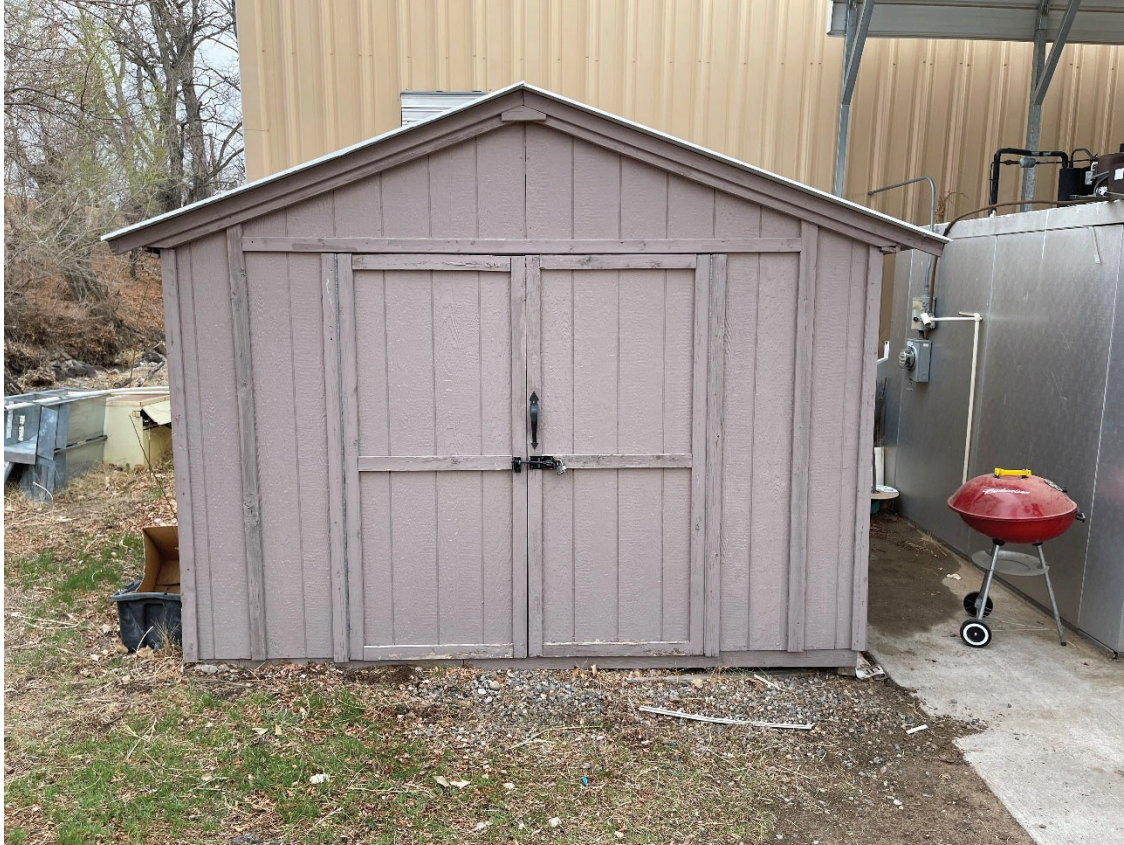
Tool storage wood shed:

Needs: Entry stoop, repair rotted siding and trim, repaint all exterior surfaces, rain gutters and down leaders, regrade 3 sides.

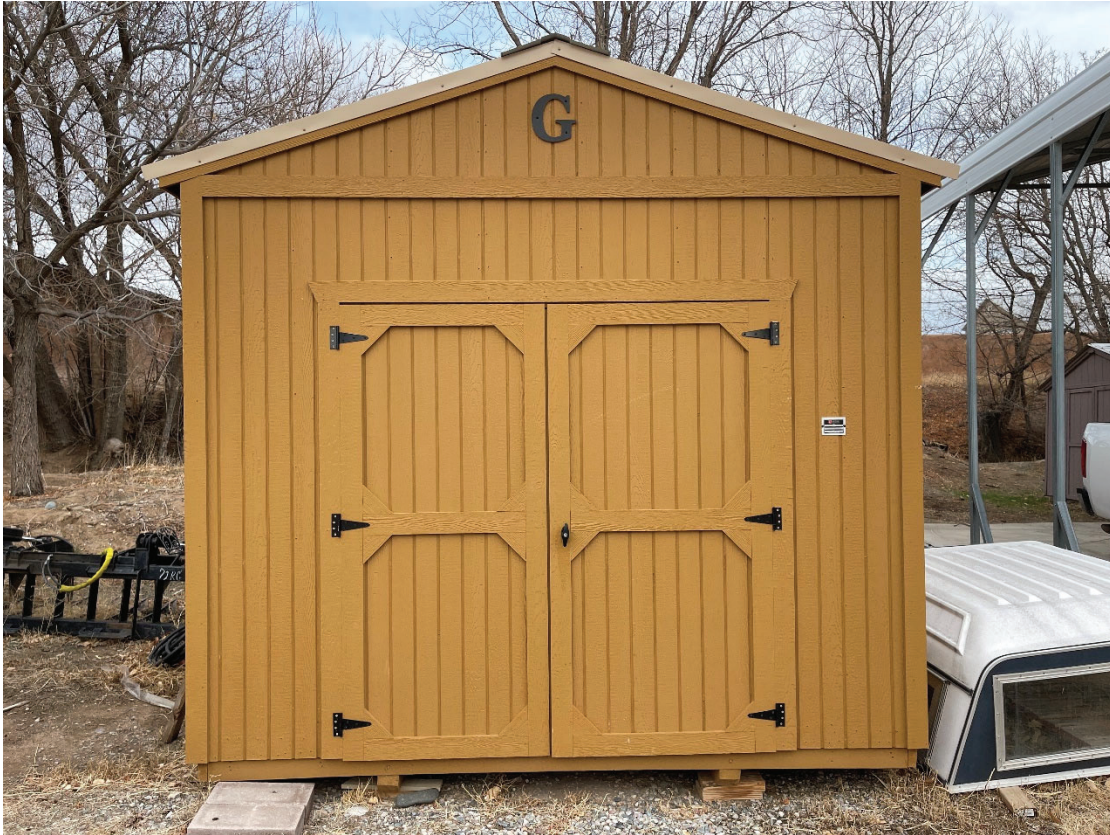
Tool storage wood shed:

Needs: Entry stoop, rain gutters and down leaders, regrade sides.

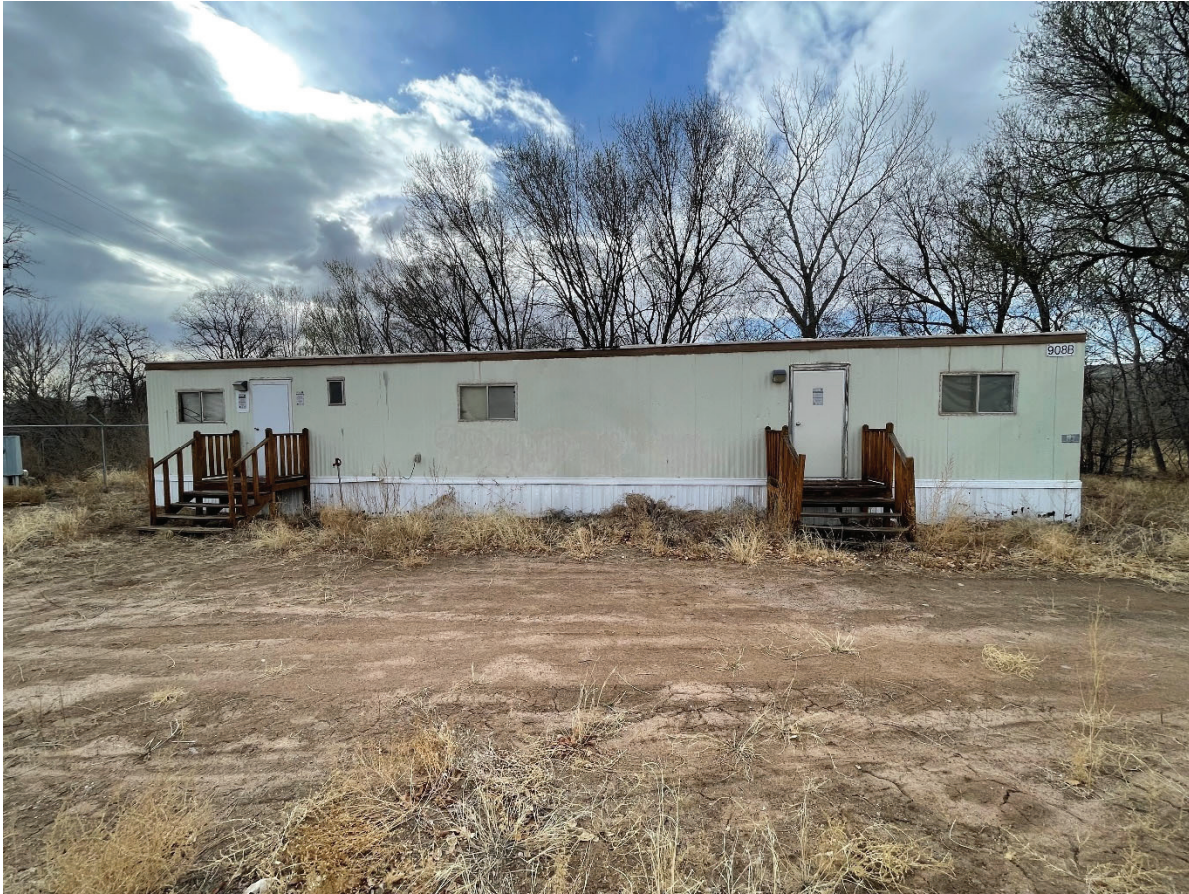
Mobile home office building:

Needs: Skirting repairs, replace wood trim around doors, repaint doors, new roof, ADA access ramp and deck at each door, reattach upper edge of metal wall panels, regrade all around, repair all damaged ceiling areas, replace ceiling light fixtures, replace windows, rain gutters and down leaders.

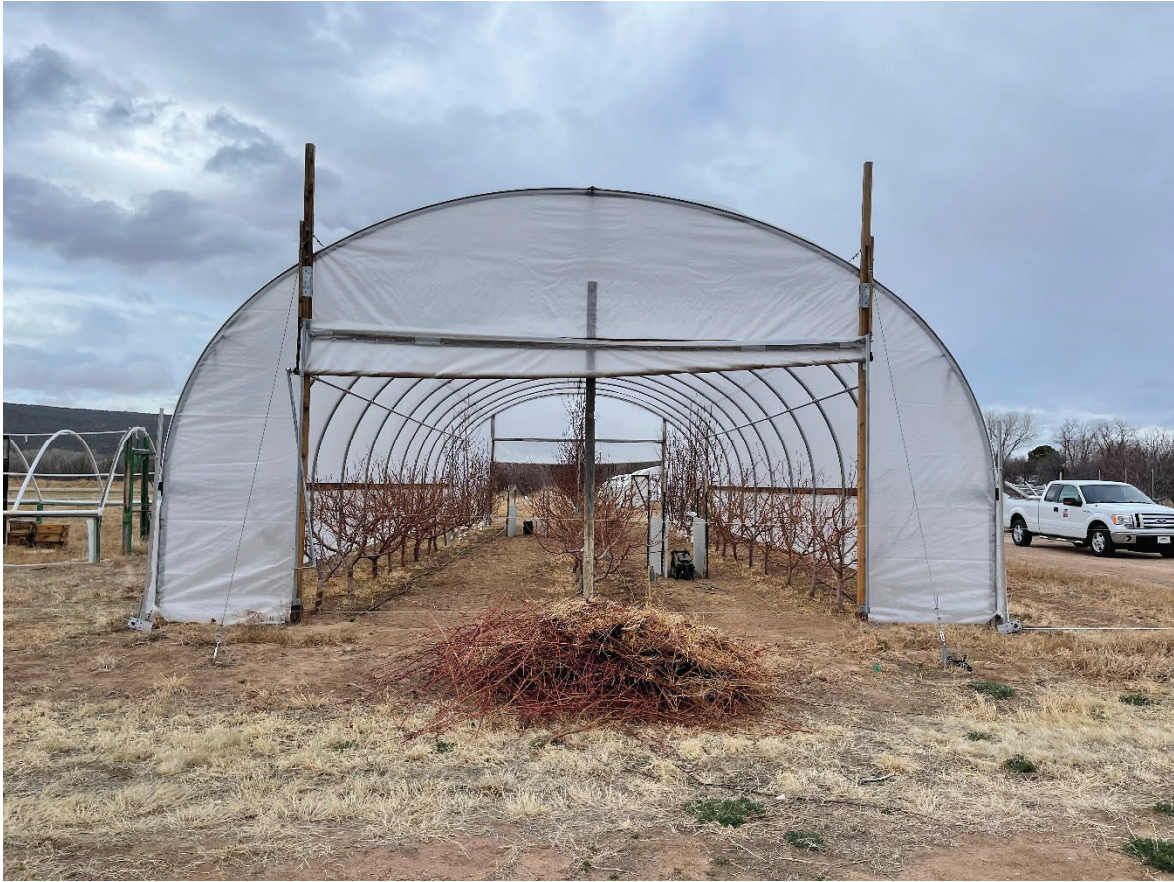
Greenhouse:

Needs: Electric fence repairs and access door through fenced perimeter.
