Fabian Garcia & Leyendecker Plant
Science Research Center

BOOK 9 OF 12

FACILITIES MASTER PLAN REPORT

Executive Summary | July 2023

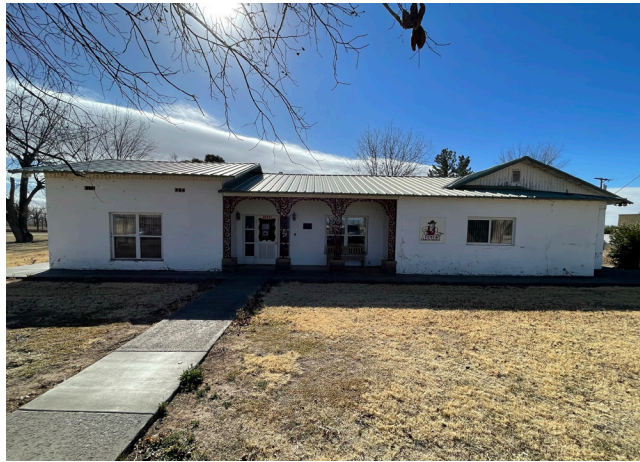
OFFICE 306

The existing stucco coat over CMU is cracking and de-laminating throughout it needs the crack repaired and the exterior walls repainted. The soffit needs repairs and repaint and a concrete apron along exterior walls on areas where existing landscaping is next to house is needed along with the removal of all landscaping close to exterior walls. The building needs gutters and downleaders including the repair of the rotted fascia boards and then repaint,. The existing CMU garden walls needs refinishing and replace damaged sidewalk around house. Replace damaged screen doors and an ADA lockset are needed at all perimeter doors. In the interior South West corner of room 104 the existing floor is settling over crawlspace area, repair settlement crack in wall at closet, and replace broken glass at entry area.

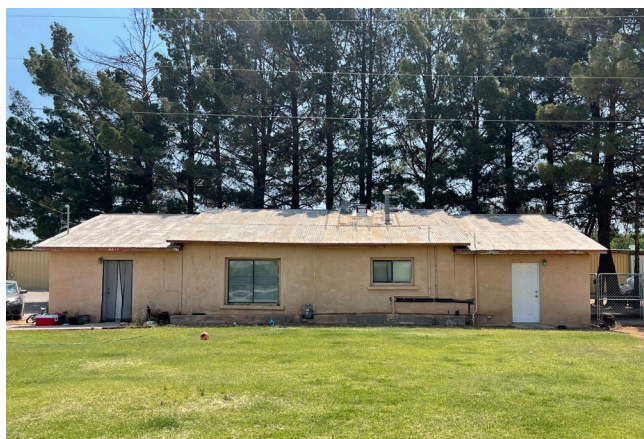
SUPERINTENDENT RESIDENCE 308

The corrugated metal roof panels needs to be replaced and install roof decking along west side overhand. Outriggers and wood fascia need to be repaired and painted, need installation of gutters and downleaders. The building needs a concrete apron on all 4 sides and regrading to provide positive flow away from building. Existing stucco cracks needs repair and repainted. Replace rotted wood and repaint all exposed wood gable ends (including at roof step down). All exterior wood doors need to be repainted and the rotted wood trim at doors replaced. Need to seal all exterior wall conduit penetrations and at exterior mechanical room at West side replace the door assembly.

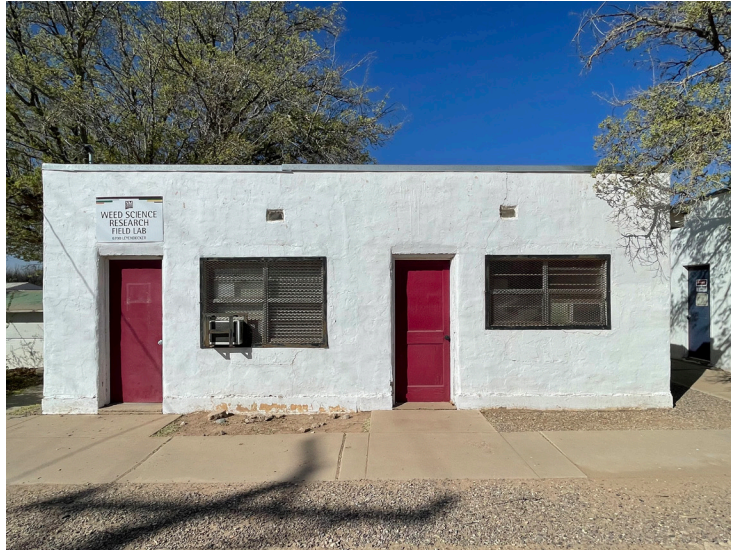
WEED RESEARCH STORAGE SHED 313A

Repair wood fascia and outriggers are needed and paint, and the building needs gutters and downleaders. The building needs a concrete apron around all 4 sides and regrade site to provide positive flow away from building. The exterior facade needs the stucco cracks repaired and repaint. Replace rotted wood around doors and it needs for ADA lockset compliant at all doors, and replace all windows with double pane insulated. All exterior wall conduit penetrations need to be sealed, the water heater enclosure at North side of building needs replacement and a ADA ramp to one of the side doors.

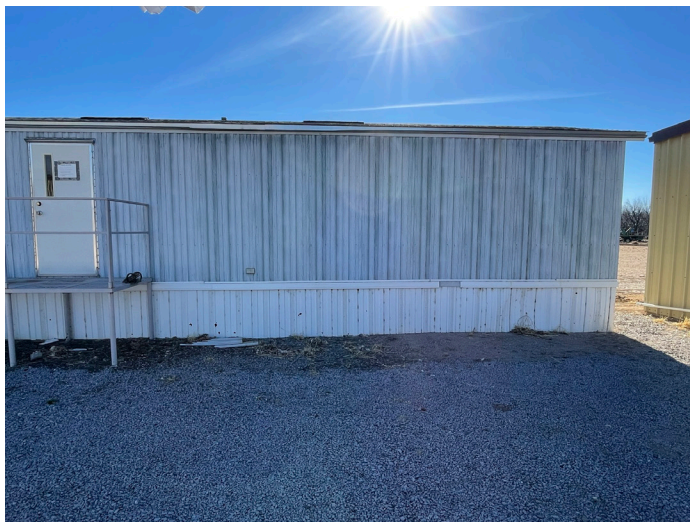
OFFICE TRAILER A 394

The structure needs a new skirting along the base of the structure, and repair damaged exterior wall panels. The structure also needs and ADA accessible access and ramp and deck both at the entrance and rear door. The existing restroom is not ADA accessible, and it needs ADA hardware to entry and back. Site need to be regraded for erosion and add concrete apron all around.

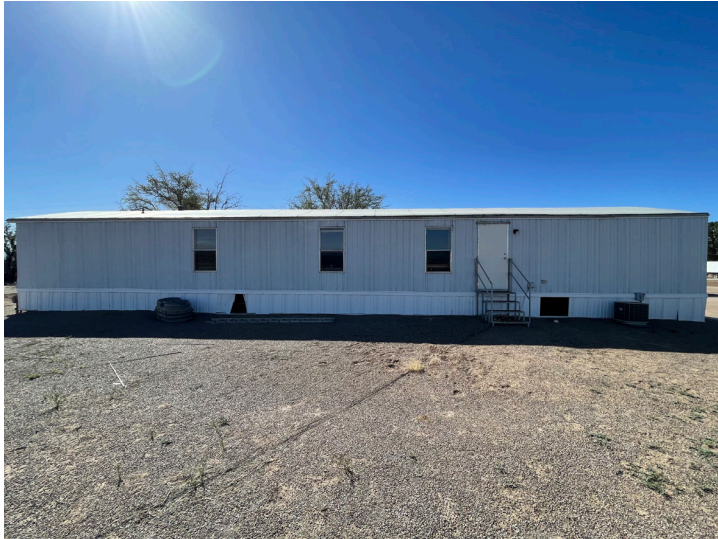
LAB TRAILER B 595

The structure needs a new skirting along the base of the structure, add new gutters and downleaders to manage soil erosion and repair damaged exterior wall panels. The structure also needs an ADA accessible access and ramp and deck both at the entrance and rear door. The existing restroom is not ADA accessible, and it needs ADA hardware to entry and back. Site need to be regraded for erosion and add concrete apron all around.

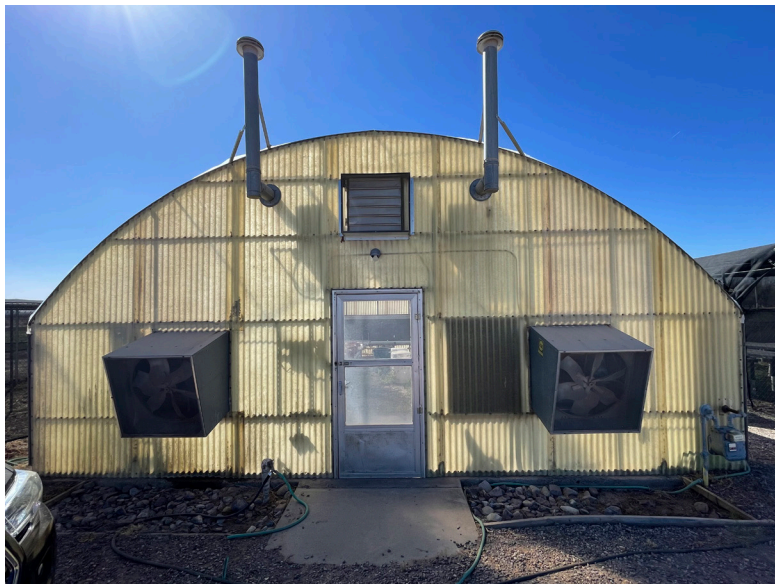
GREENHOUSE 150 B

The greenhouse needs an ADA compliant access concrete landing and equipped with ADA hardware. All exterior plastic corrugated fiber reinforced panels need to be replaced. The site needs to be regraded around the building to create positive drainage away from structure and prevent erosion.

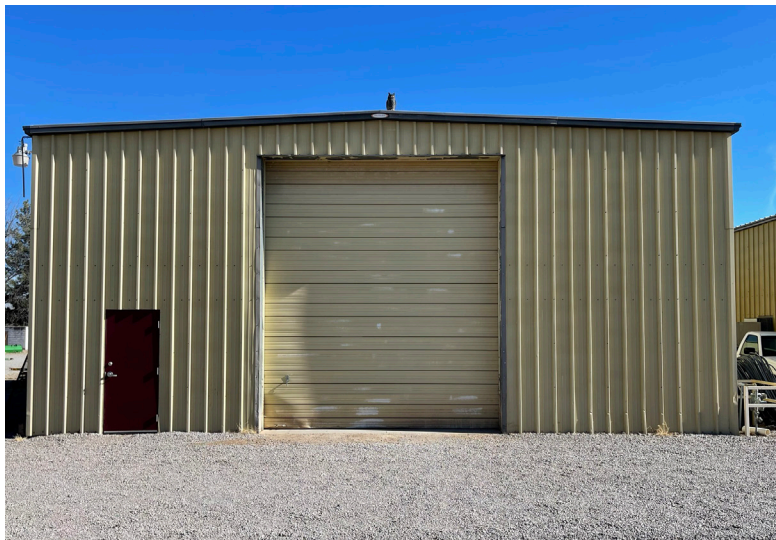
IMPLEMENT SHED 312

Overhead doors needs to be replaced. The damaged exterior wall metal panels need replacement and the head and jambs at overhead doors need to be painted. Add concrete approach aprons at both overhead doors and add soil at eroded corners of the buildings. The building needs a concrete apron all around for drainage control, and regrade to provide positive drainage away from buildings. Gutters and downspouts need to be added, repaint entry main doors, and fix roof leak.

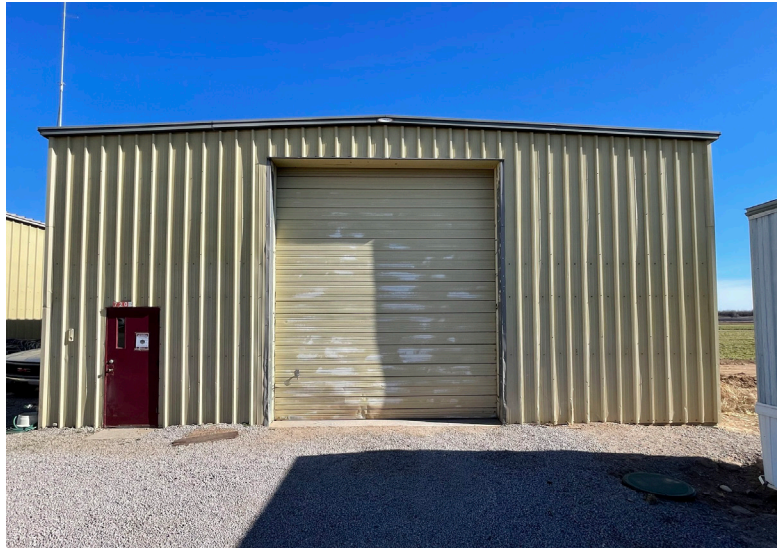
SHOP 310

Overhead doors needs to be replaced. The damaged exterior wall metal panels need replacement and the head and jambs at overhead doors need to be painted. Add a concrete approach aprons at both overhead doors and add soil at eroded corners of the buildings. The building needs a concrete apron all around for drainage control, and regrade to provide positive drainage away from buildings. Gutters and downleaders need to be added, repaint entry main doors, and fix roof leak.

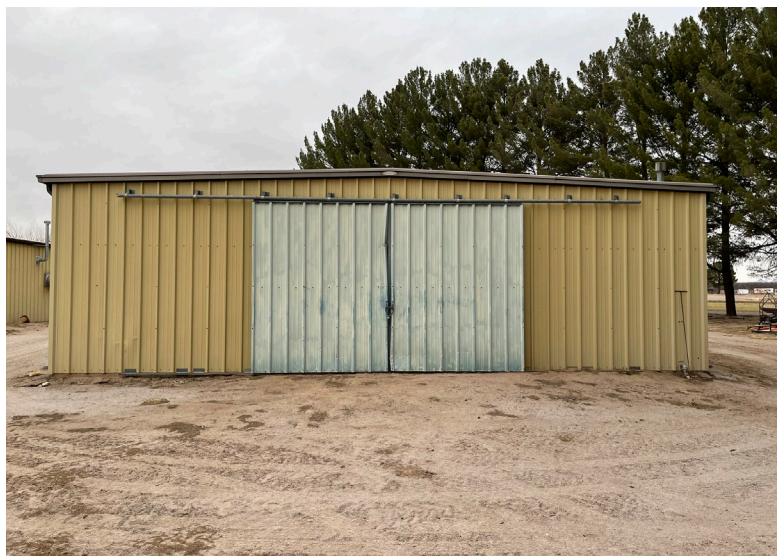
GIN DRYER 344

Needs to add an ADA accessible door with ADA ramp and concrete landing. Need to replace damaged exterior wall panels, and needs roof repairs for metal panels leaks, replace existing sliding barn doors with new and all new hardware. Regrade all around to stop erosion and add a concrete apron all around, and a concrete drive approach to each large sliding barn doors.

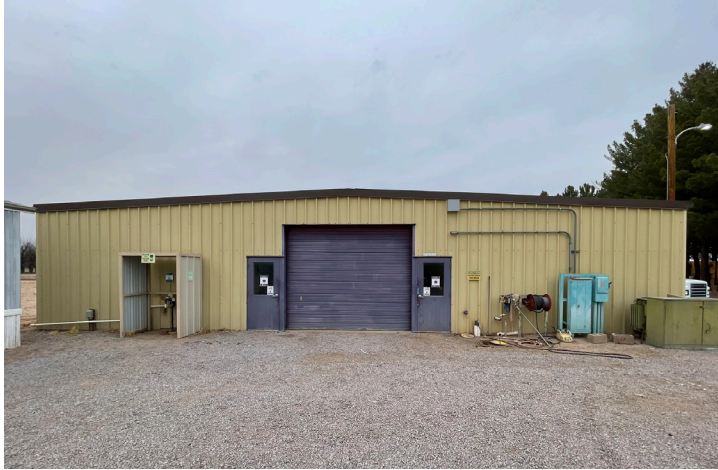
LAB BUILDING 345

Needs to replace overhead doors, and replace damaged exterior wall metal panels. Repaint the head and jambs at the overhead doors, and add a concrete aprons at both overhead doors. The site needs to add soil at eroded corners of the building and it needs a concrete apron all around. ,Two rusted hollow metal doors needs to be replaced, including adding new ADA hardware and concrete pad. The main door needs to be repainted and needs a concrete landings at all main doors for ADA compliance. Need to paint new overhead doors, repair existing roof leak, regrade site to provide positive drainage away from buildings. Interior work include repair gyp wall board cracks inside main hallway and re-paint, add needed LED lighting inside main hallway since space is too dark now.

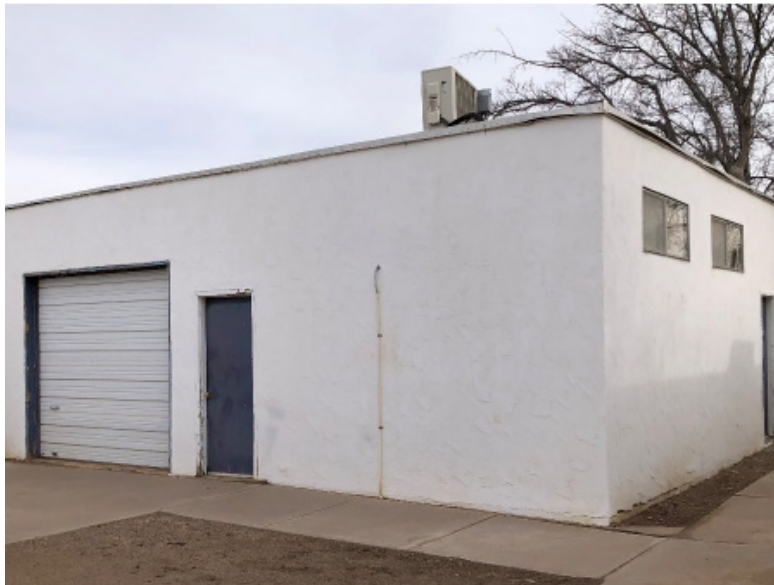
CHEMICAL STORAGE 313B

South side needs regrading for drainage and the stucco walls need all crack repaired and repainted. A new side walk and ramp along south side is needed. The door jambs/ trims need repaired and repainted, including adding ADA access hardware. The parapet metal cap needs reattachment, overhead door seals, needs repair, and door jambs and head on West doors need to be repaired and repainted.

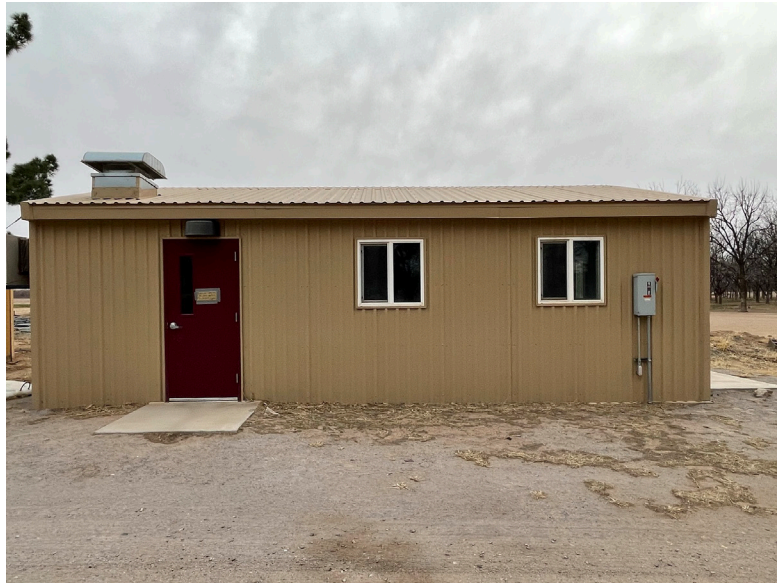
FIELD RESEARCH LAB 649

Need to install gutters and downleaders, and the building needs concrete apron along all four sides including grading the site to create positive drainage away from building.

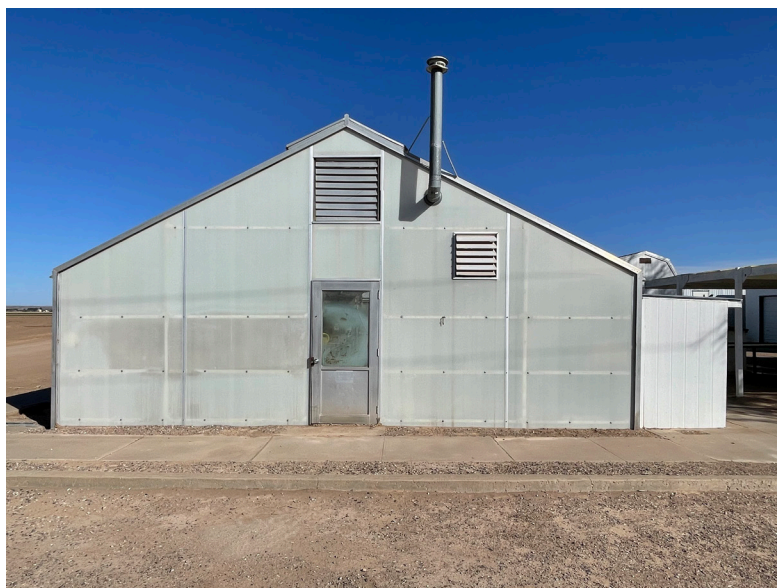
GREENHOUSE 150 A

Needs to replace broken door vision panels. Needs to install ADA access ramp concrete sidewalk, including ADA hardware to entrance door.

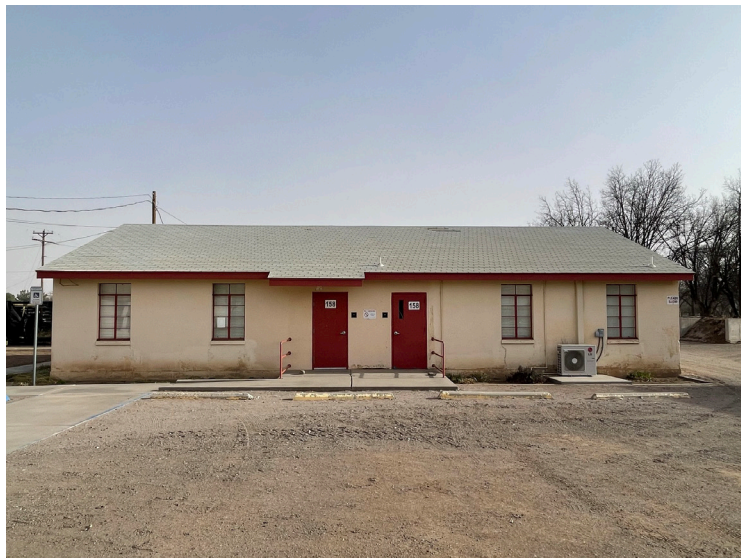
OFFICE AND LABS 158

Stucco cracking and de-laminating throughout, needs crack repairs and new exterior wall repaint, needs soffit repairs and repaint, roof shingles flown off (needs re-roofing), needs concrete apron along exterior walls on 4 sides of building and greenhouse, needs removal of all landscaping close to exterior walls, needs regrading to create positive drainage away from building, needs gutters and downleaders, greenhouse perimeter pony walls, repair west greenhouse wall moisture damage interior and exterior.

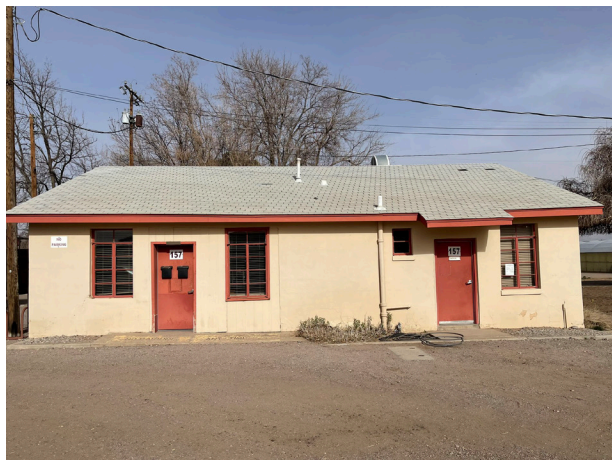
OFFICE SEED ROOM 157

Stucco cracking and de-laminating throughout, needs crack repairs and new exterior wall repaint, needs soffit repairs and repaint, roof shingles flown off (needs re-roofing), needs concrete apron along exterior walls on 4 sides, needs removal of all landscaping close to exterior walls, needs regrading to create positive drainage away from building, needs gutters and downleaders, need ADA access landing and entry to building, need ADA restroom, replace lights to LED, repair cracked plaster at front door jambs, repair excessive cross slope on inside to meet ADA

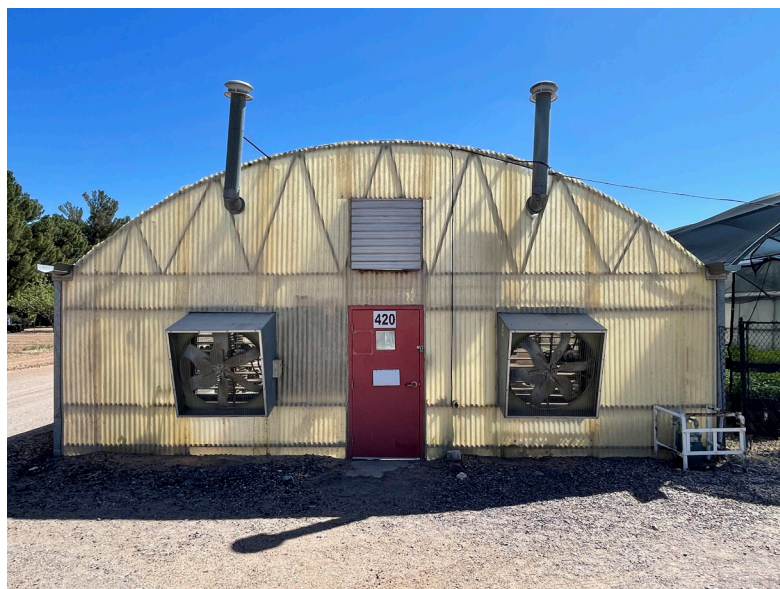
GREENHOUSE B 420

Needs to replace all exterior plastic corrugated fiber reinforced panels, Need downleaders for existing gutters, need repaint entry door, Needs ADA access and landing at front door, regrade around building to create positive drainage away from building on two end elevations and add soil to long elevation along North to fight erosion.

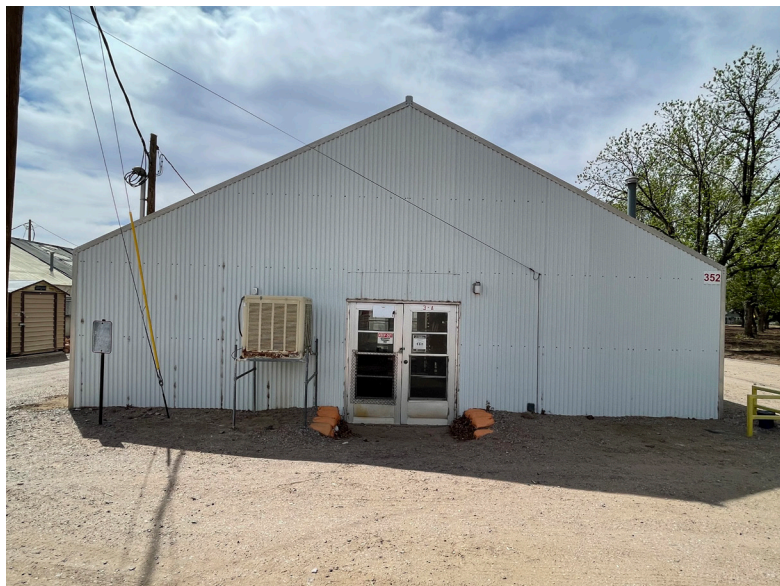
GREENHOUSE 352

Needs ADA access ramp to front door, Ada hardware to entry door, needs repaint frames of exhaust hood, Need to replace rusted metal panels around head house, concrete apron around headhouse exterior walls, regrade around building to create positive drainage away from building, need gutters and downleaders at the headhouse.

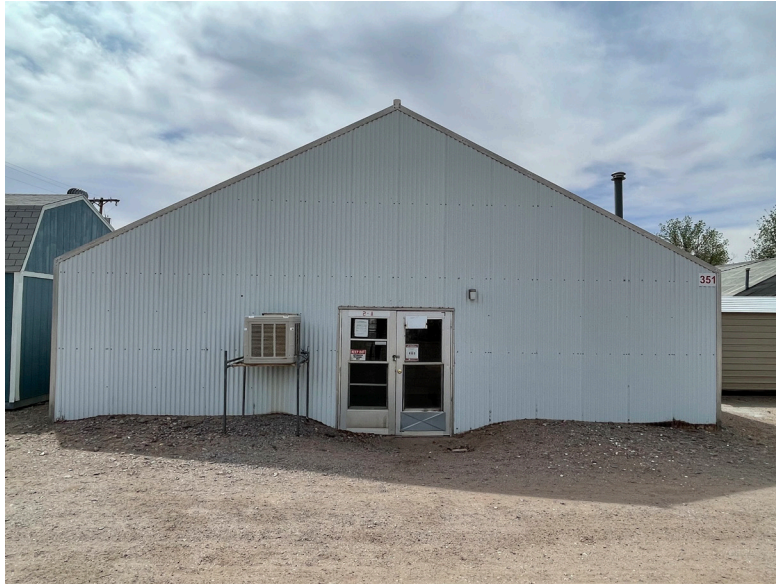
GREENHOUSE 351

Needs ADA access ramp to front door, Ada hardware to entry door, needs repaint frames of exhaust hood, Need to replace rusted metal panels around head house, concrete apron around headhouse exterior walls, regrade around building to create positive drainage away from building, need gutters and downleaders at headhouse

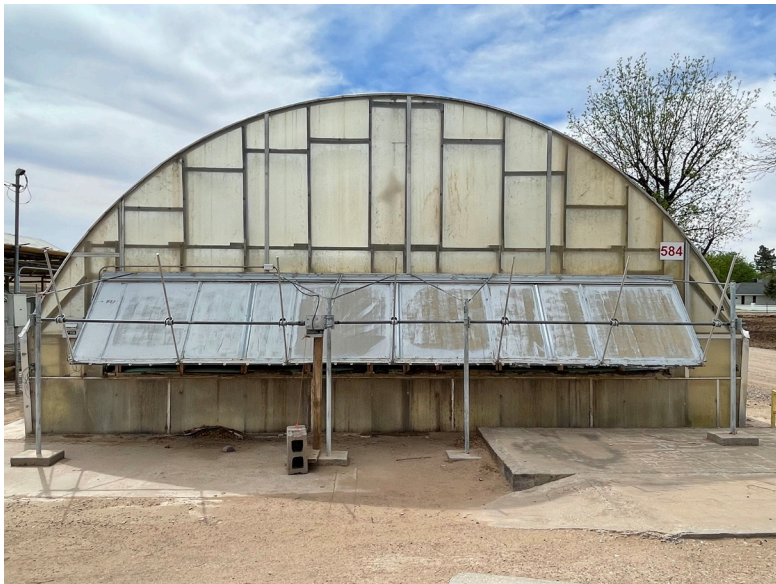
GREENHOUSE 584

Needs to replace rotted wood trim around Southern entry door and pressure relief ports.

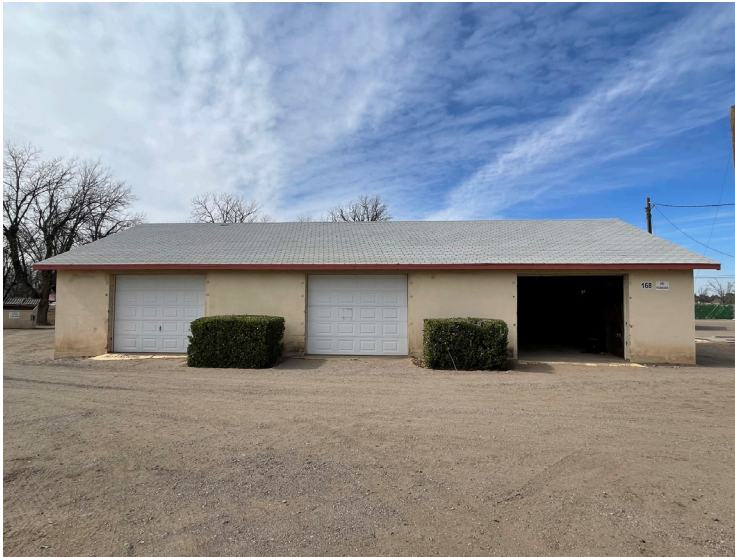
IMPLEMENT SHED 168

Stucco cracking and delaminating throughout, needs crack repairs and new exterior wall repaint, needs soffit repairs and repaint, roof shingles flown off (needs re-roofing), needs concrete apron along exterior walls on 4 sides, needs removal of all landscaping close to exterior walls, needs regrading to create positive drainage away from building, needs gutters and downleaders.

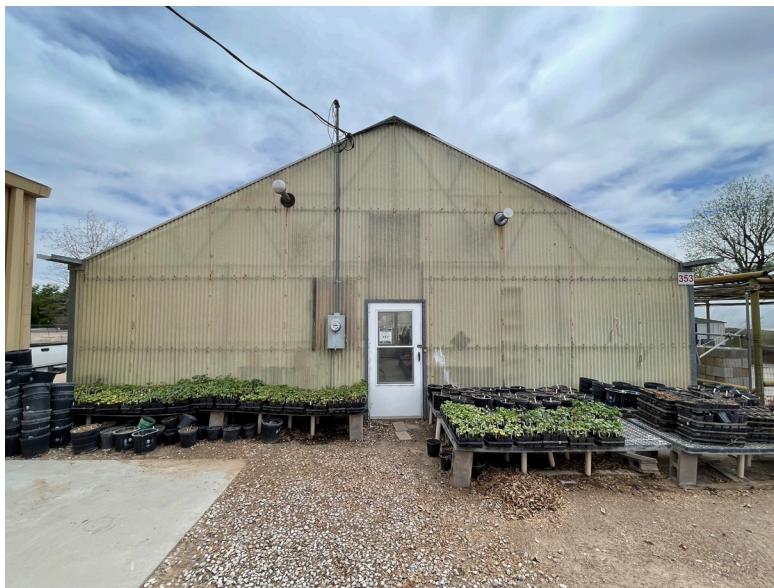
GREENHOUSE 353

Needs to replace all exterior plastic corrugated fiber reinforced panels, Needs ADA access ramp to front door, Ada hardware to entry door, needs concrete apron around headhouse exterior walls, regrade around building to create positive drainage away from building, need gutters and downleaders at headhouse.

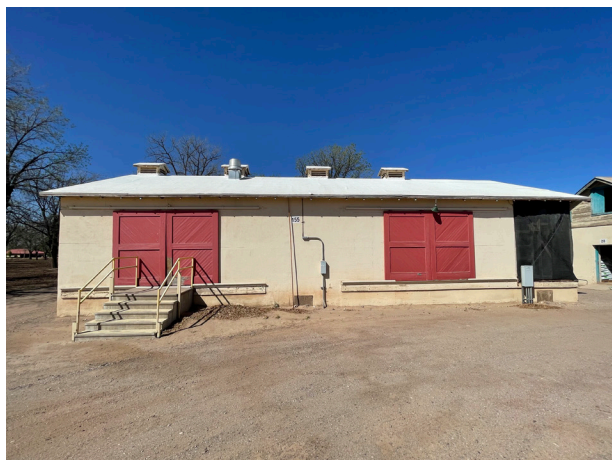
PACKING SHED 155

Repaint/ repair wooden roof monitors/ dormers/ vent enclosures, Stucco cracking and de-laminating throughout, needs crack repairs and new exterior wall repaint, needs soffit and outrigger repairs and repaint, roof coating needs removal and replace with metal R panel roof, needs concrete apron along exterior walls on 4 sides of building, needs regrading to create positive drainage away from building, needs gutters and downleaders, replace rotted wood below sliding barn doors, repair and repaint sliding barn doors, replace all rotted wood at West elevation deck fascia, repaint concrete base wall at West dock area, replace rotted wood at North entry stairs, repaint all exposed wood at North sliding doors and repaint, replace all rotted vertical shade drapes, replace all vertical wire mesh along dock perimeters.

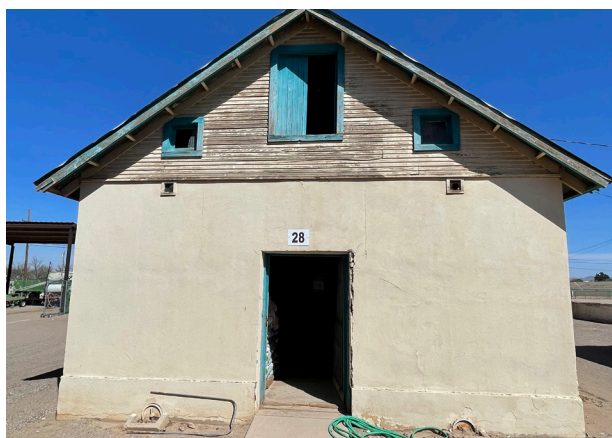
STORAGE SHED 28

Rebuild roof vents and paint, replace corrugated metal roof panels, repair wood fascia and outriggers and paint, need gutter and downleaders, concrete apron on all 4 sides, regrade to provide positive flow away from building, repair stucco at entry door jambs, repair stucco cracks and repaint, replace rotted wood and repaint all exposed wood gable ends, replace broken window at upper level, ADA ramp needed at entry door, repaint all exterior wood doors and window trims, seal all exterior wall conduit penetrations.

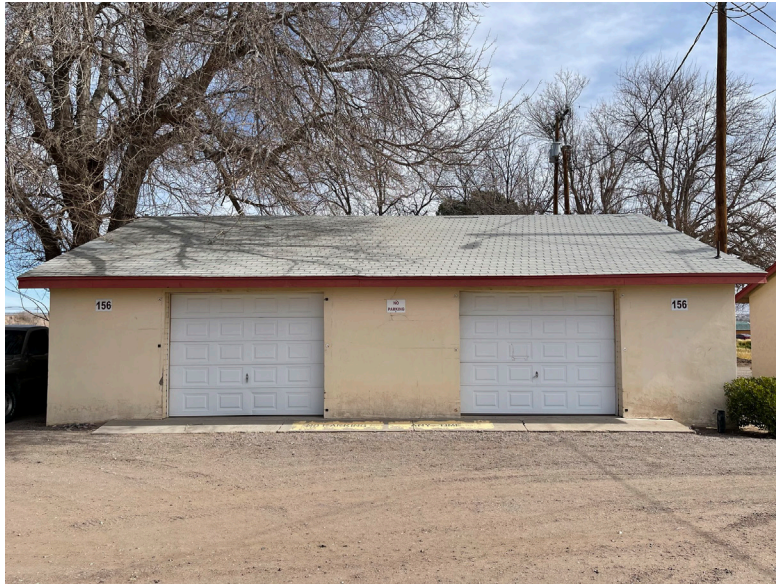
FERTILIZER STORAGE 156

Stucco cracking and de-laminating throughout, needs crack repairs and new exterior wall repaint, needs soffit repairs and repaint, roof shingles flown off (needs re-roofing), needs gutters and down-leaders, needs concrete apron along exterior walls on 4 sides, needs removal of all landscaping close to exterior walls, needs regrading to create positive drainage away from building.

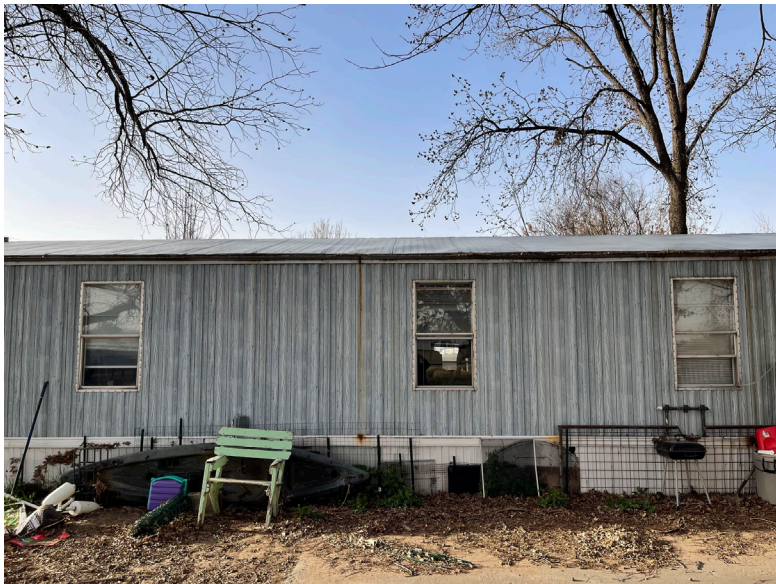
TRAILER 478

Need new skirting, new gutters and downleaders, repair damaged exterior wall panels, replace rotted wood on rear deck and repaint, trim branches over roof, need ADA access ramp and deck at entry and rear door, reinstall electrical disconnect for condensing unit, restroom not ADA accessible need replace door and complete renovation, need ADA hardware to entry door and deck door.

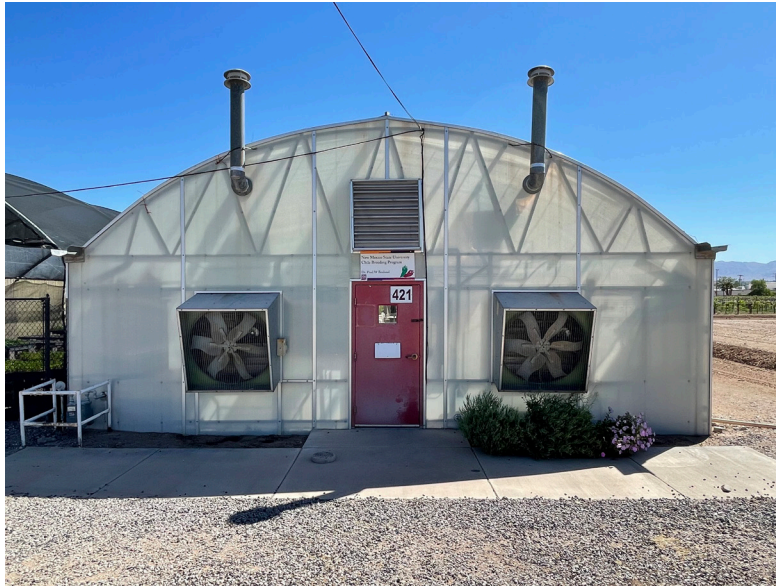
GREENHOUSE C 421

Needs to replace hollow metal entry door and frame, paint new door and frame, Need downleaders for existing gutters.

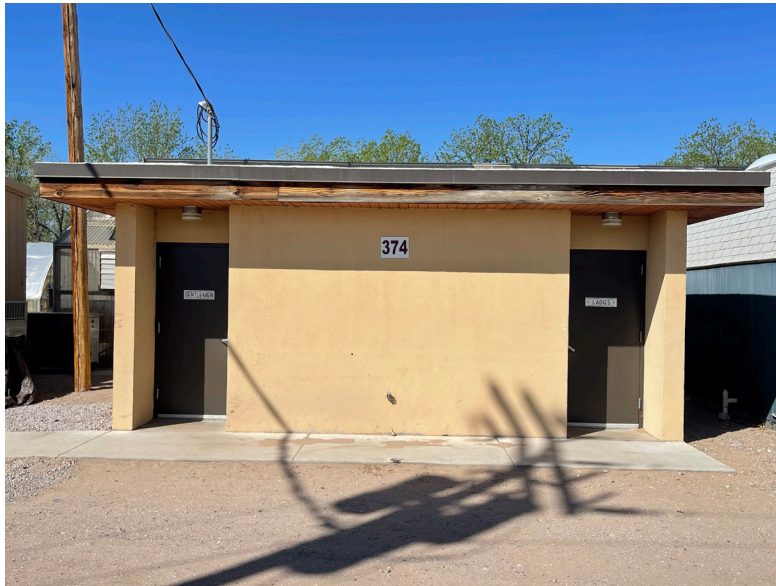
RESTROOMS 374

Replace rotted wood fascia and repaint, paint entire soffit, Need entry door ADA access by creating entry door relocation to face of wall, EIFS repairs, repaint eifs, concrete apron along exterior walls on 3 sides, need gutters and downleaders, replace interior lights to LED

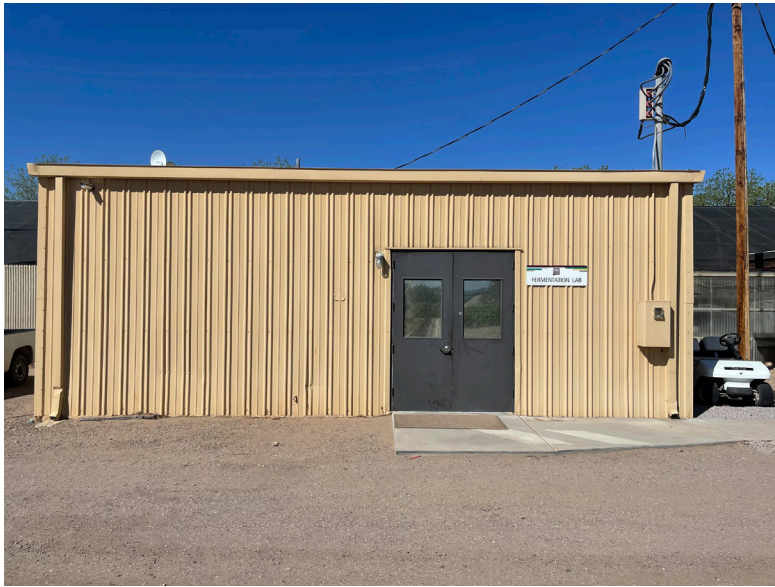
FERMENTATION LAB 659

Replace damaged metal wall panels, replace door vision panel in rear door, replace two windows with insulated windows, needs new exterior wall repaint, needs interior repairs (wall/ ceiling tiles, repaint), needs repaint of exterior doors, needs ADA hardware locks at double doors, needs concrete apron around exterior walls along 3 sides.

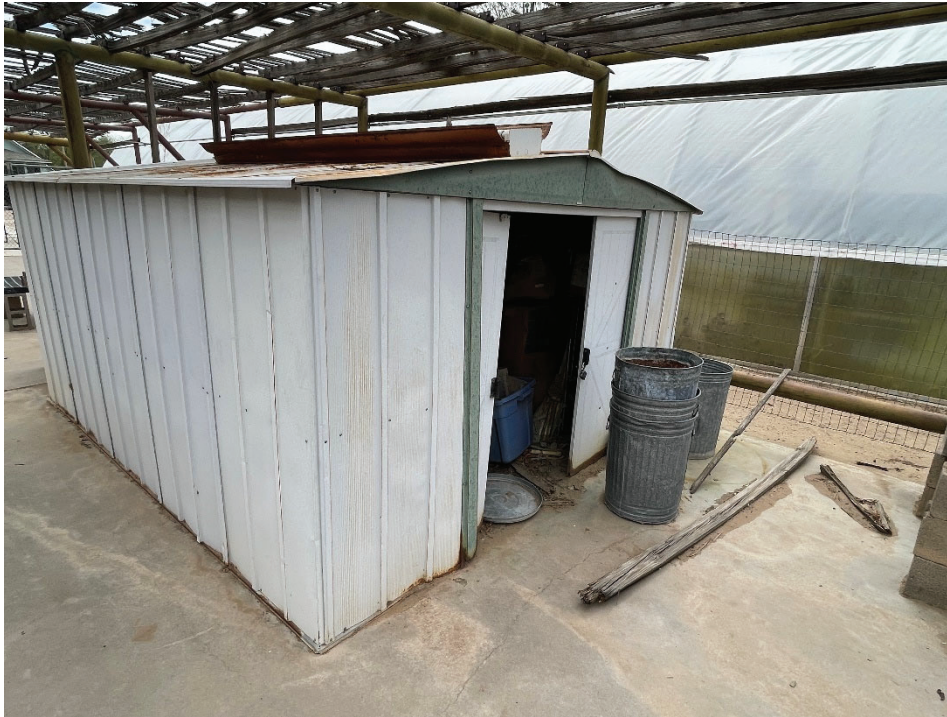
- ☒ Small storage building has rusted roof panels and damage to door assembly. Building beyond feasible repair

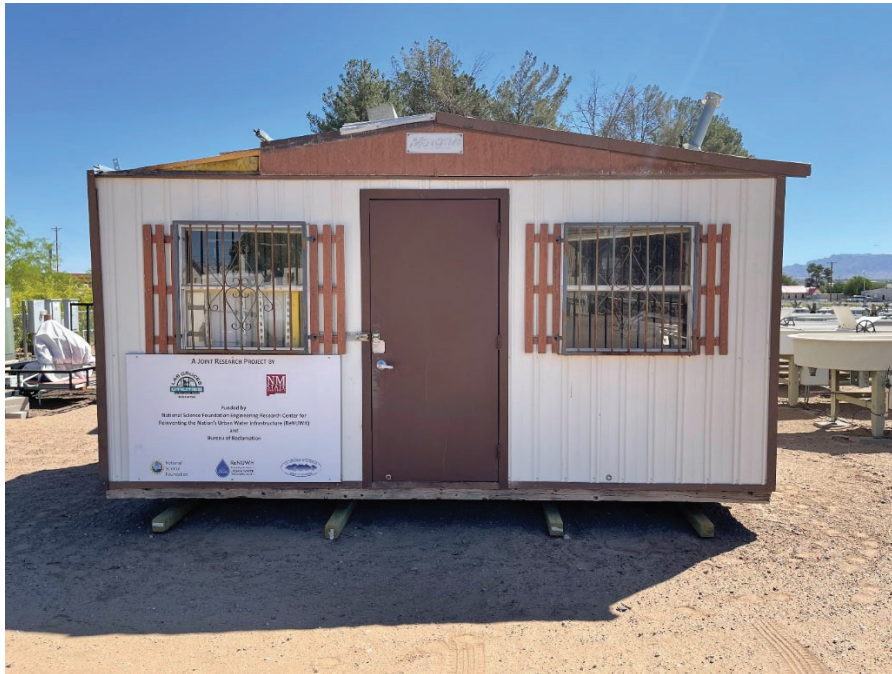
- ☒ Storage building has missing roof in sections. Building beyond feasible repair.

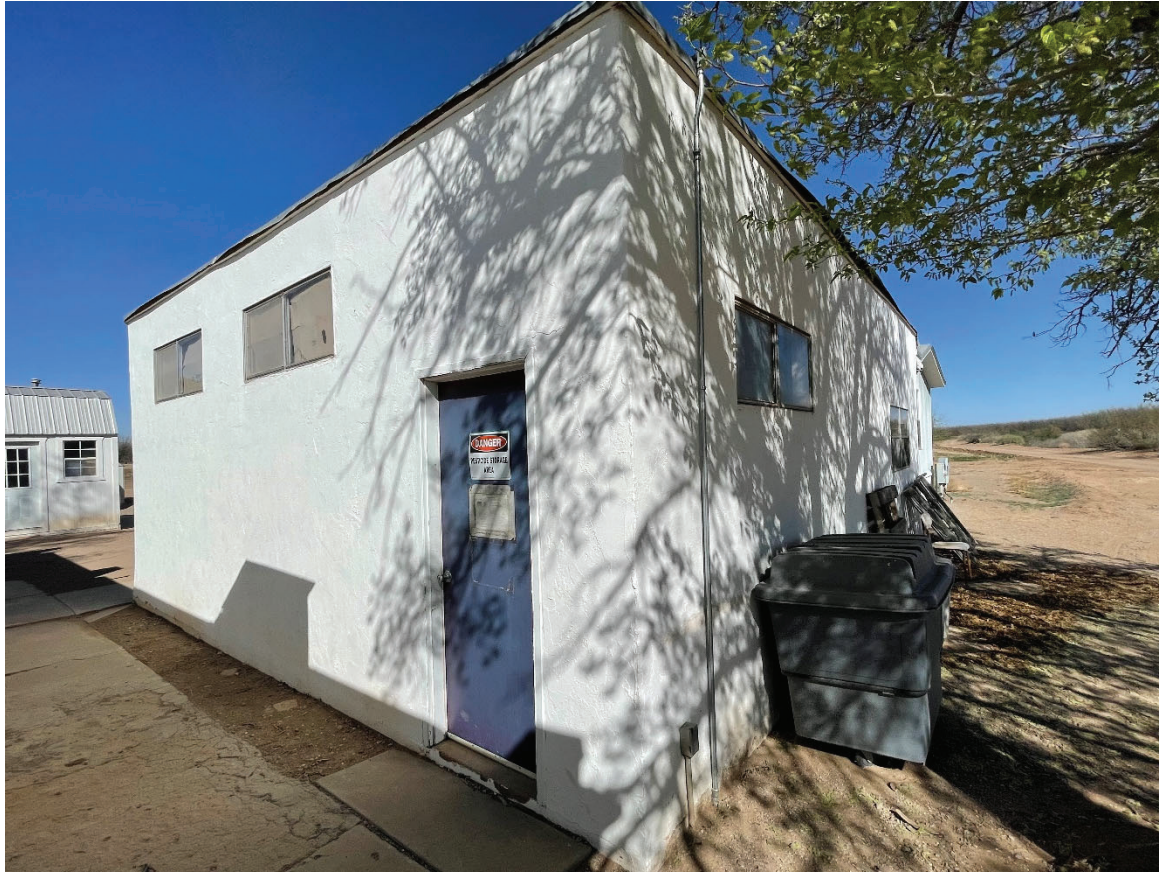
Weed research Pesticide storage/ equipment storage:

Needs: regrade South side, stucco crack repairs and repaint, new side walk along south side and ramp, repair door jambs/ trims and repaint, ADA access hardware, parapet metal cap reattachment, overhead door seals, repair/ repaint door jambs and head on West doors.

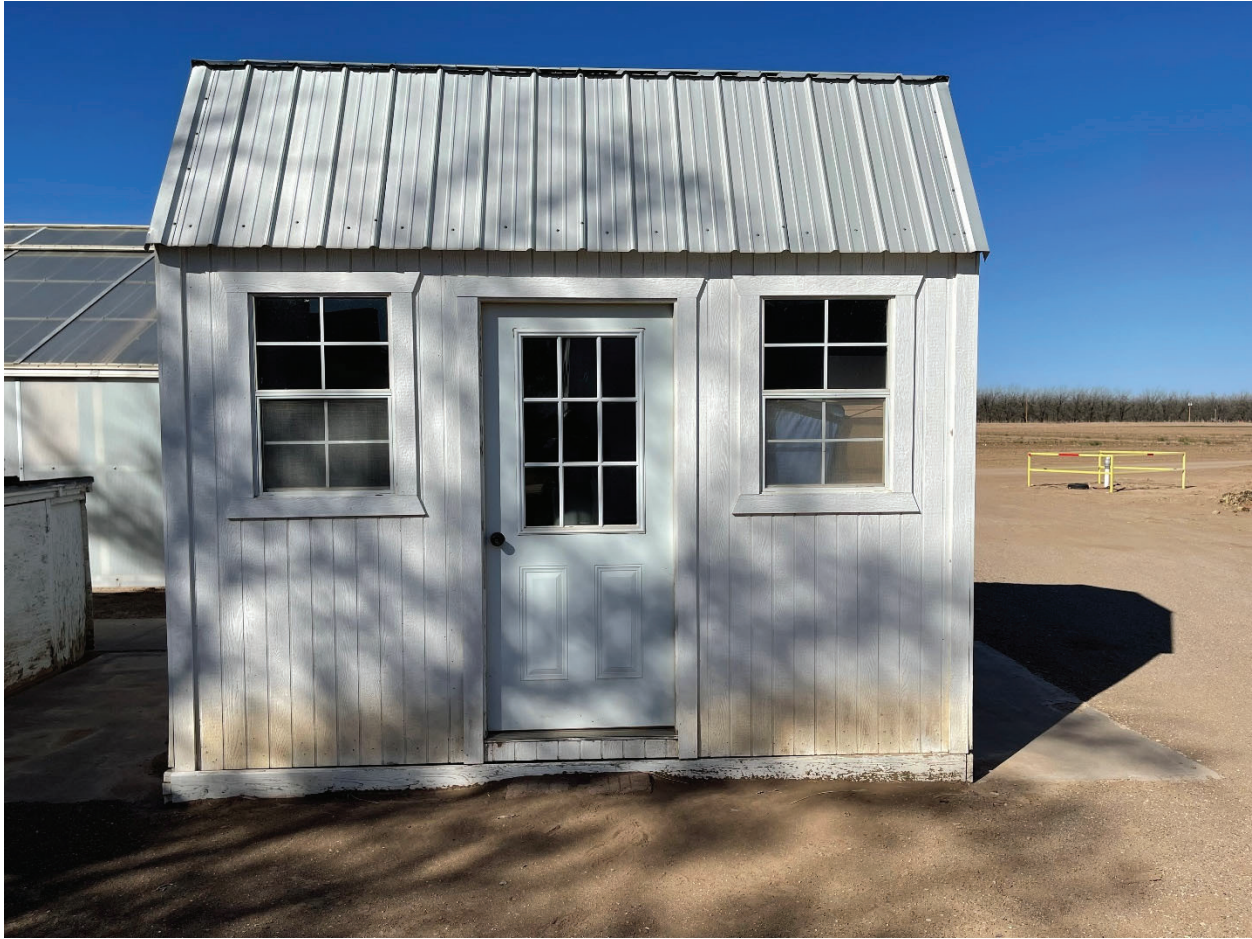
Weed research storage shed:

Needs: Repaint exterior siding, concrete entry stoop, ADA door hardware, rain gutters and down leaders.

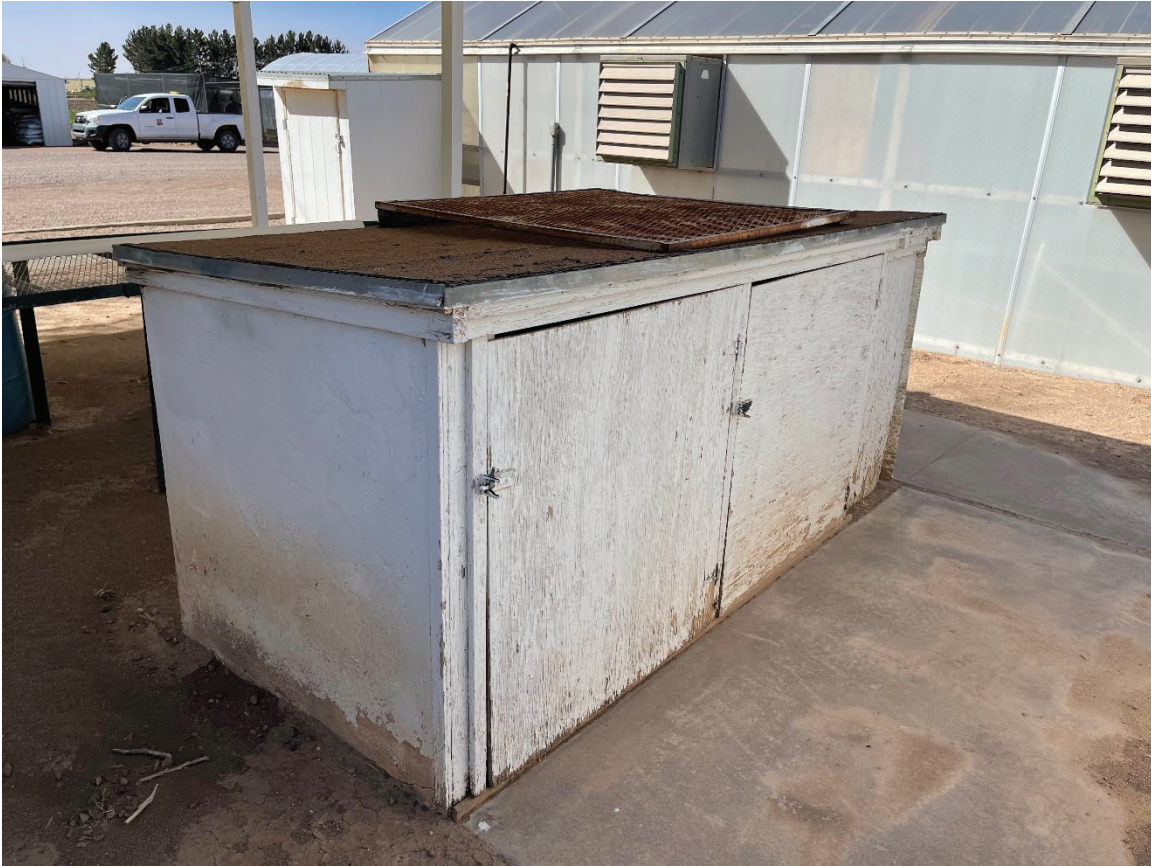
Weed research pot storage box:

Needs: Repaint exterior wood and plaster surfaces, replace rotted door, new roof.

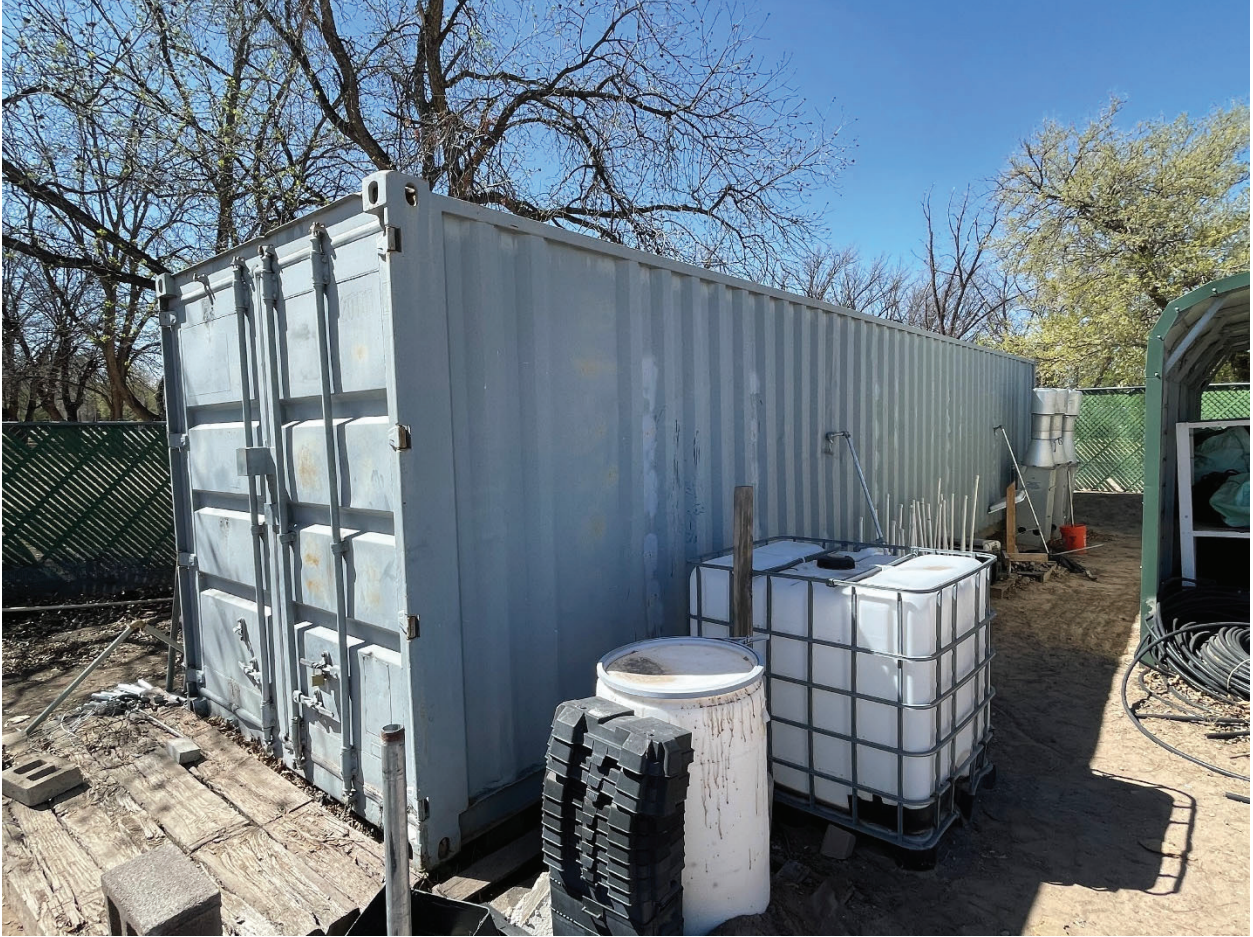
Boxcar Storage:

Needs: Repainting, concrete stoop at entry.

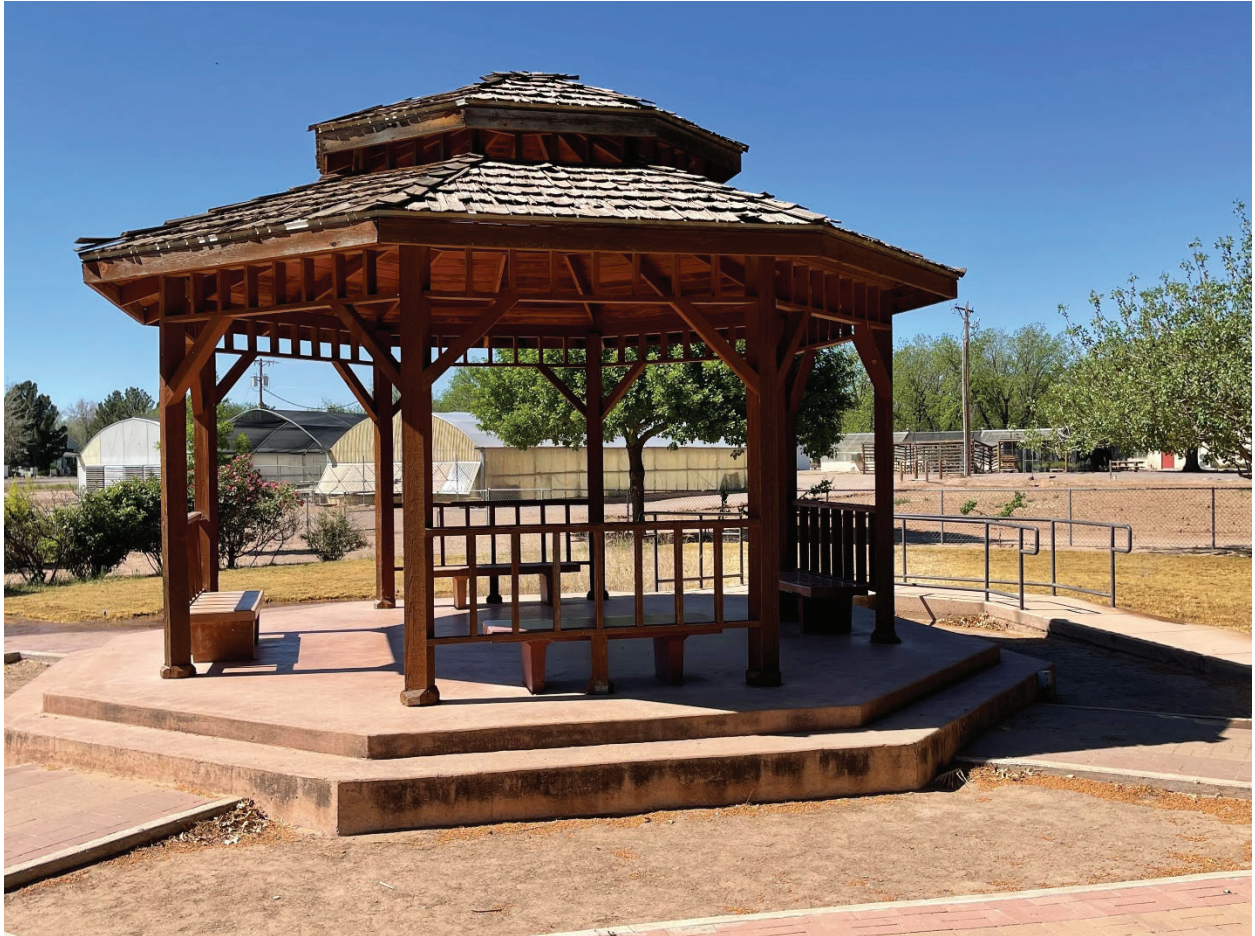
Gazebo:

Needs: Reseal all wood columns, railings and perimeter wood fascias, replace rotted wood shakes.

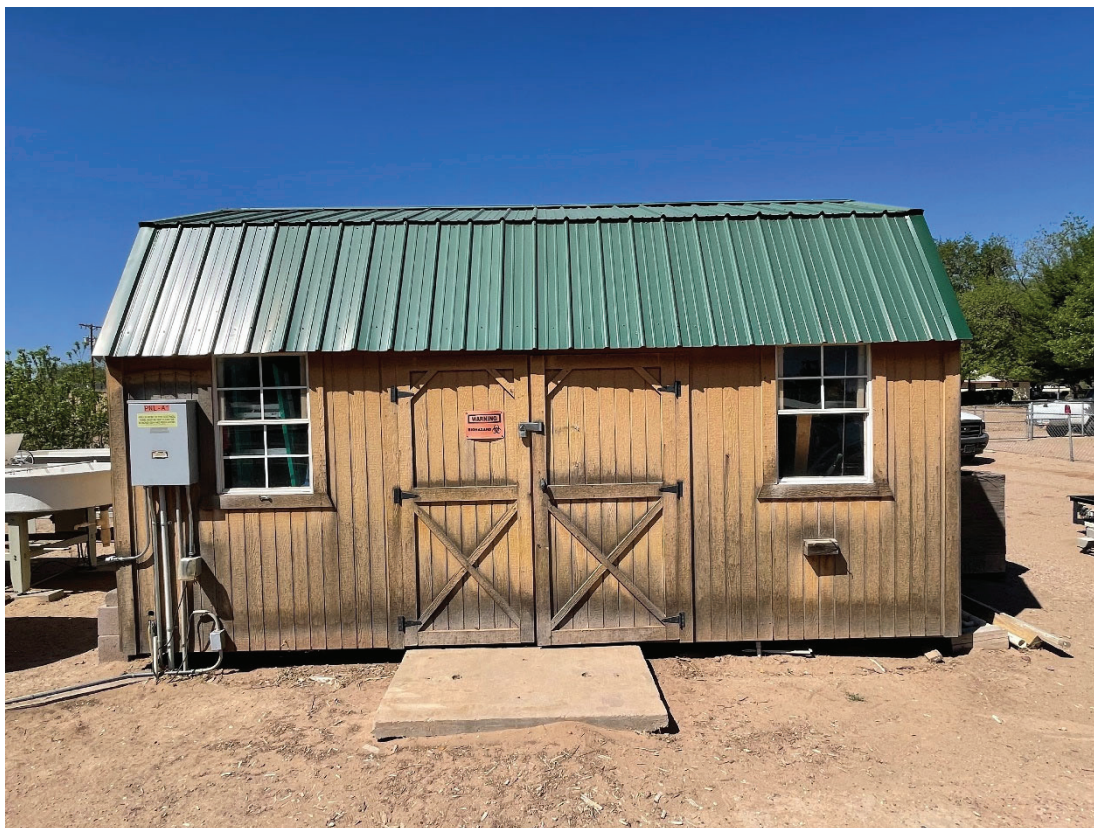
Pesticide Storage:

Needs: Repaint all siding, replace one warped door, Rain gutters and down leaders.
