Fabian Garcia & Leyendecker Plant
Science Research Center

BOOK 9 OF 12

FACILITIES MASTER PLAN REPORT

Executive Summary | July 2023

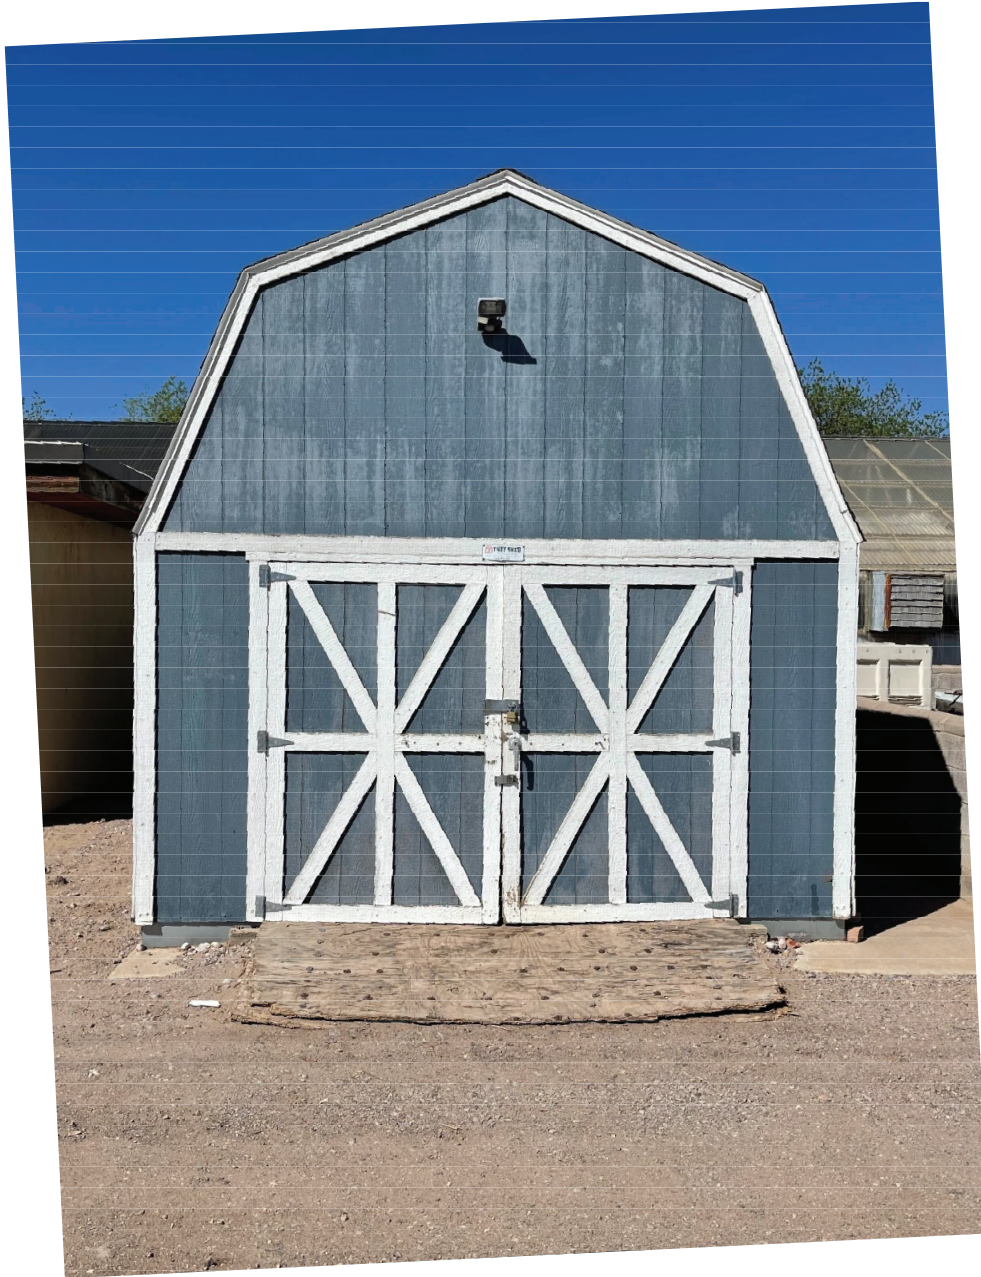
Tuff shed Storage 1:

Needs: Replace warped doors, new shingle roof, repair damaged wall siding, repaint all exterior surfaces, rain gutters and down leaders, concrete entry ramp, regrade 2 sides for positive drainage.

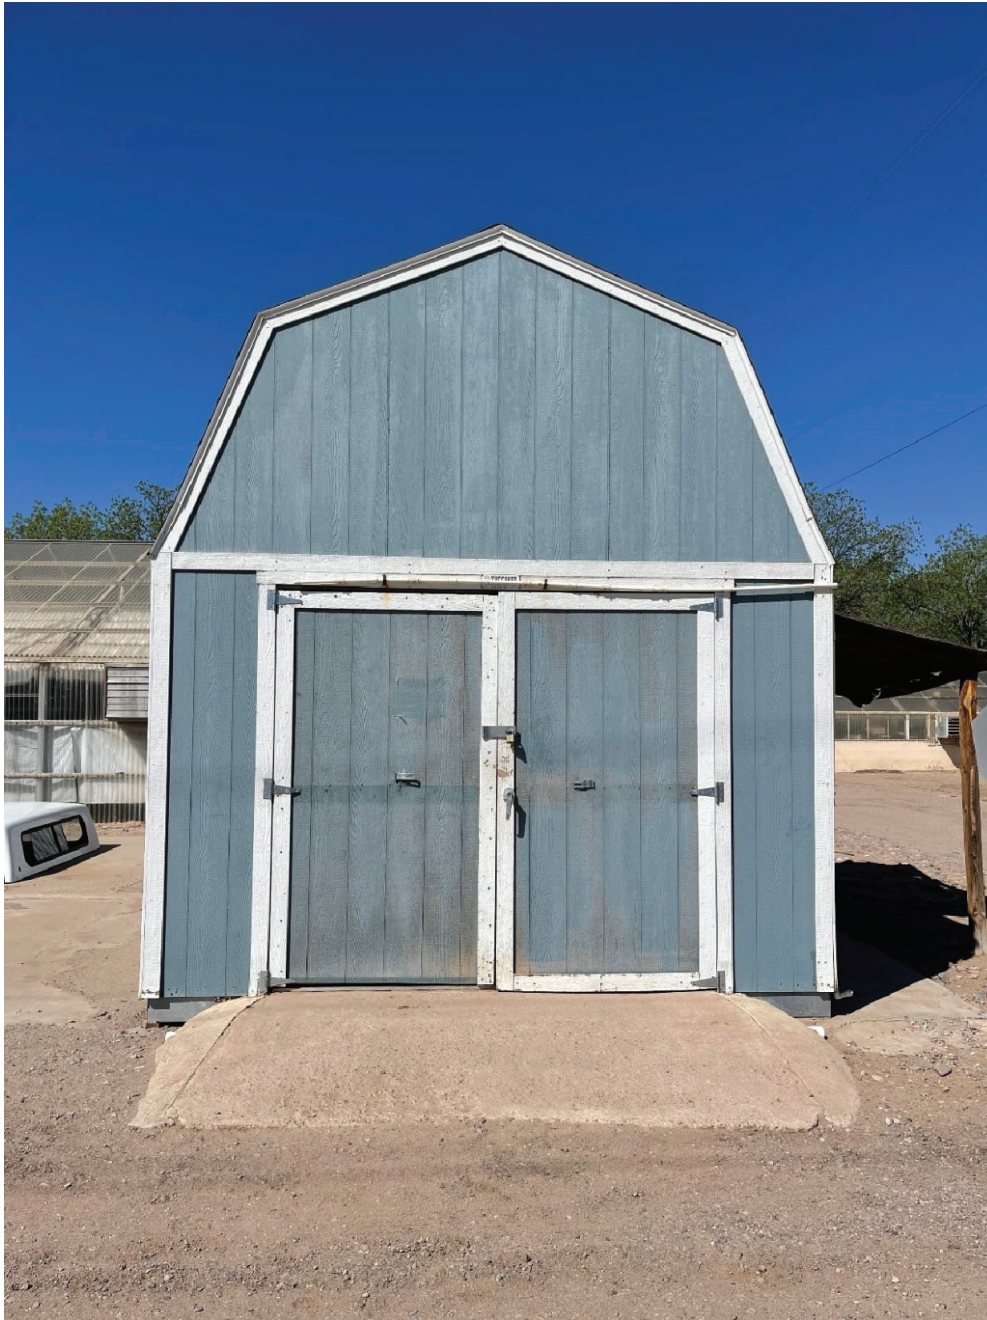
Tuff shed Storage 2:

Needs: Replace damaged doors, replace rotted accent corner trim, new shingle roof, rebuild attached shade structure along North side, repaint all exterior surfaces, rain gutters and down leaders.
