New Mexico State University

Science Center at Tucumcari

FACILITIES MASTER PLAN REPORT

NMSU REX E. KIRKSEY AGRICULTURAL SCIENCE CENTER AT TUCUMCARI

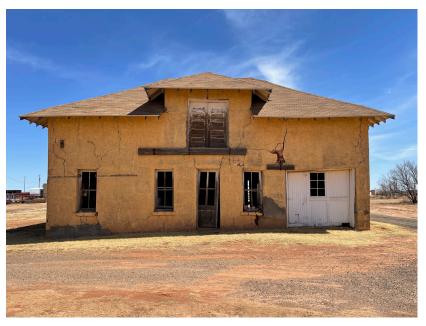
STORAGE BARN 4041

This building has eroded foundations and load bearing walls, shows differential settlement, has negative water drainage toward it from road, the floor is heaving and needs new roof. This building it's a candidate for removal and replacement.

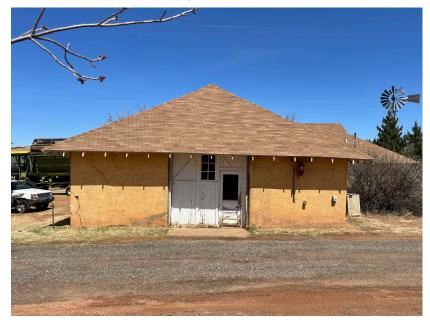
SHOP AND STORAGE 404E

This building has eroded foundations and load bearing walls, shows differential settlement, has negative water drainage toward it from road, the floor is heaving and needs new roof. This building it's a candidate for removal and replacement.

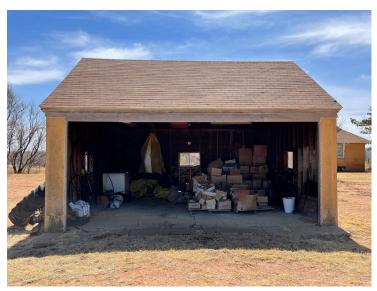
GARAGE A 404 H

The stucco is cracked and need repair, it has differential settlement, the building East wall is leaning and has rotted wood in all interior walls. This building is candidate for removal and replacement.

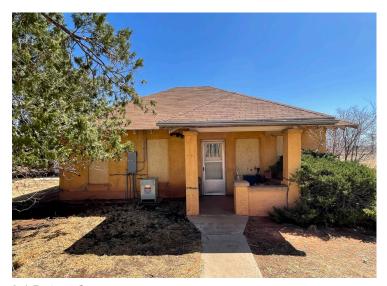
LAB 404C

The building needs an ADA accessible route and parking spaces to the building entrance and North door. Existing stucco has cracks that need to be repaired and repainted, it needs a new roof including gutters and downleaders. The roof outriggers need repairs and or replacement, and adding or repaint entire soffit areas. Need a ADA restroom, the concrete floor has big gaps and cracks that needs to be repaired and coated with epoxy, and the building needs ADA lockset throughout. All wood at entry porch needs to be primed and repainted. Remove vegetation from next to building, concrete apron all around with regrade for positive drainage away from building,

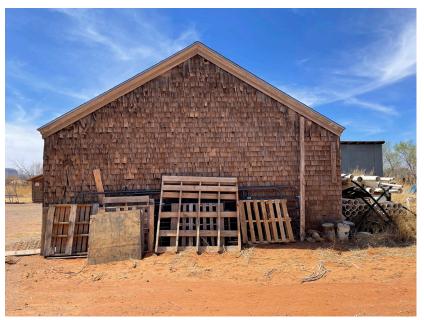
CARPORT 404F

The East side of the building has extensive rot to be repaired, the foundations are eroded, and has differential settlement, the East wall has rotted wood and is leaning, and in the North elevation shakes are rotted, This building is candidate for removal and replacement.

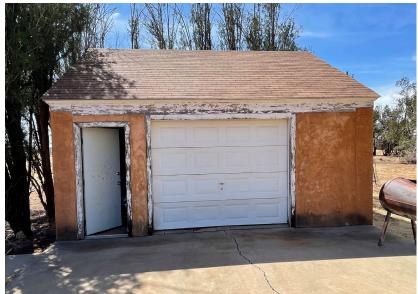
GARAGE B 404G

This building need a new front door and overhead garage door including new jambs. The wood cornice trim needs to be repaired and painted. It needs a need new roof including gutters and downleaders. It needs a concrete apron all around with additional site grading. Repair stucco cracks and repaint, need to install new window trim and paint, and replace the garage concrete floor and driveway apron since is severely cracked need replacement.

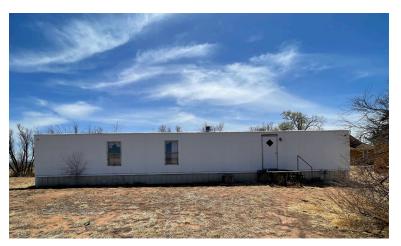
GRADUATE STUDENT TRAILER 404L

Need ADA ramp and deck with parking space, roof leak repairs, gutters and downleaders, need ADA restroom, need skirting repairs, concrete apron and positive drainage regrade away from foundation.

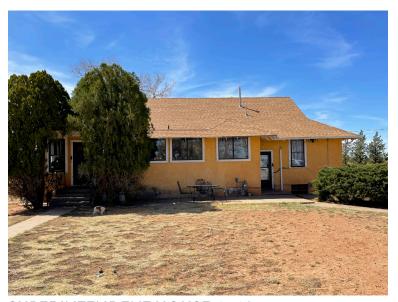
SUPERINTENDENT HOUSE 404A

Needs ADA access and parking space with accessible route to entrance. Exterior walls has cracked stucco coat in needs of repairs and repaint. The window accents and trim need repainting, the roof framing outriggers need replacing, repaint, and repair along with the soffits, the North and South dormer-wood vent need repainting. Replace broken concrete apron, the basement concrete perimeter stem wall needs extensive crack repairs and an exterior drainage tile system to stop moisture from reaching it. The basement concrete floor needs extensive patching and coating at sewer line repair work. Inside the building, ceiling repairs are required throughout and repaint, as well as wall cracks that require patch, repair and paint.

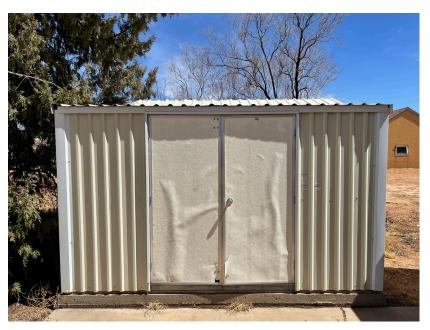
OVEN DRYING BUILDING 404K

Need new hollow metal doors and new concrete entry stoop including regrading the site to drain away from the building with ADA ramp and ADA hardware.

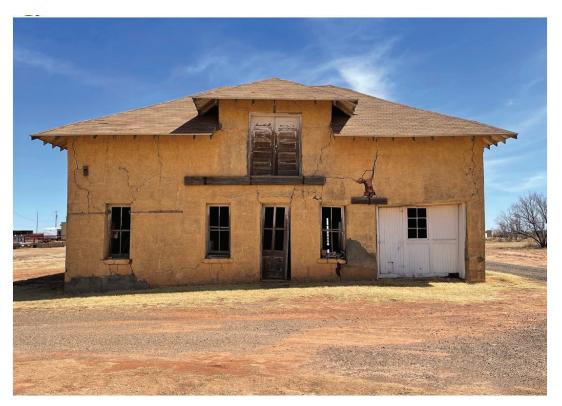
The subject building is a rectangular, two-story load-bearing adobe wall structure which is currently used for storage of hand tools and other small size materials. The building has been temporarily reinforced with tension cables along all four perimeter walls to stop the adobe walls from buckling further and collapsing. The adobe walls have eroded beneath the exterior stucco layer in various locations due to years of water intrusion, thereby weakening the walls' load bearing capacity. The stucco system has come lose from its connection to the adobe bricks in most areas and is mostly loose and unstable. Thru-wall cracks indicating differential settlement are evident along the perimeter walls. The perimeter walls are leaning in different directions as a result of differential settlement and damage to the adobe bricks.

Based on our observations, it is our opinion that this building is beyond restoration as it would not be cost-effective to attempt to rehabilitate/ restore it with its buckling adobe perimeter walls. This building has extensive differential settlement and vast structural problems. It is our belief this building presents a safety hazard for users and should be considered a candidate for demolition.

View of main façade showing structural cracks throughout the adobe walls due to differential settlement. This condition is typical.

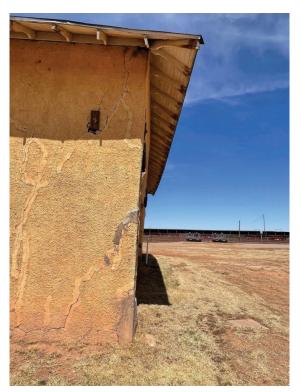
View of Southeast corner showing wall leaning out with differential settlement. This condition is typical.

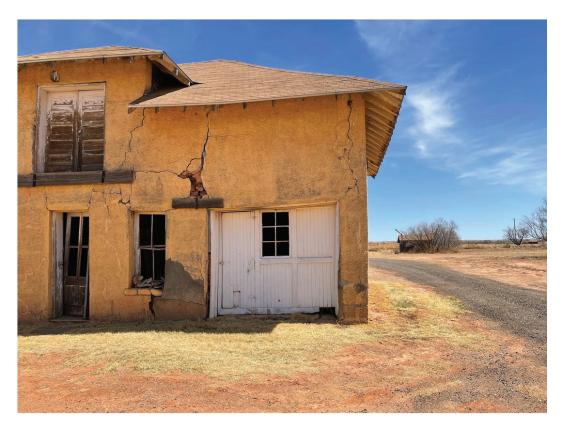
Close-up view of structural cracking and differential settlement. This condition is typical.

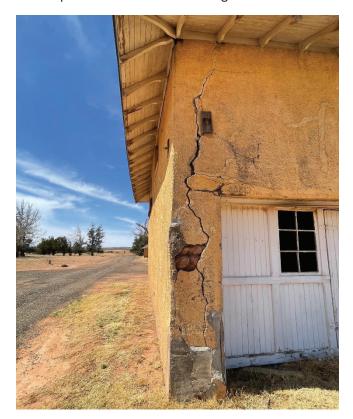
View of corner settlement and through-wall cracking. This condition is typical.

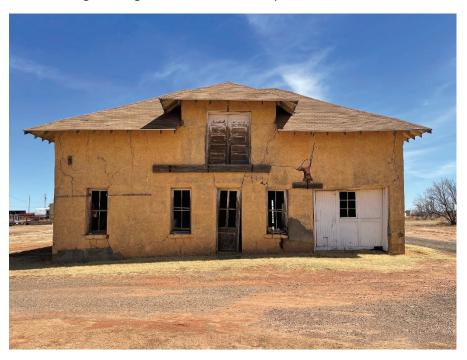
Horse barn has differential settlement. Building is beyond feasible repair.

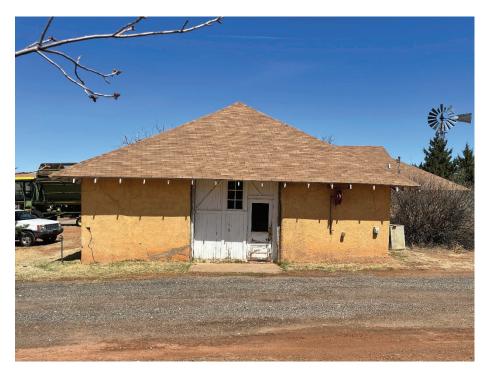
Shop building has differential settlement. Building is beyond feasible repair.

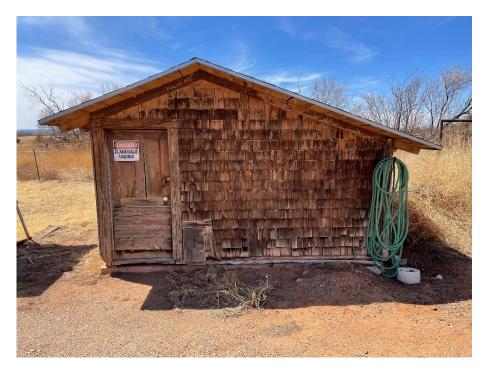
The fuel storage is a combustible building with rotted wood and has erosion undermining foundation. Building beyond feasible repair

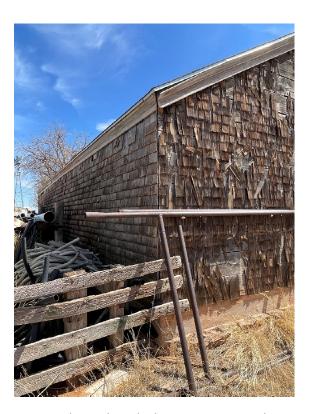
• The multi-vehicle storage carport has rotted shakes and cornices all throughout. Also, it has erosion undermining foundation. Building beyond feasible repair

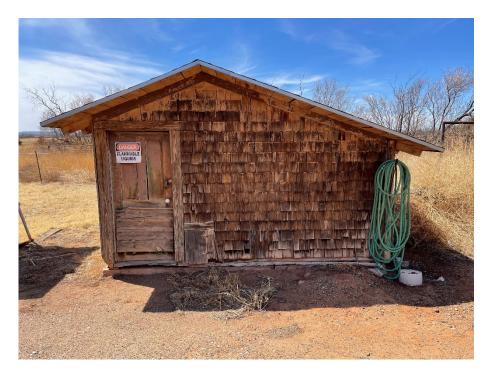
The fuel storage is a combustible building with rotted wood and has erosion undermining foundation. Building beyond feasible repair

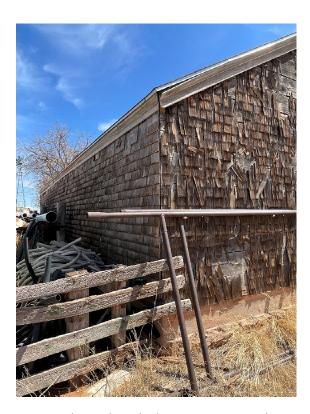
• The multi-vehicle storage carport has rotted shakes and cornices all throughout. Also, it has erosion undermining foundation. Building beyond feasible repair

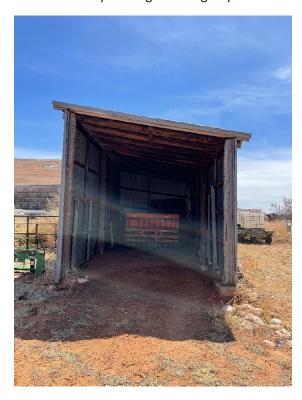
• The single bay implement storage has rotted wood columns sitting on earth. It has erosion undermining foundation. Building beyond feasible repair

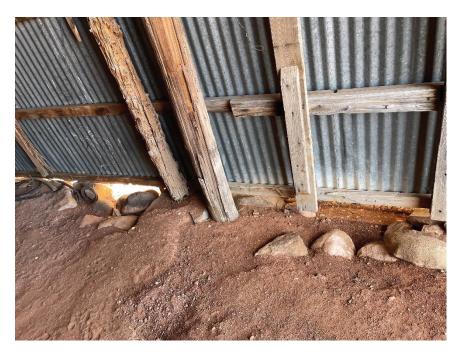
The single bay implement storage has rotted wood columns sitting on earth. It has erosion undermining foundation. Building beyond feasible repair

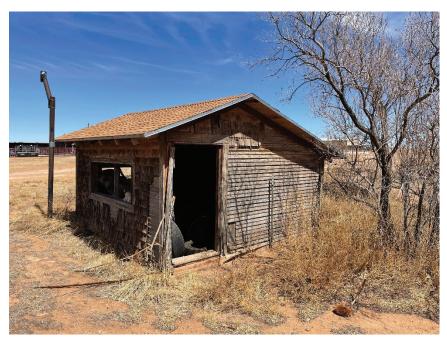
The tire storage is a combustible building with rotted wood throughout. Building beyond feasible repair

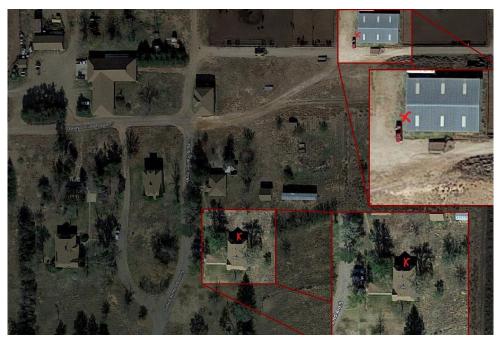
DMARC and network equipment reside in the basement used for storage. The Main Office needs to be rewired and more wireless access points could be use in Auxiliary buildings.

Network space is needed at this ASC and needs to meet standards. It is our recommendation to build out an IT/network space for this ASC. If there is no room that can be modified into this space, it is our recommendation to build a separate IT/network space outside, close to the existing DMARC, that is cooled, isolated only for IT needs, has proper lighting, floor loading, power, network racks and equipment, airflow, and meets standards.
