Facilities and Services
Project Development
and Engineering

New Mexico State University Campus-Wide Tunnel System Repair Plan

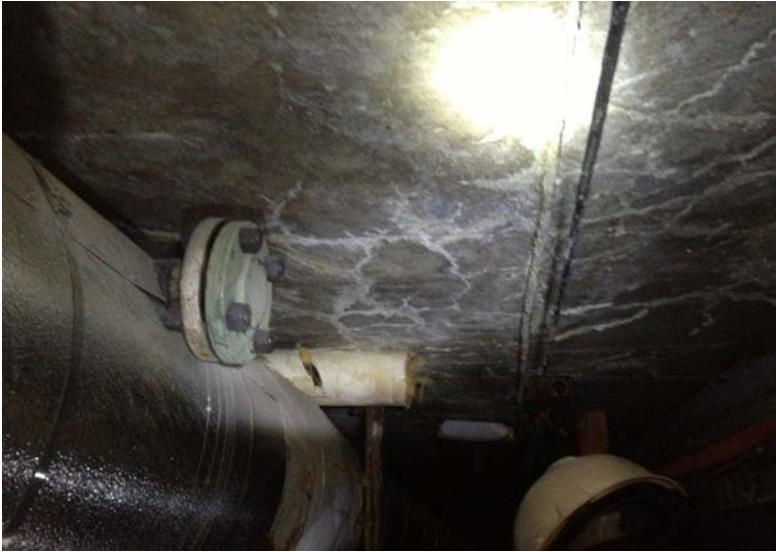
Lid Section Failure

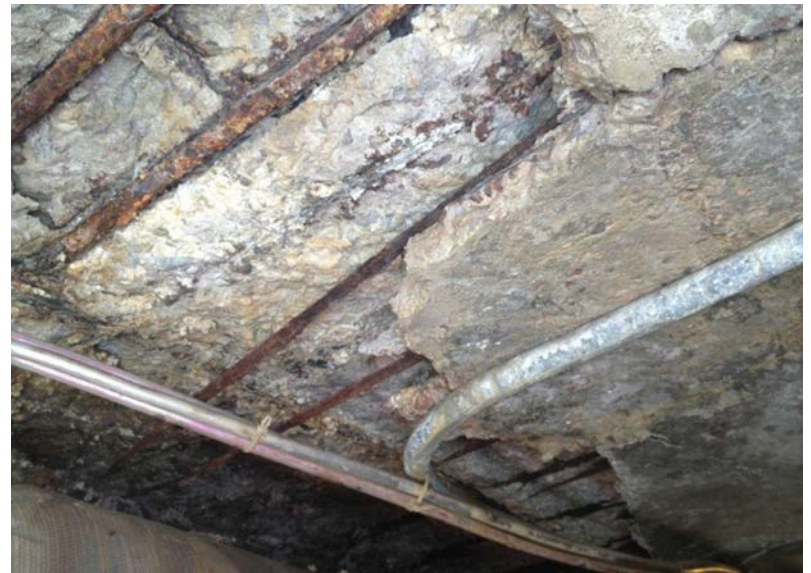
Extensive Reinforcement Corrosion

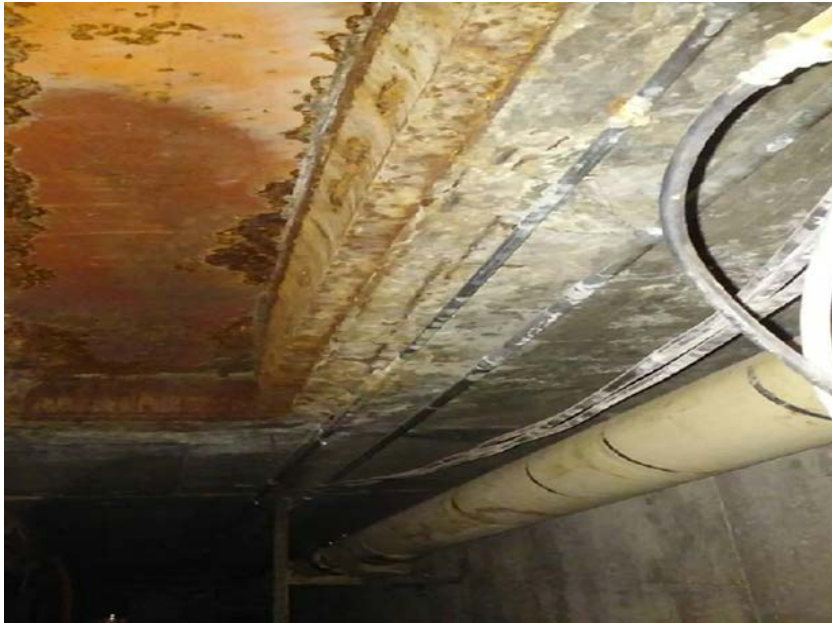
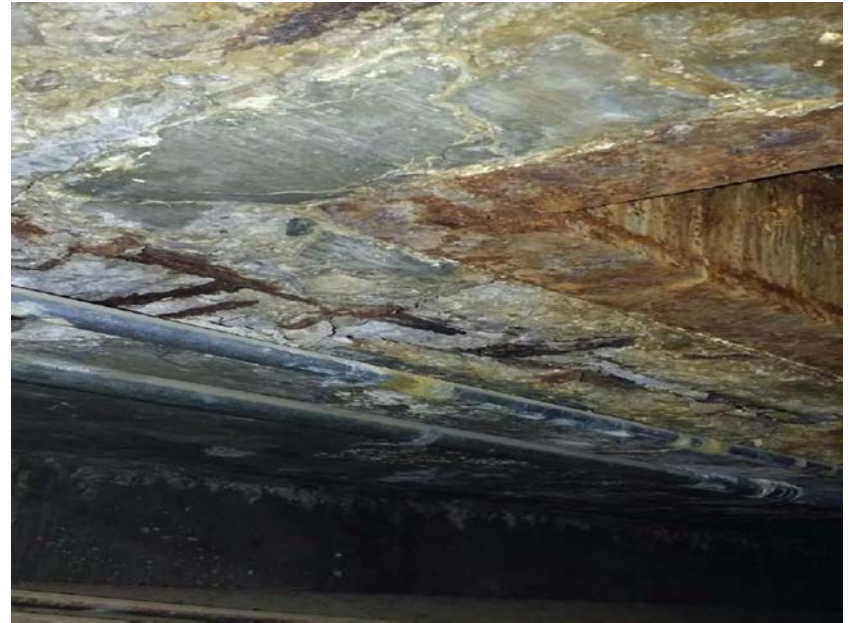
Extensive Reinforcement Corrosion
