Building Investigation, Design and Consulting

Project: DACC Media Center Roof Inspection, NMSU Las Cruces

Overall Conditions, Recommendations

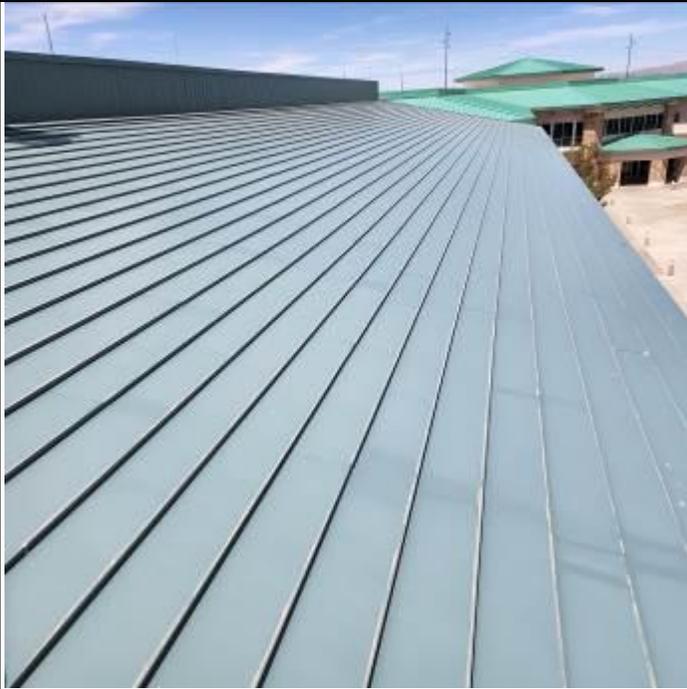
1. This roof system is a Berridge metal roof panel called Bermuda. This roof is designed to be applied on roofs with 3.5" per foot and greater. The current condition has valleys, hips, and ridges less than 1.5" and the main field of the roof is approximately 2.5" per foot slope with the flat portion of the panel less.

001 overview of Berridge metal roof panel called Bermuda. The roof is less than the manufacturers 3.5" per foot slope.

5. There is no way to trace the leaks to start a program of sealing. Unfortunately, the roof was installed on the improper slope and the details are wrong. The only way to fix this is to remove and replace. Also, there is one other factor, and it is the sub straight conditions. We need to perform destructive testing see what they used for the underlayment and insulation. Currently there are no signs of insulation in the attic space. The assembly could be under insulated.

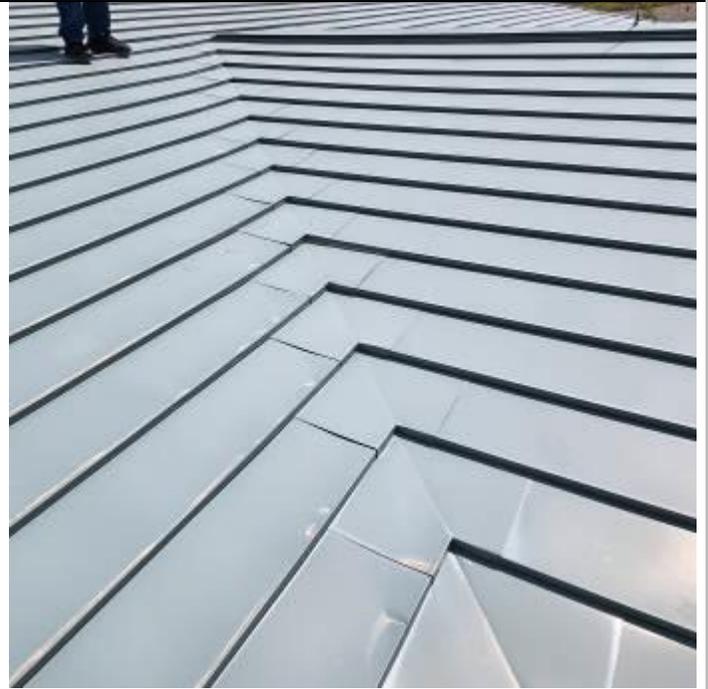
002 Overview example of valleys and hips with slopes less than 1.5" per foot

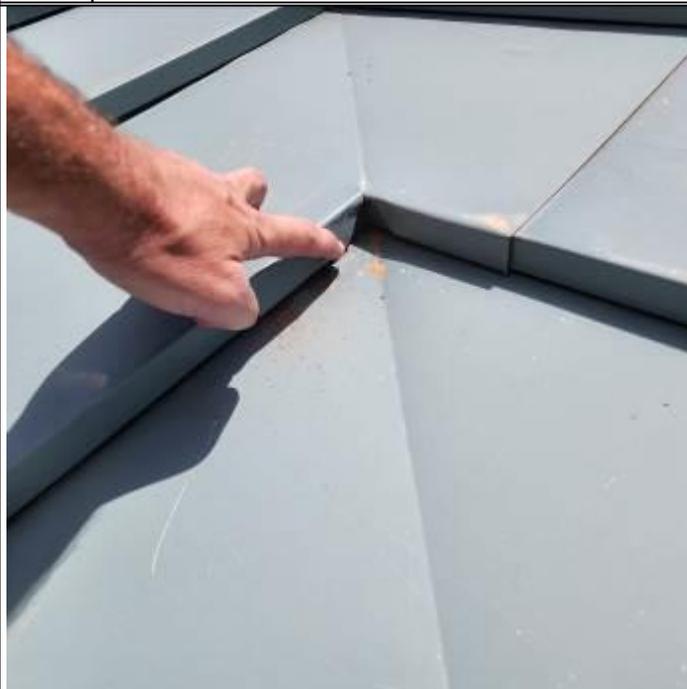
003 Typical of joints that are open in valley

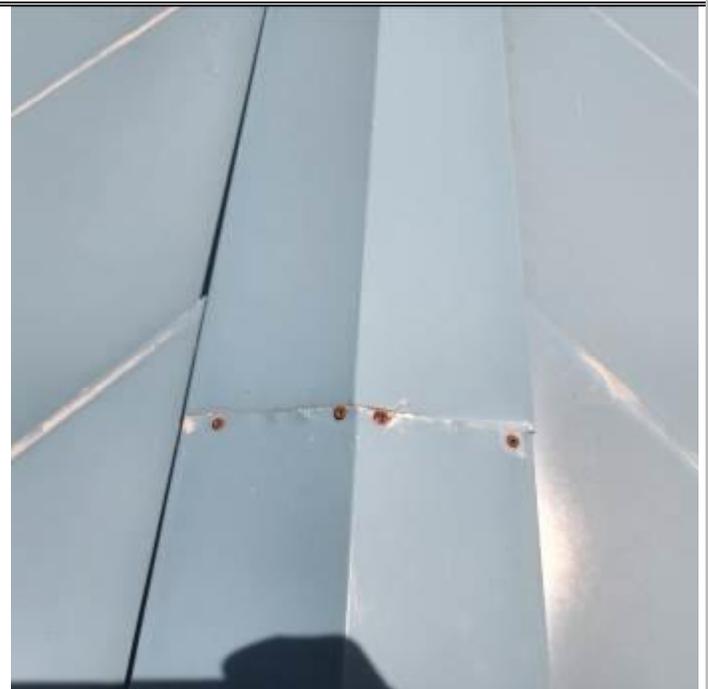
2. There are defects due improper installation details in the ridge flashing, hips, and ridges.
3. Improper use of plastic foam closures instead of neoprene foam closures.

004 Overview of Typical conditions of the hips ridge fasteners are rusted and improper sealing of joint.

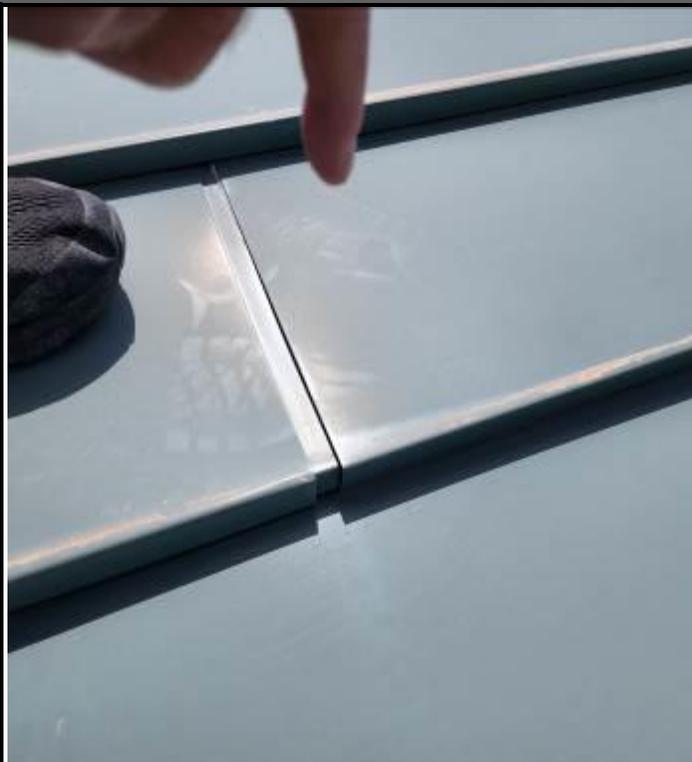
005 Typical of splice plate that is open more than 1/4" between panels.

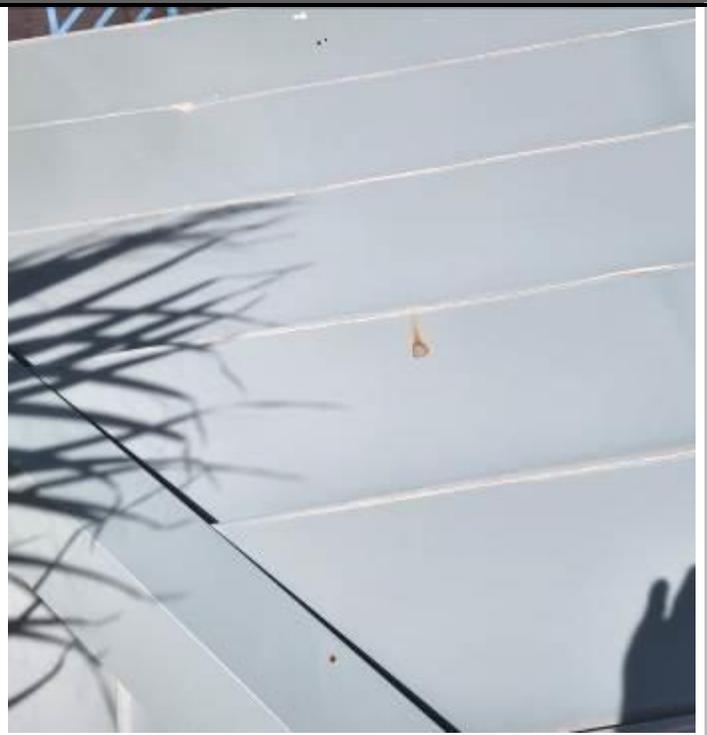
006 Overview of open panels at valley. Overview of rusted area

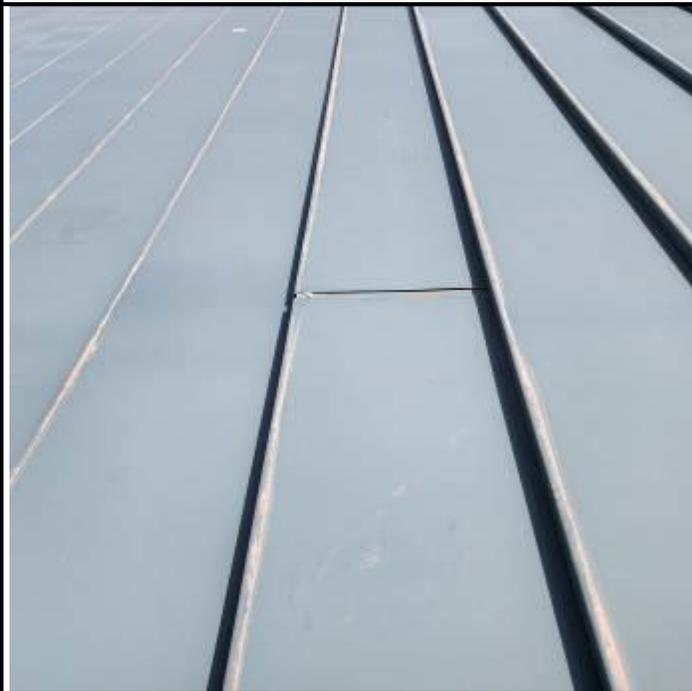
007 Typical overview of open joints and residue left from standing water

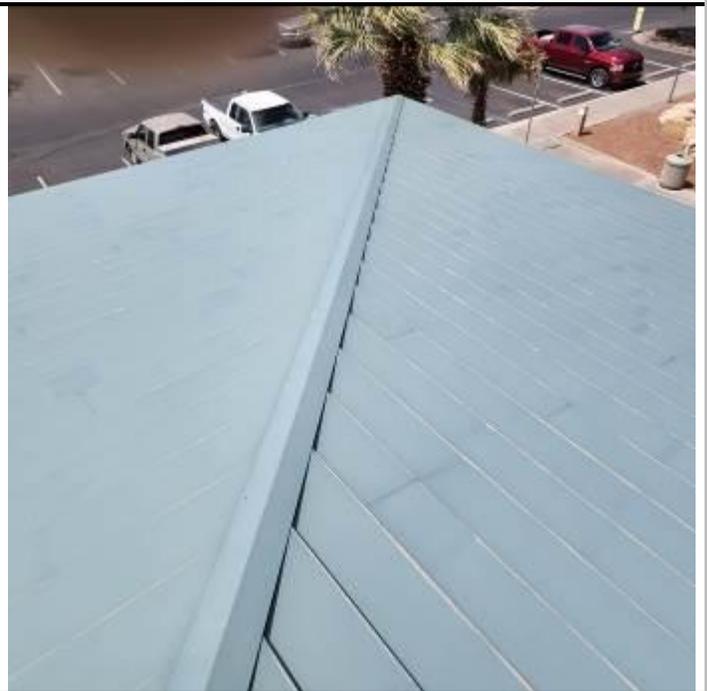
008 Typical overview of hip, residue left from standing water and water staining of panels.

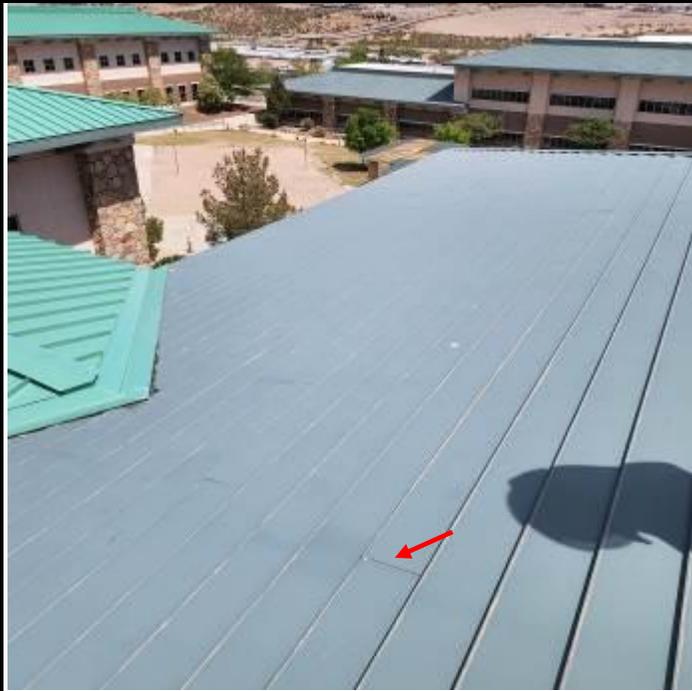
4. The water is getting in behind the panel at the laps, joints, and details. The water is then running in the flutes of the metal decking until it is gets to a lap or fastener hole. Then the water falls down onto the lower metal decking and travels until there is a lap, hole, or duct cutout. This explains the consistent water staining in the ceiling tiles under the metal roof areas.

009 This photo highlights the opening at the laps. We suspect that water is entering at this joints and along the side laps.

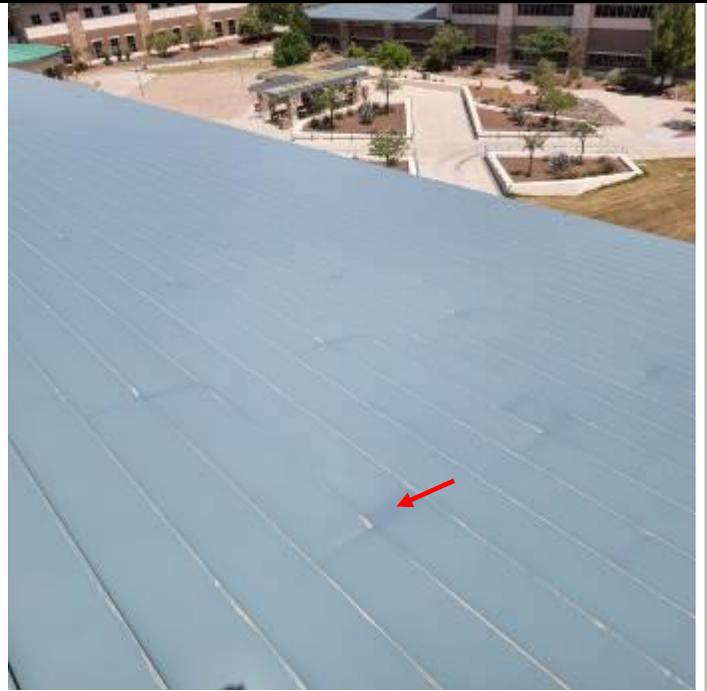
010 The arrows are showing where water is getting out under the panel. This means that water is traveling behind the panel.

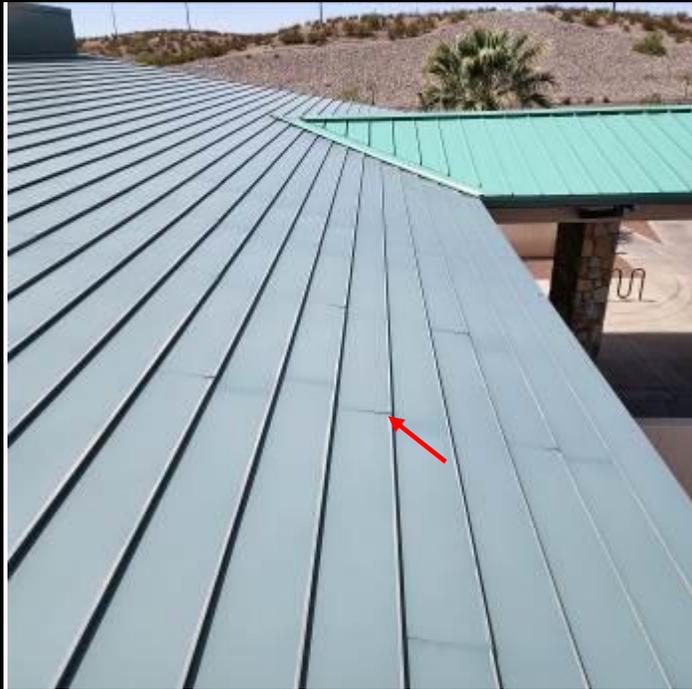
011 Typical of open seams joints.

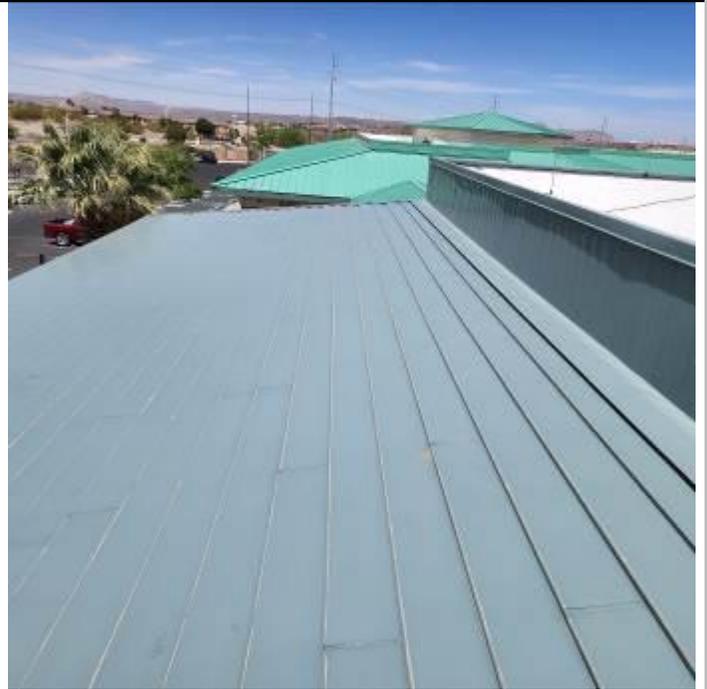
012 Typical of open seams joints and residue left from standing water.

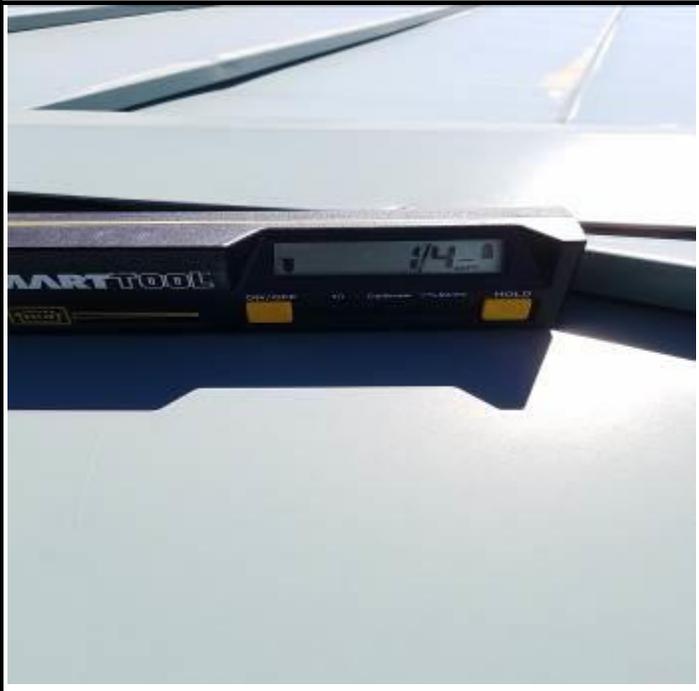
013 Typical slope on the valleys, and panel

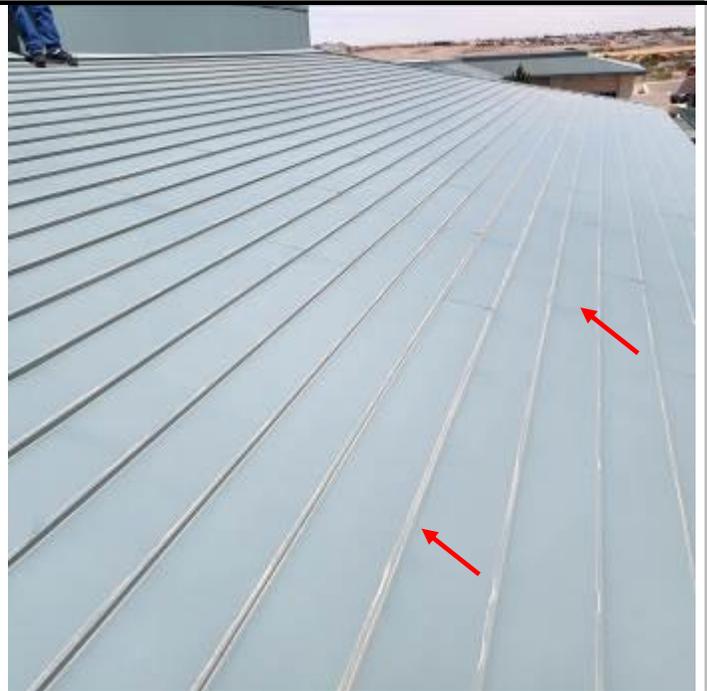
014 Overview of residue left by standing water and water stains coming from bottom of panel.

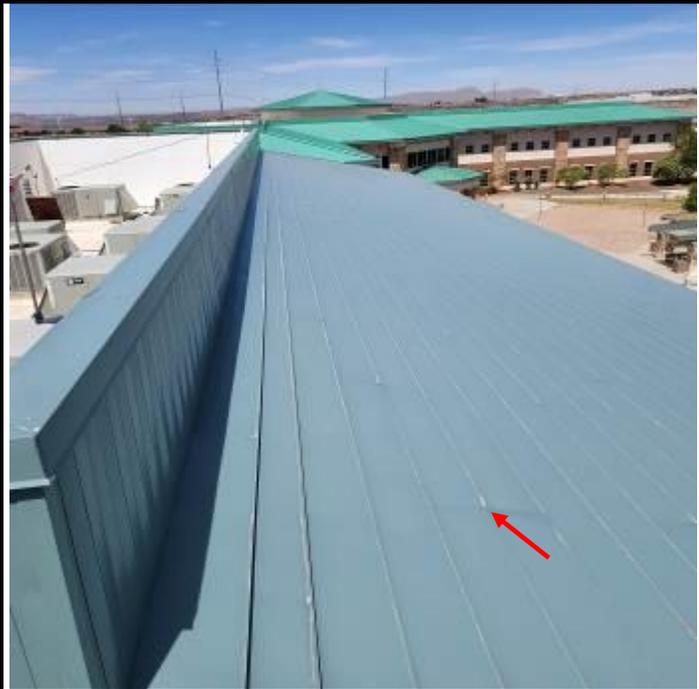
015 The arrows show residue of where water was standing and staining of panel.

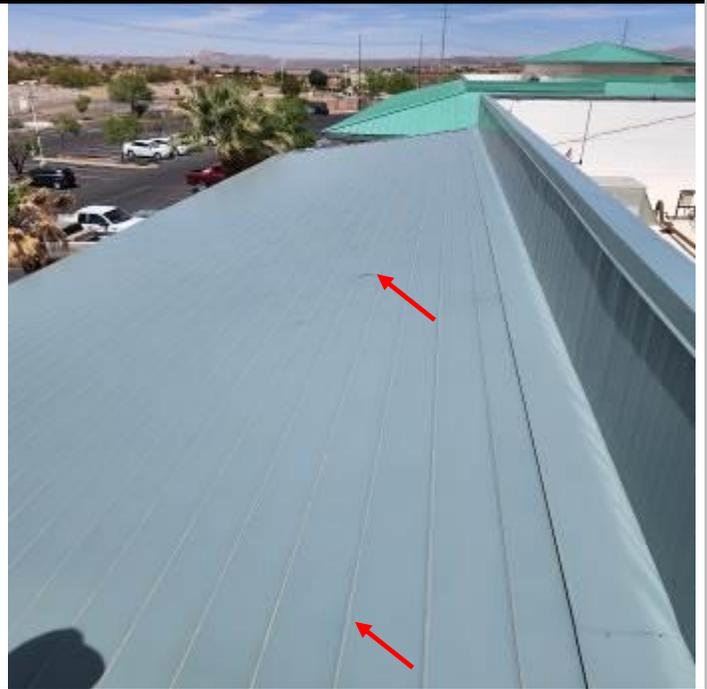
016 The arrows show residue of where water was standing and open joint.

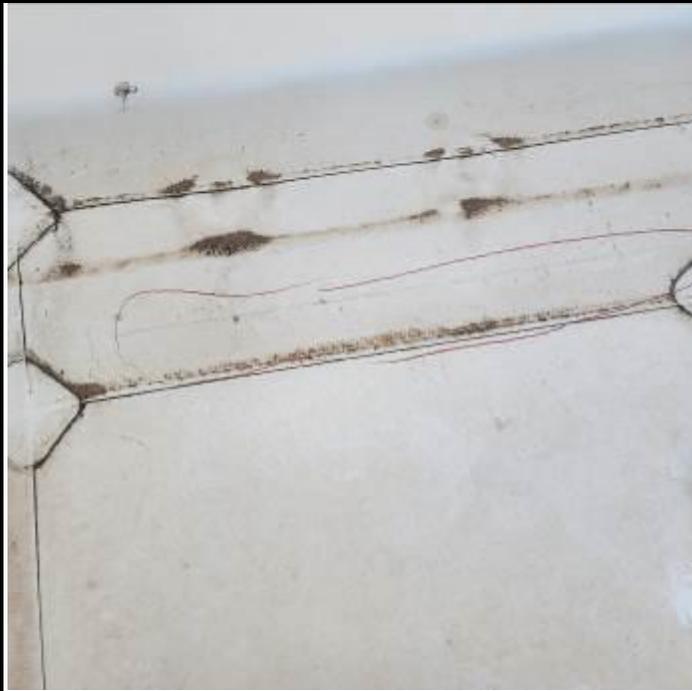
3. The leaking under this section of roofing is due to the fact that the crazing has migrated down past the scrim to the underside of the sheet.
4. No cores were done at the time of the inspection but based on what we see we think there is polyisocyanurate insulation on the metal decking and the TPO membrane mechanically fastened over the insulation. In the many TPO failures we have been able save some of the insulation.

017 TPO membrane is deteriorating. The lines are crazing that is down beyond the scrim.

6. We recommend that a plan for replacement is implemented right away.

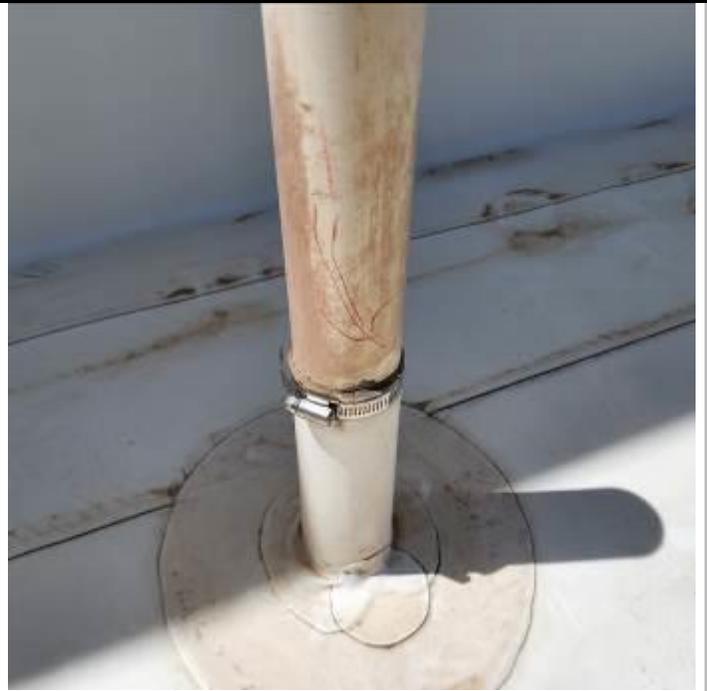
018 overview of deteriorating TPO pipe boots.

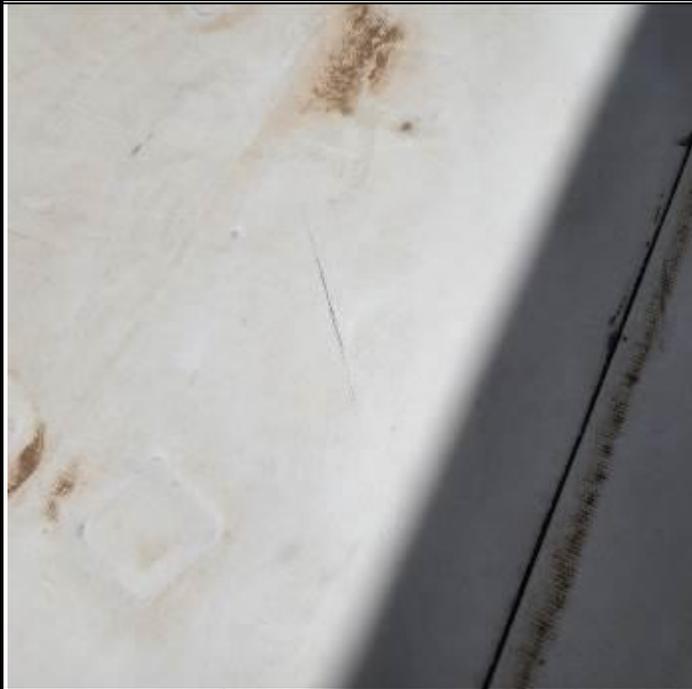
019 overview of cut in membrane.

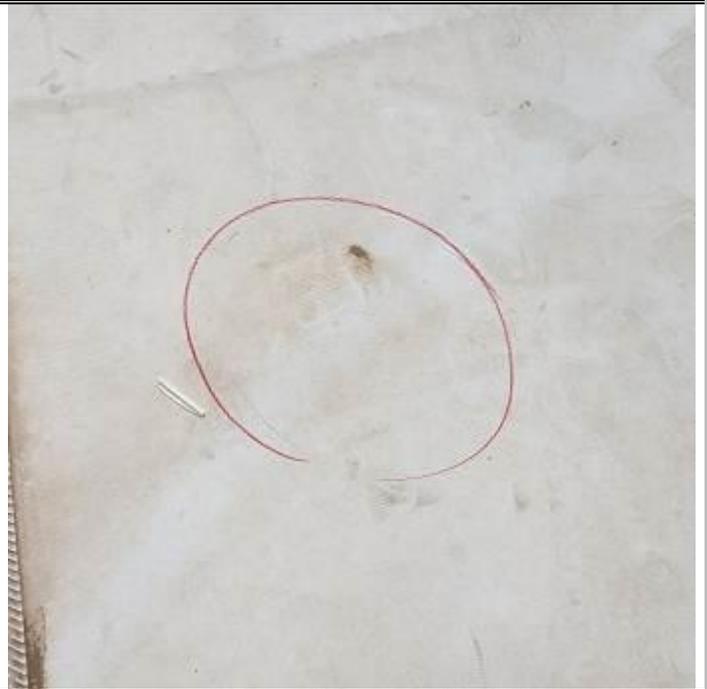
020 overview of cut and divot in membrane

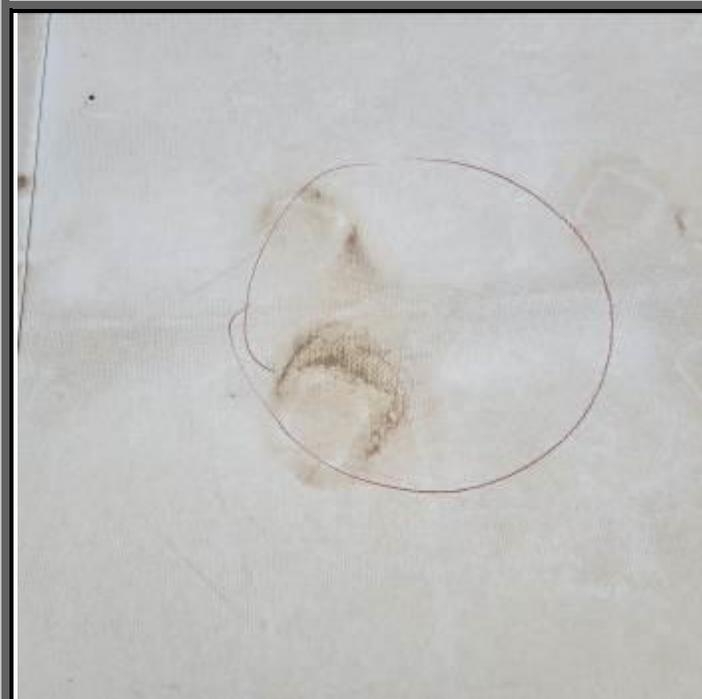
021 overview of deteriorating TPO membrane.

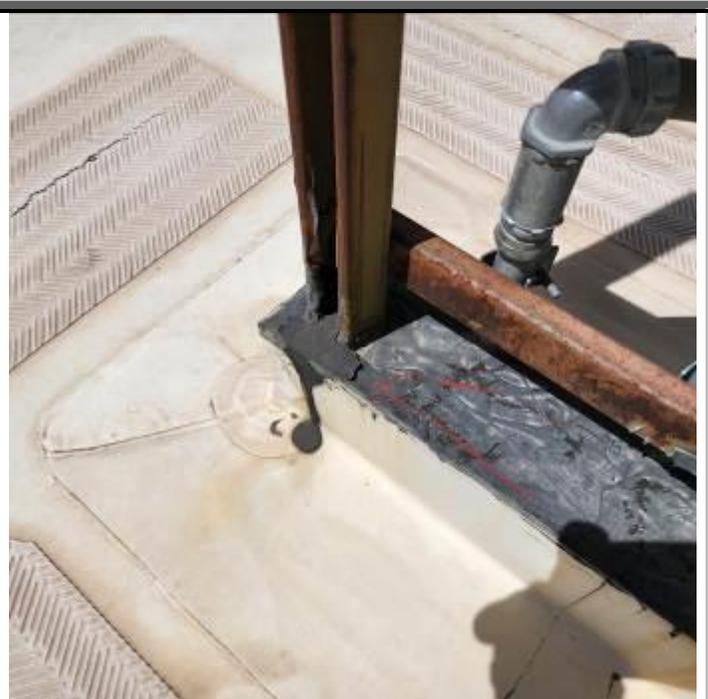
022 overview of repaired pitch pan.

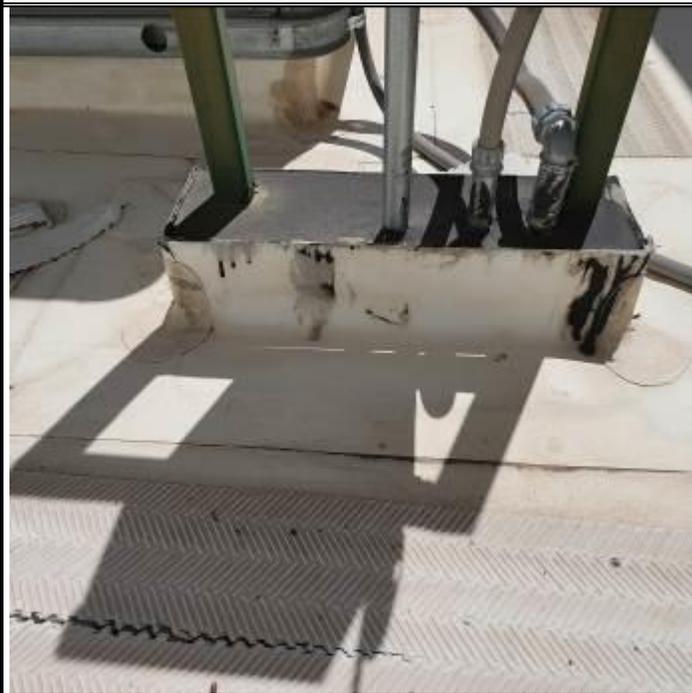
023 overview of repaired pitch pan.

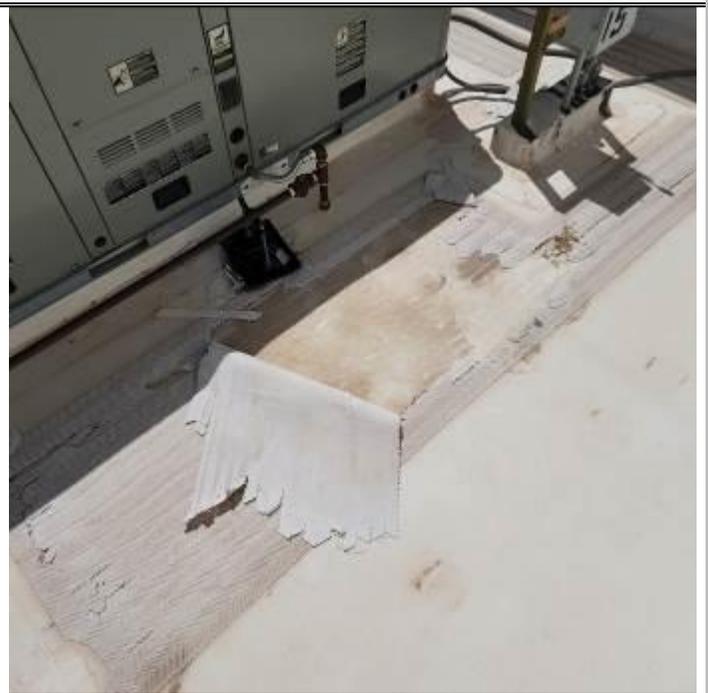
024 Typical overview of walk pads that are deteriorating.

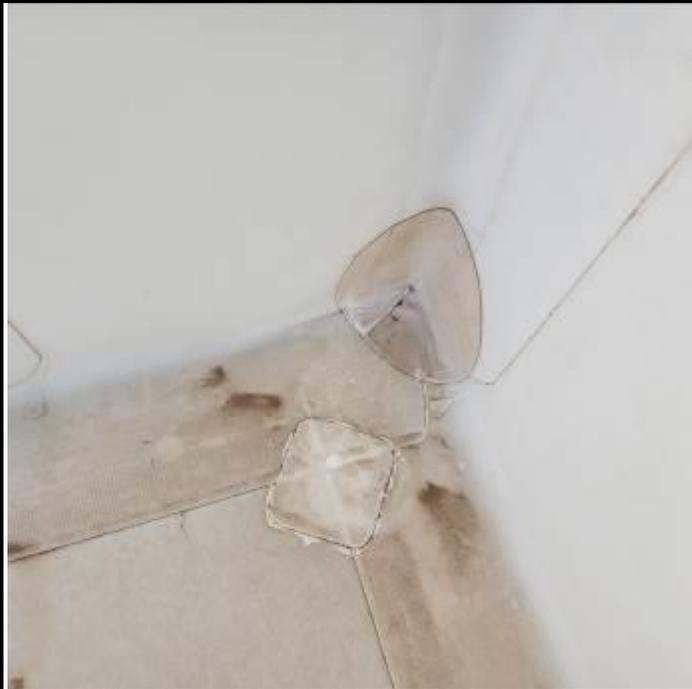
25 overview of deteriorating TPO corner patches.

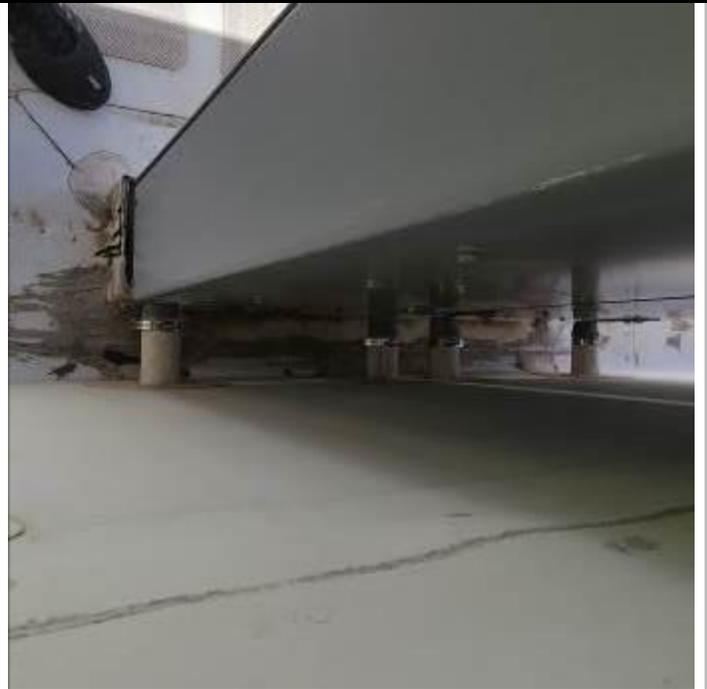
26 overview of TPO between electrical box and wall and attempt to seal a water leak.

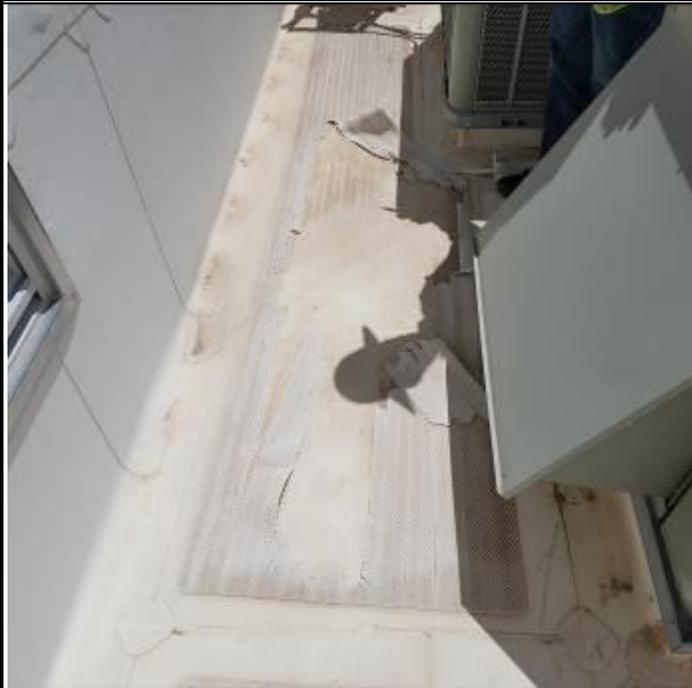
028 overview of deteriorating TPO corner patches.
