NEW MEXICO STATE UNIVERSITY

MAIN CAMPUS SEWER SYSTEM IDENTIFICATION

FINAL REPORT OF FINDINGS

FEBRUARY, 2015

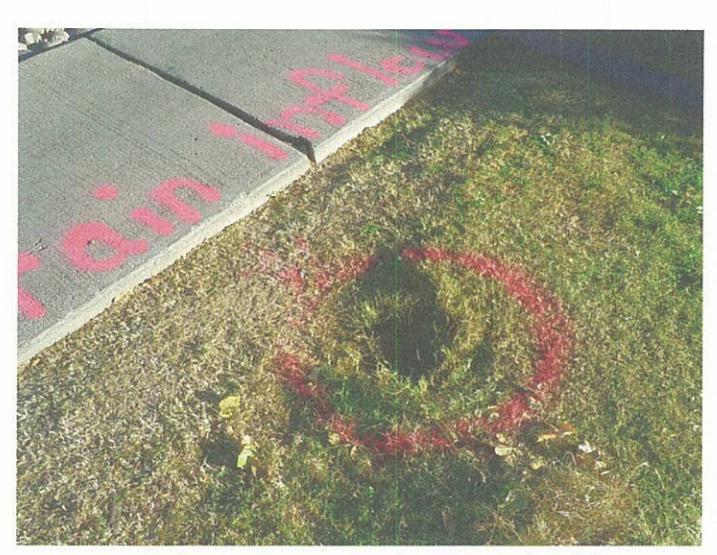
South east corner chemistry building

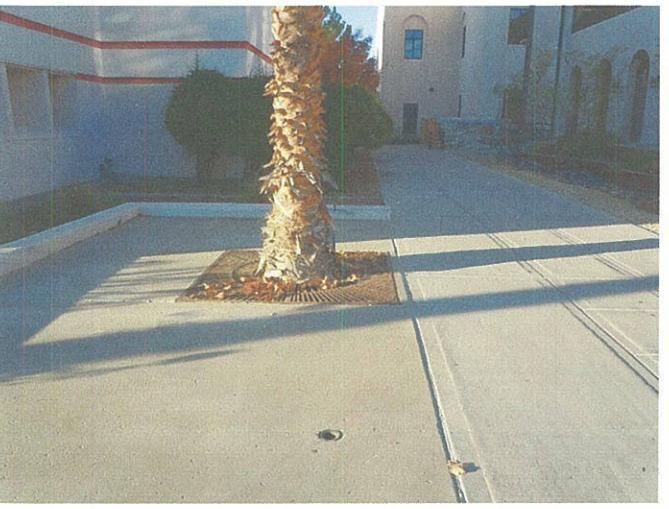
South side Guthrie Hall

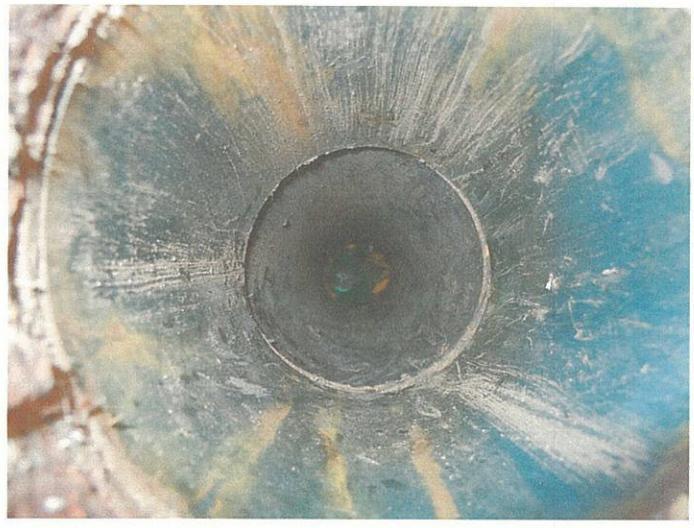
plastic soda bottle in cleanout on the South side of north chemistry wing

We recommend that cleanouts for each of the buildings have caps replaced to eliminate storm water infiltration into the sanitary sewer system through cleanouts. NMSU is committed to installing water tight manhole covers, a process which they have already begun implementing. The storm sewer lines within the drop inlets at Gardiner Hall, Garcia Hall, and Dan W. Williams Hall should be further investigated. Though it is reasonable to assume that the outlet pipe for the drop inlet at Dan Williams Hall ties into the City storm sewer system, it should be verified.

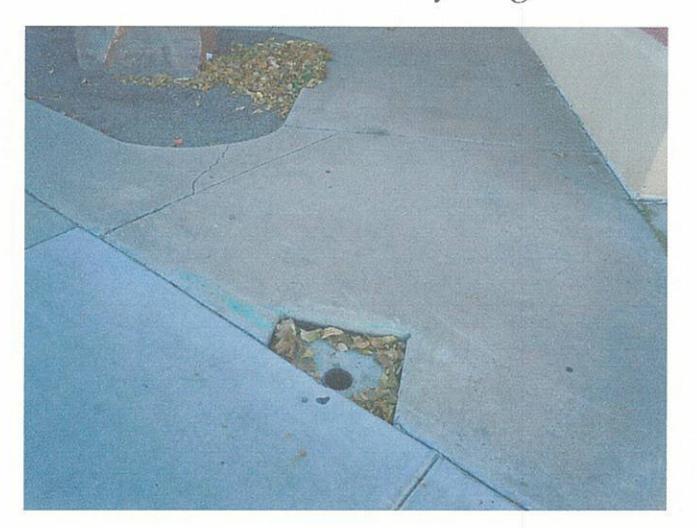
southeast corner Monagle Hall

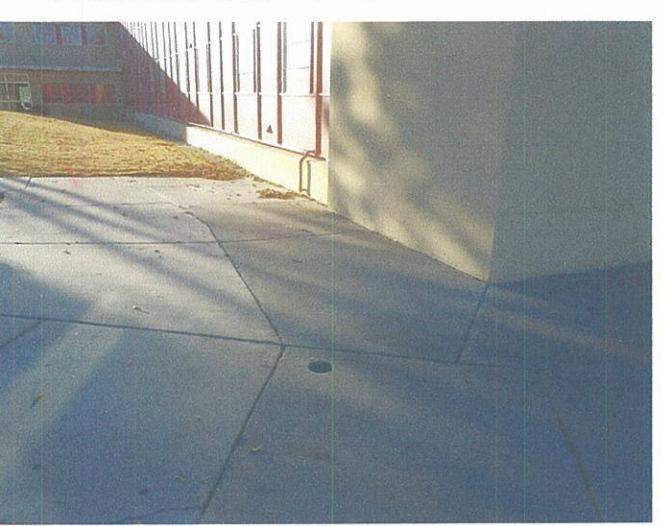
southeast corner Monagle Hall
