James B Delamater Activity Center Master Plan Update December 2022

New Mexico State University FCA 2021
0321 · JAMES B. DELAMATER ACTIVITY CENTER
CIP Project Summaries

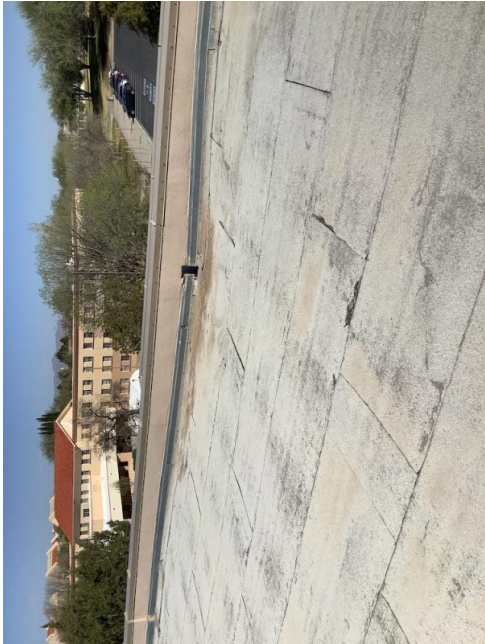
Facility:	JAMES B. DELAMATER ACTIVITY CENTER	IDNO:	0321
Category:	4. Type 1:	08. Type 2:	C05. P/Class: 3.

The building is protected by a combination of modified bitumen roofing and spray foam roofing. The modified bitumen roofing system is in fair to poor condition. The cap sheet granules are worn, and the walk pads are peeling from the roof. The spray foam roofing is uneven, creating lower areas for ponding.

Remove the spray foam and modified bitumen roofing systems. Install a thermoplastic polyolefin (TPO) membrane roofing system. The roofing system shall include tapered rigid insulation to provide positive drainage, as well as all required flashing and terminations.

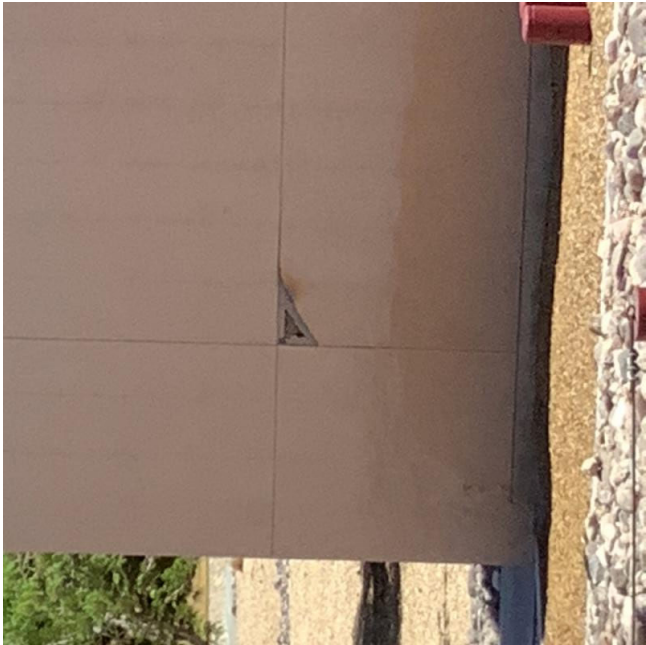
Facility:	JAMES B. DELAMATER ACTIVITY CENTER	IDNO:	0321
Category:	4. Type 1:	05. Type 2:	C02. P/Class:
			2.

The stucco system is cracking and chipping in multiple areas. A portion of the stucco system is starting to peel off the building.

Repair the cracks and chips in the stucco system. Apply a fog coat to the walls where stucco was repaired.

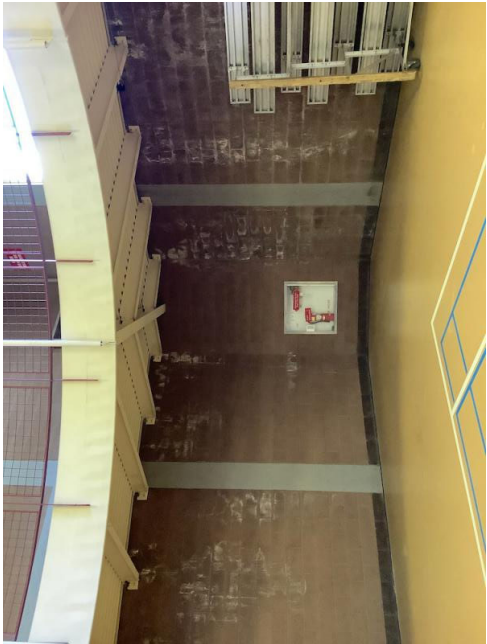
Project 0321.2003 · Exterior Wall Waterproofing

Efflorescence is visible on the north, east, and south walls of the auxiliary gym. The presence of efflorescence indicates that water is seeping through the walls. Staff reports that water will pond along the east wall of the auxiliary gym during heavy rainstorms.

Excavate the area adjacent to the north, east, and south walls of the auxiliary gym. Power wash and prep the exterior face of the wall. Apply a spray-on cementitious waterproofing agent to the portions of the walls that are below grade. Install a French drain along the north, east, and part of the south walls of the auxiliary gym. Backfill the area adjacent to the north, east, and south walls. After this is complete, clean interior walls. Regrade the area to the east, north, and south of the auxiliary gym to prevent water from ponding against the building.

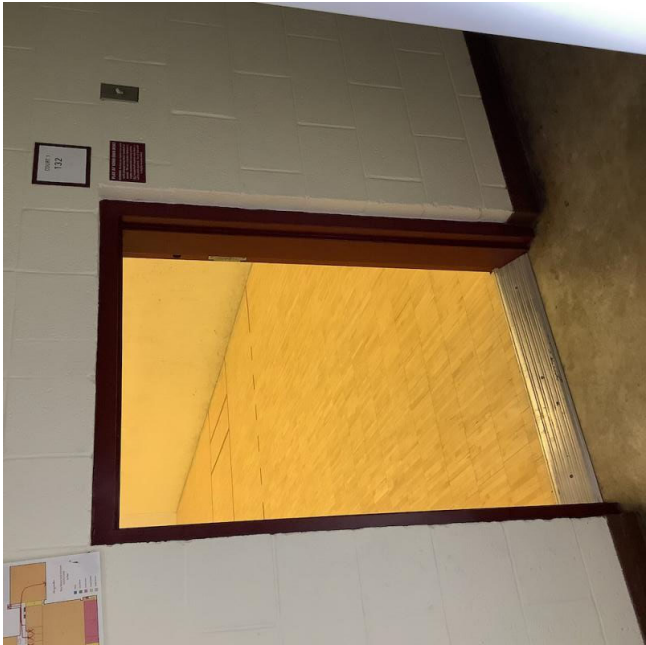
Facility:	JAMES B. DELAMATER ACTIVITY CENTER	IDNO:	0321
Category:	3. Type 1:	05. Type 2:	A03.3. P/Class: 3.

None of the four racquetball courts is ADA accessible. The doors leading into the courts do not meet the minimum ADA width requirements. The height difference between the raised wood racquetball court floor and the adjacent corridor floor exceeds the maximum allowed by current ADA standards. The slope of the door threshold exceeds the maximum slope allowed by current ADA standards. None of the racquetball courts are identified with an ADA compliant sign.

Enlarge the door opening at one racquetball court to meet current ADA requirements. Install door with ADA-compliant hardware. Install an ADA-compliant ramp to allow for access at the same racquetball court. In stall an ADA compliant tactile and Braille sign to identify the ADA accessible racquetball court.

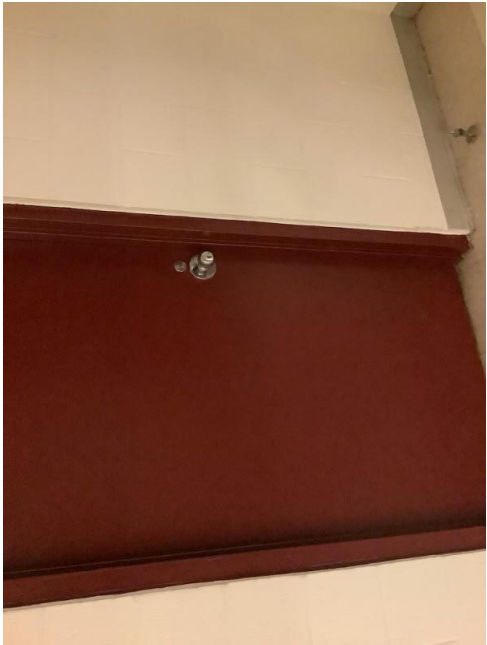
Facility:	JAMES B. DELAMATER ACTIVITY CENTER	IDNO:	0321
Category:	3. Type 1:	05. Type 2:	A03.3. P/Class: 3.

Numerous interior doors are equipped with knob-style handles. The mechanical rooms, electrical rooms, janitorial closets, and storage rooms are not identified with ADA-compliant signage. The main lobby reception desk is not equipped with a lower section that meets current ADA height requirements.

Replace the doorknobs with lever-style door handles as required on interior doors. Install ADA-compliant tactile and Braille signs at janitorial closets, mechanical rooms, electrical rooms, and storage rooms. Replace the main lobby reception desk to provide a lower section that meets current ADA height requirements.

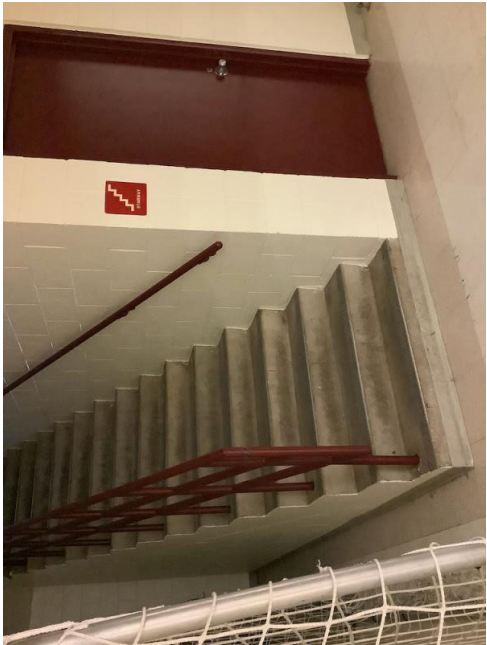
Facility:	JAMES B. DELAMATER ACTIVITY CENTER	IDNO:	0321
Category:	3. Type 1:	05. Type 2:	A03.3. P/Class: 3.

The handrails of stair 2 and stair 3 do not have the required extensions. Only the top and bottom treads of stair 2, stair 3, and stair 4 have a non-slip nosing.

Install handrail extensions at stair 2 and stair 3. Install non-slip nosing as required on the treads of stair 2, stair 3, and stair 4.

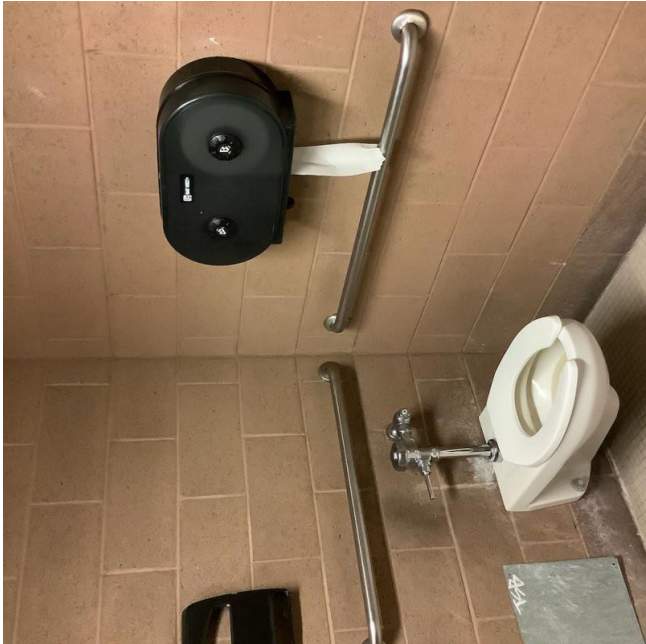
Facility:	JAMES B. DELAMATER ACTIVITY CENTER	IDNO:	0321
Category:	3. Type 1:	05. Type 2:	A03.2. P/Class: 3.

Two sets of public men's and women's multi-stall restrooms are available in the building. One set of restrooms is on the first floor, and the second set is on the second floor. Both sets of multi-stall restrooms do not meet current ADA requirements. The accessible stalls are not equipped with vertical grab bars. The water supply and waste lines are not insulated to protect against contact. The toilet paper dispensers hang at incorrect heights. The toilet compartment door does not close properly in the second-floor men's multi-stall restroom.

Install vertical grab bars in the accessible stalls. Install pipe insulation beneath the lavatories on the water supply and waste lines to protect against contact. Relocate the toilet paper dispensers to meet current ADA clearances at both the horizontal and vertical grab bars. Replace the toilet compartment in the second-floor men's multi-stall restroom.

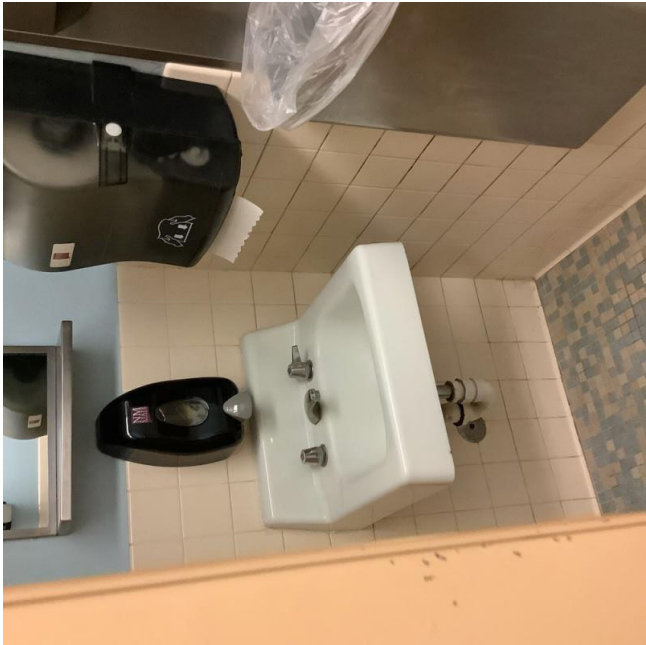
Facility: JAMES B. DELAMATER ACTIVITY CENTER IDNO: 0321

The Kinesiology and Dance Departments have their own dedicated men's and women's multi-stall restrooms. The restrooms are not ADA compliant. The size and layout of the restrooms do not allow for an accessible stall. Water supply and waste lines beneath the lavatories are not insulated to protect against contact. The soap dispensers, paper towel dispensers, mirrors, and toilet paper dispensers do not hang at the correct heights. The required clear floor space and turning space are not provided.

Renovate the men's and women's multi-stall restrooms in the Kinesiology and Dance Departments to bring them into compliance with current ADA requirements.
