Agricultural Science Center at Clovis

BOOK 6 OF 12

FACILITIES MASTER PLAN REPORT

Executive Summary | July 2023

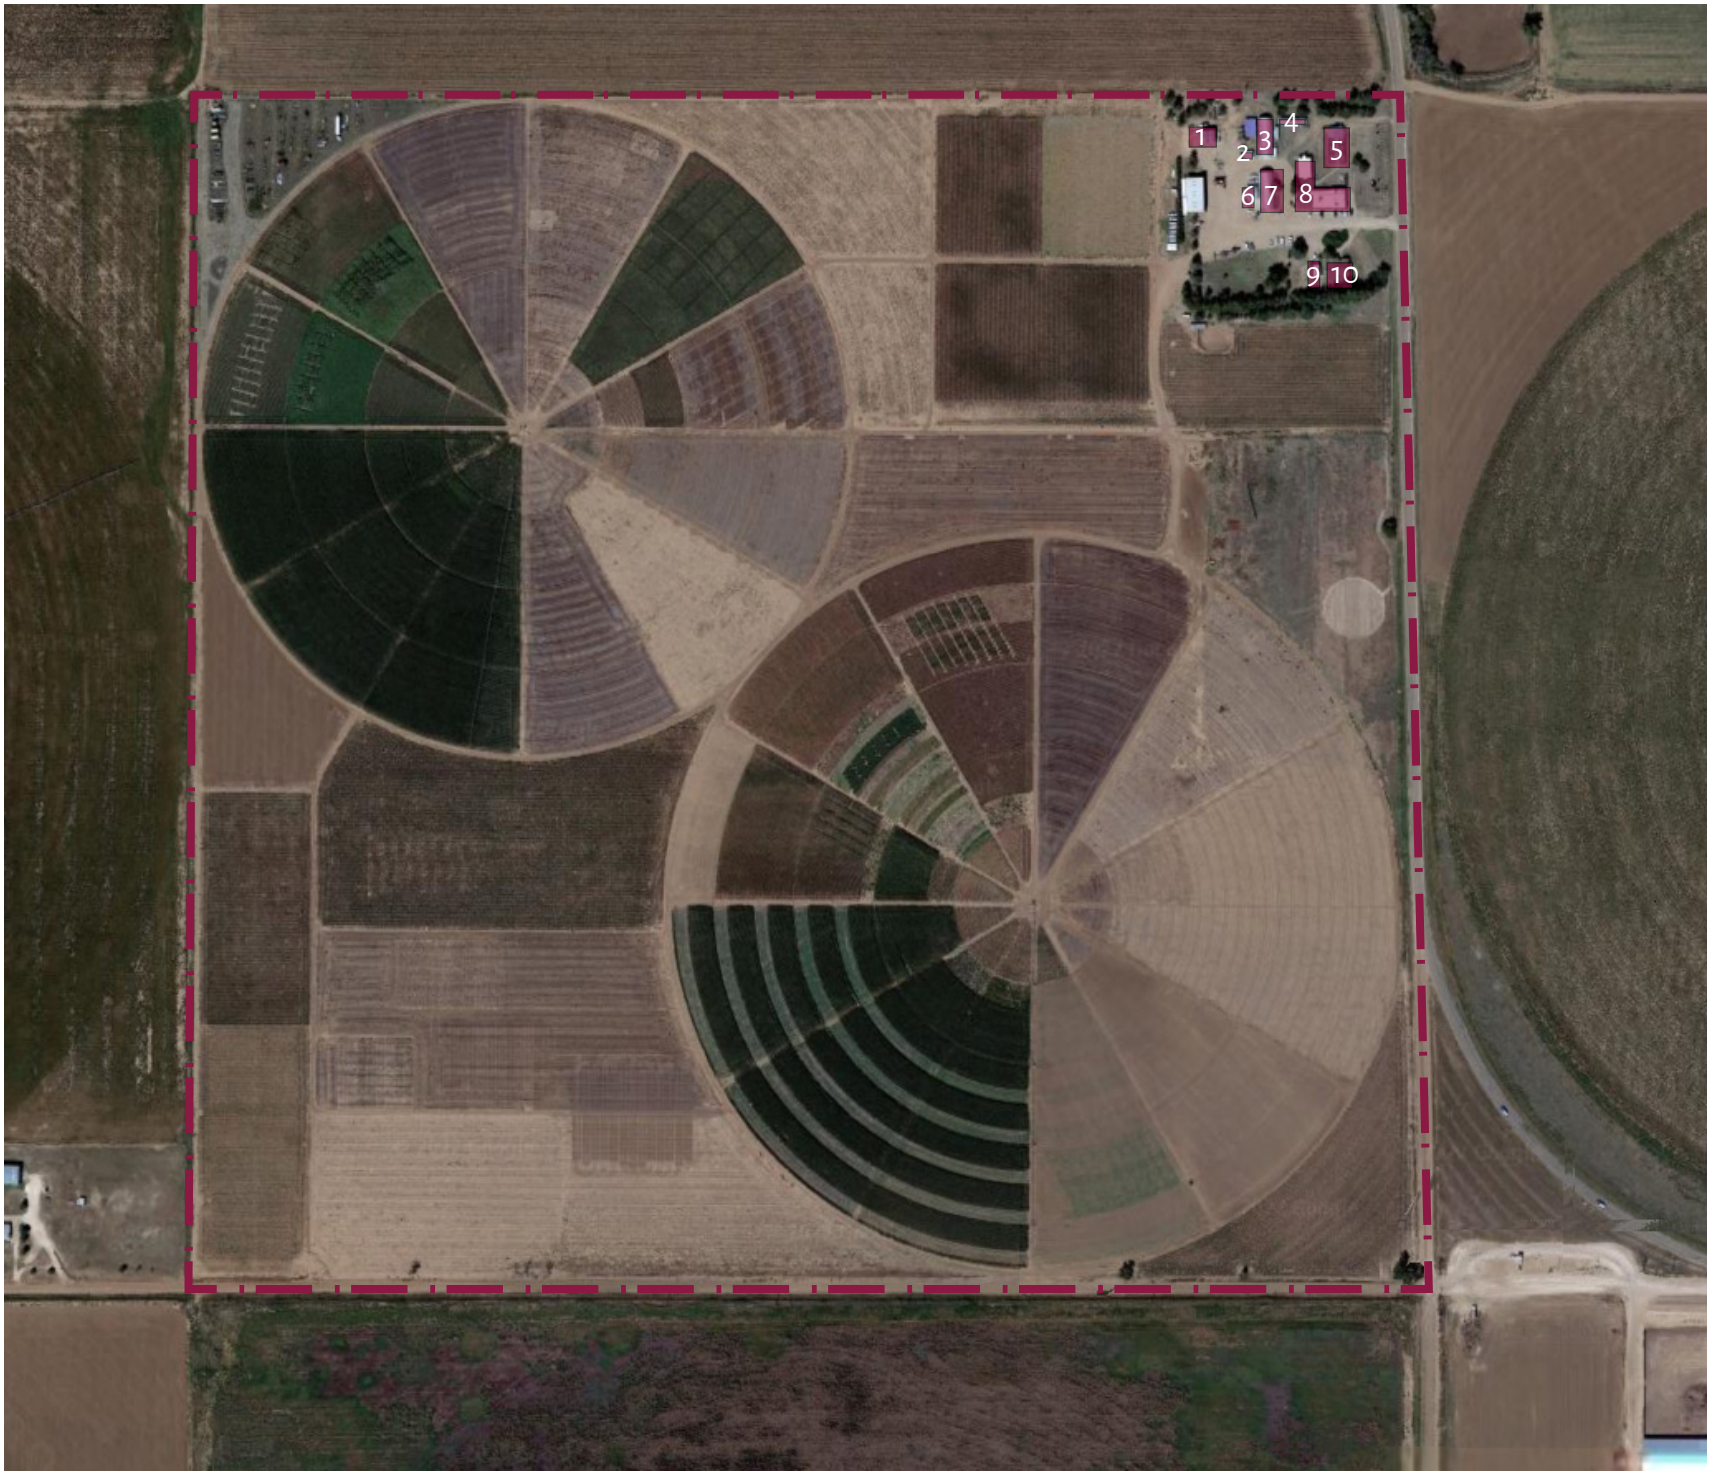
Agricultural Science Center at Clovis

- 1. Shop (Old Alcohol Facility) 340B (FCI Score 0.026)
- 2. Hazardous Storage (Old Grainery) 340I (FCI Score 0.954)
- 3. Crop/Feed Storage (N. Quonset) 340H (FCI Score 0.280)
- 4. Guest Trailer 340J (FCI Score 0.130)
- 5. Greenhouse 340F (FCI Score 0.021)
- 6. Pesticide Shed 340A
- 7. Storage (S. Quonset) 340G (FCI Score 0.280)
- 8. Office, Lab & Greenhouse 340E (FCI Score 0.048)
- 9. Garage 340C (FCI Score 1.249)
- 10. Residence 340D (FCI Score 0.089)

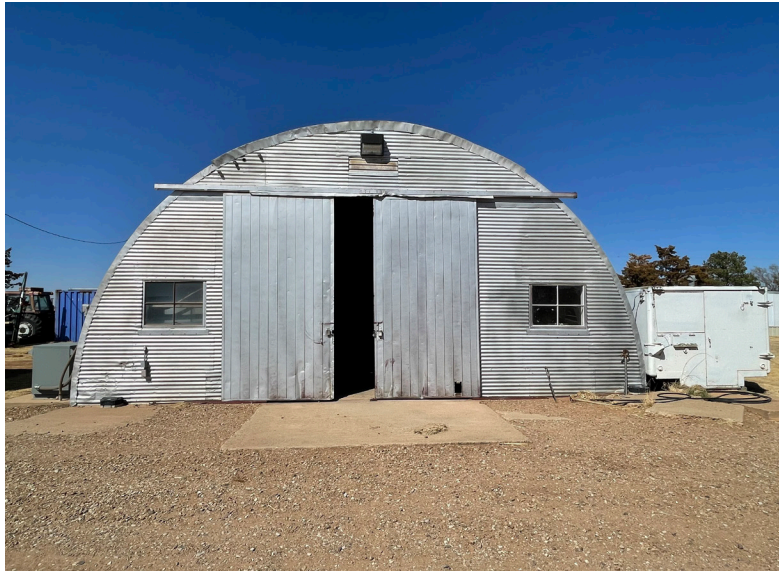
CROP- FEED STORAGE 340H

Building need all corrugated metal panels to be replace due to the majority are rusted and leaking. Need to replace skylight Lexan panels and repaint interior wood walls and doors. Replace windows with double pane and screens and replace both barn doors. Install a concrete apron all around the building and regrade the site for positive flow away from building.

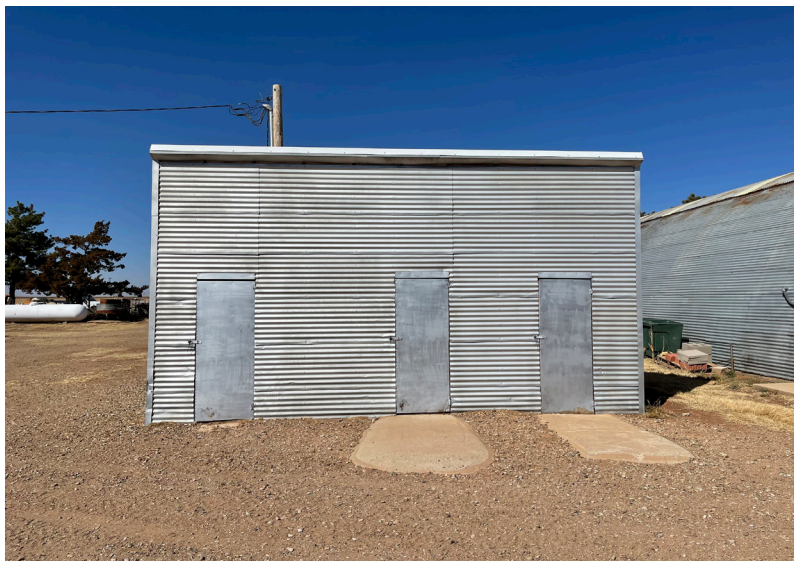
HAZARDOUS STORAGE 340I

The building requires a continuous concrete landing at all 3 front doors and the addition of ADA lockset at each door. Addition of gutters and downleaders at back of the building will help with roof drainage. The building could benefit from a concrete apron on three sides with regrading the site for positive flow away from building. General, metal panels need to be repaired and replaced, repair rotted wood outriggers and soffit.

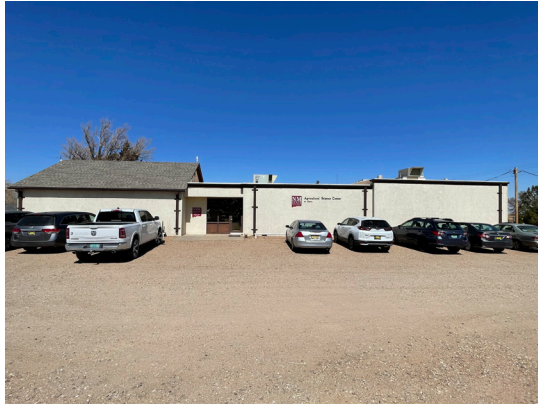
OFFICE LAB AND GREENHOUSE 340E

The building requires that the EIF's seal the upper edge gap where it meets metal fascia, additional repair to the brick holes at Southwest corner, repair concrete spalling at West entry and add missing handrails at west entry stairs. The brick needs sealant along west facade, the stucco cracks at old openings need to be resealed and repainted, and the connection from the modular building to main building needs crack repairs and corner soffit repairs at NW corner. Repaint North columns and adjacent areas at the entry door and frames, and the Northeast corner of modular building needs the rotted wood to be repaired. Metal caps at brick column at East entry are needed, repaint East entry door and railings, and the East door needs an ADA landing of the right size at door. This door needs an ADA lockset and hardware. Spalling concrete grade beam along east entry needs to be repaired, repaint East entry door by the electrical service and add ADA lockset, all exterior doors need their weatherstripping redone. The building needs an ADA restroom and upgrades, the interior ramp needs handrails, and the entry door and sidelite need to be repainted and refinish. The building could use a concrete apron around facility and grade site away from building for positive flow, remove landscaping next to building all sides to improve moisture damage and the building needs a ADA parking spot with striping and signage including an accessible concrete access to front door.

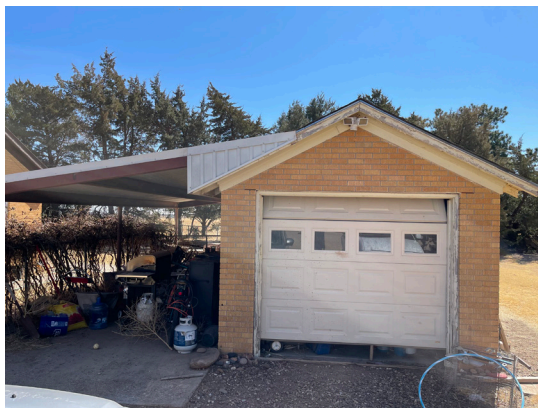
GARAGE 340C

The building need to repair and repaint entry door and add the necessary ADA lockset. The garage overhead door needs to be replaced along with the rotted wood door jambs and head at garage and refinish. The roof needs new shingles, gutters and downleaders. The building needs a concrete apron around two sides and required grading for positive flow away from foundation. Replace rotted wood soffit and fascia and repaint, the carport columns need repair and repaint.

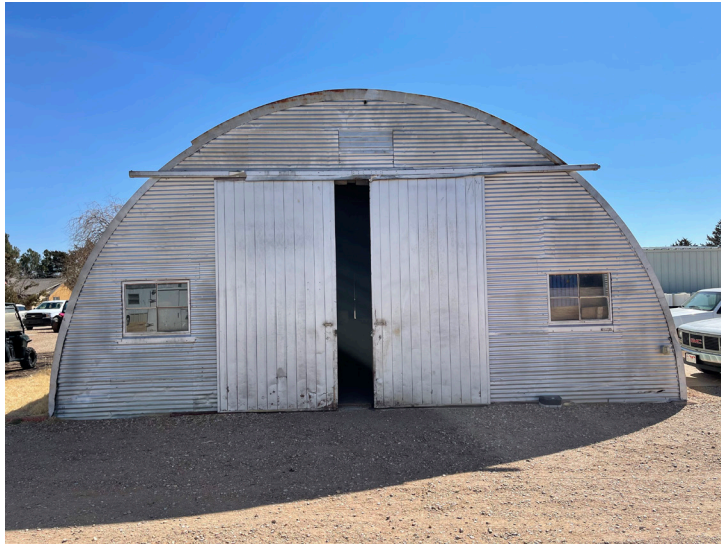
STORAGE 340G

Replace all corrugated metal panels (majority are rusted, leaking), replace skylight Lexan panels, replace windows with double pane and screens, replace both barn doors, concrete apron all around, regrade for positive flow away from building, remove landscaping from East side of building.

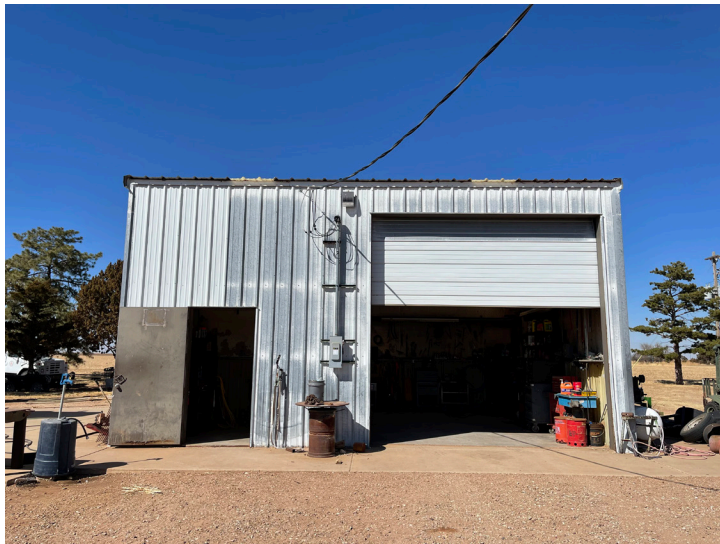
SHOP 340B

Needs new hollow metal entry door with ADA hardware and frame, repaint exterior walls, rear door needs repainting and concrete landing and ADA lockset, concrete apron all around where missing, regrade exterior to create positive flow away from building, need roof gutters and downleaders, reseal and weatherstrip the overhead doors and repaint, refasten all loose metal wall panel screws, and repair roof leaks.

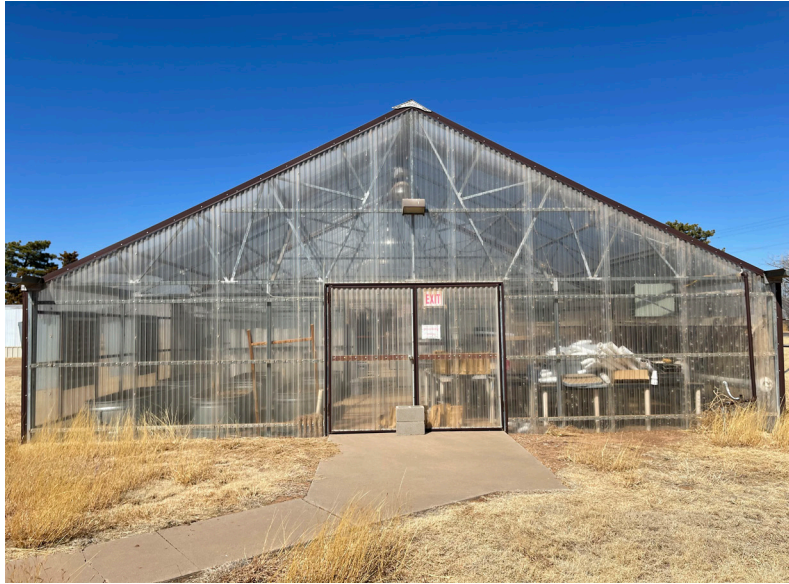
GREENHOUSE 340F

The roof leak need to be repaired at headhouse. A new paint effort at headhouse by the entry doors, add a Concrete landing and apron along corrugated metal panels for drainage management. The side-walk at South entry needs replacing, needs gutters and downleaders, regrade site away from building at headhouse and new ADA lockset at double doors are also required.

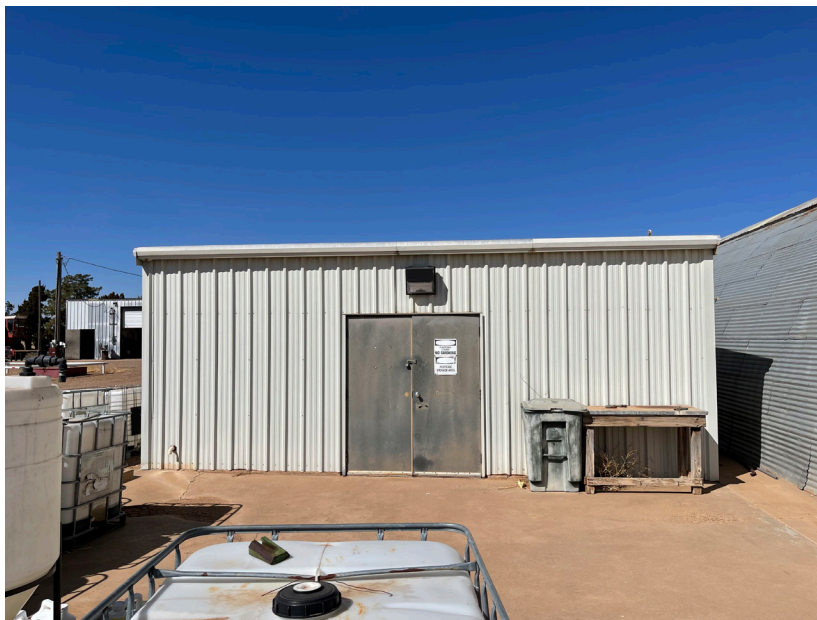
PESTICIDE SHED 340A

Needs gutter and downleader for roof drain management, add concrete apron at West and North side, regrade these two sides for positive flow away from building, repair rusted metal wall panels, re-paint entry doors, add ADA lockset at entry doors, and add missing downleader at Southwest corner.

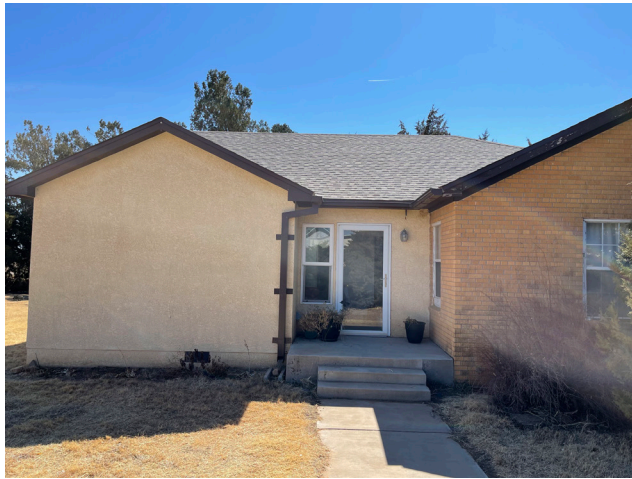
RESIDENCE 340D

Needs ADA access ramps front and rear door, repaint wood trim at windows, soffit repairs and re-paint, cracks in mortar joints, cleanout storm cellar window access pits, gutters and downleaders, need repair of wood fascia and repaint, needs concrete apron around house, regrade for positive flow away from house, remove all landscaping away from house, need ADA lockset at entry doors, remove tree at North side branches are hitting house, seal edge of stucco to brick.

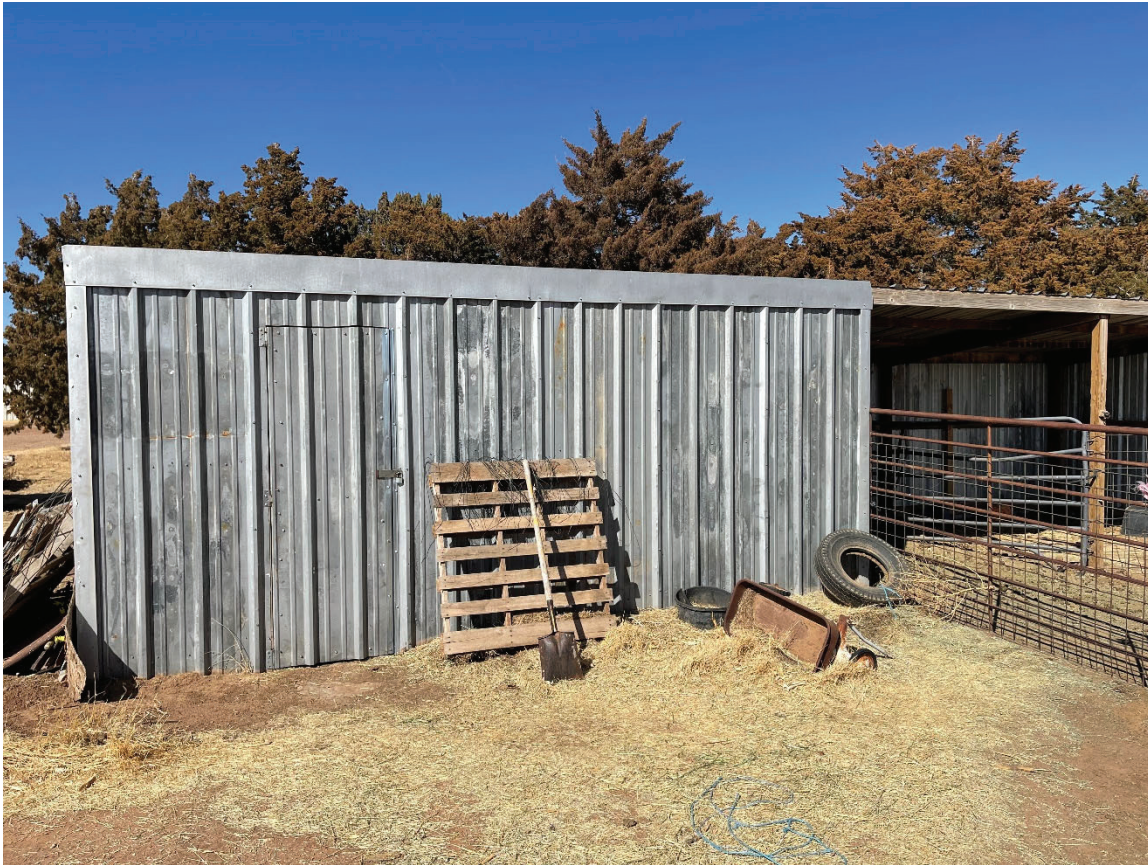
Horse barn and Storage:

Needs: Rain gutter and down leader, regrade to provide positive drainage.

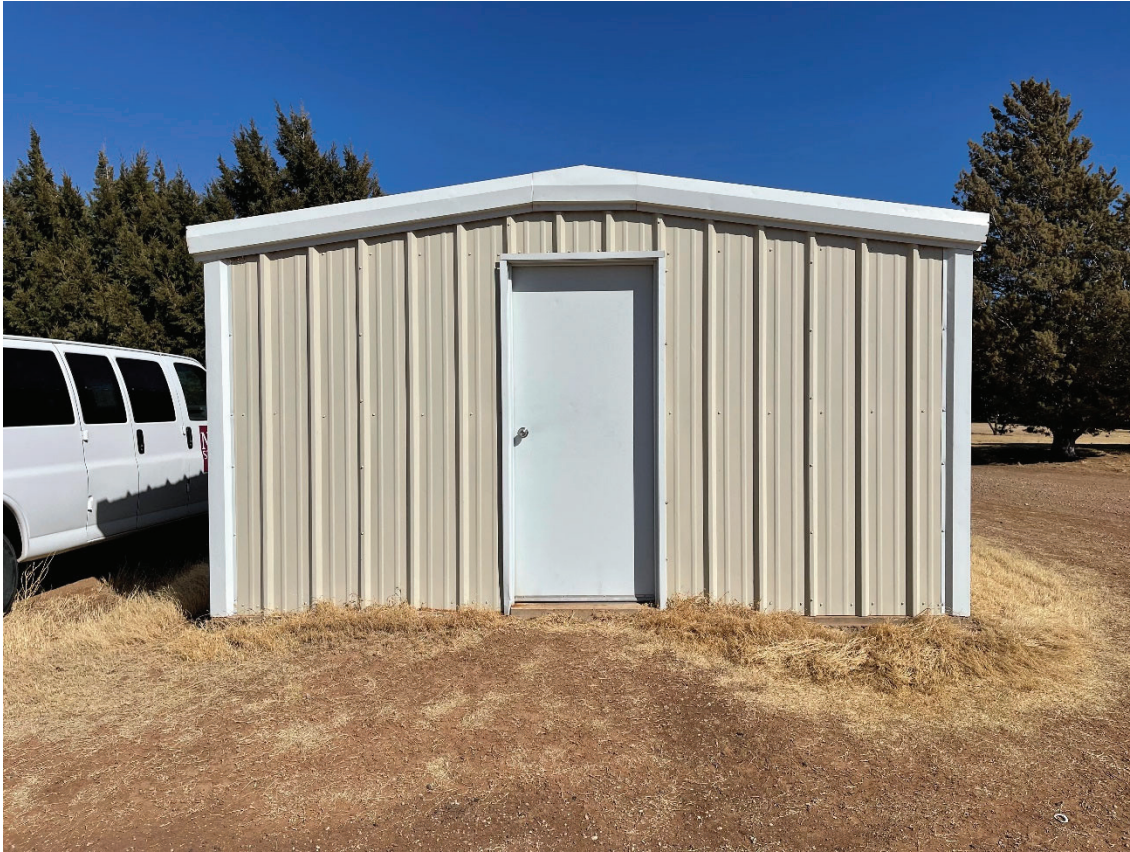
Pump House:

Needs: Concrete entry stoop, Ada door lockset, concrete apron all around, rain gutters and down leaders, regrade all around, appropriate integrated heating unit.

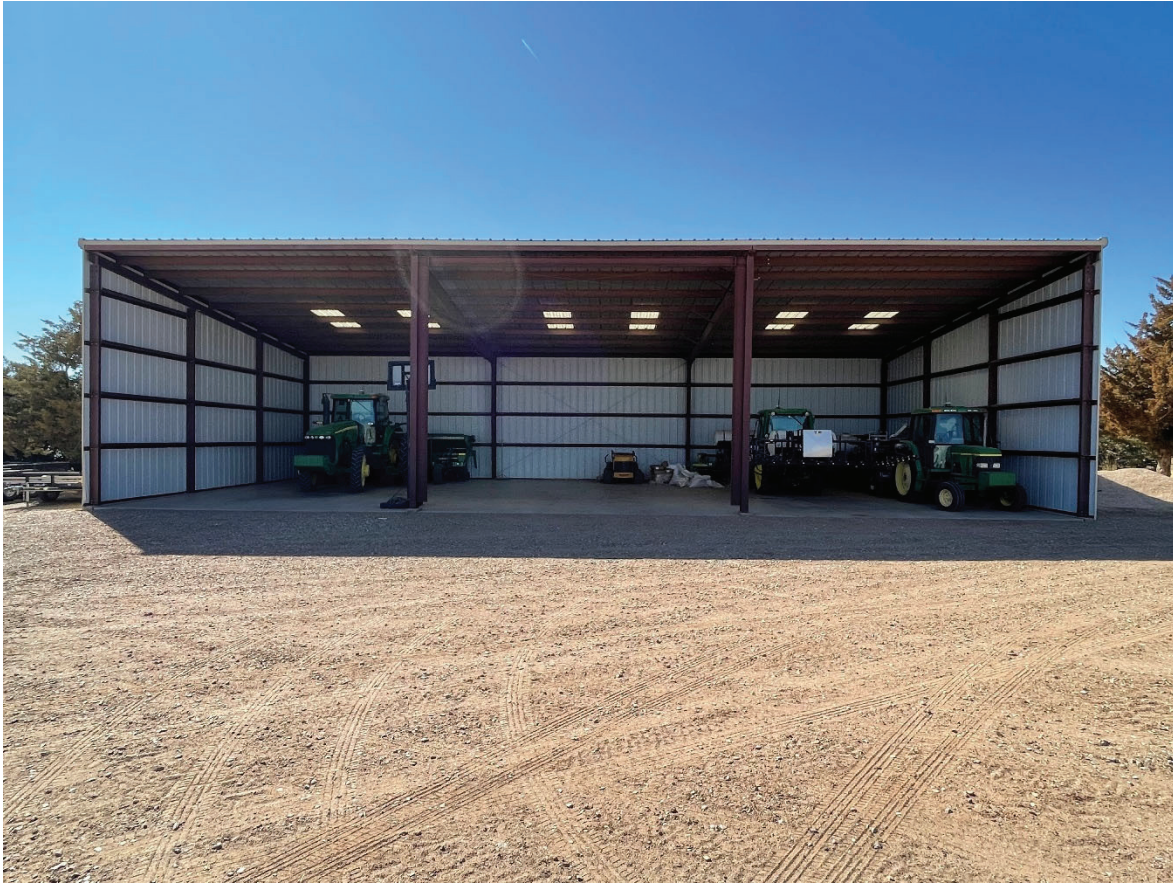
Tractor barn:

Needs: Rain gutter and down leaders, regrade all back side, concrete apron along back side, replace/repair damaged wall panels, concrete bollards around front columns.

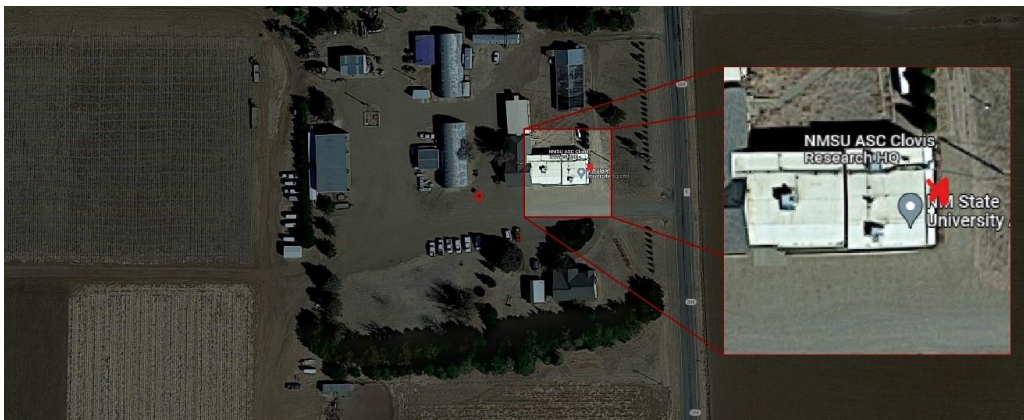
IT Spaces/Network Closets

The DMARC enters from the west side of the Main Office, then runs to the center of the building where the network equipment is located in an enclosure. The building was wired in 2015 using Cat6. Wireless coverage is good throughout the Main Office and Auxiliary Buildings.

Network space is needed at this ASC and needs to meet standards. It is our recommendation to build out an IT/network space for this ASC. If there is no room that can be modified into this space, it is our recommendation to build a separate IT/network space outside, close to the existing DMARC, that is cooled, isolated only for IT needs, has proper lighting, floor loading, power, network racks and equipment, airflow, and meets standards.

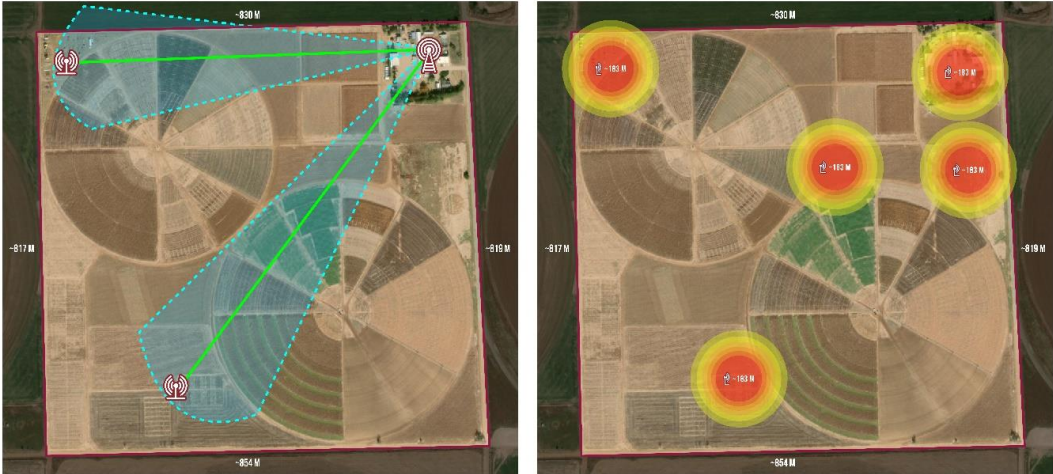
UBIQUITI ROCKET 5AC P-TMP (2)
INSTALLATION HEIGHT: 8 M (26 FT)
OUTPUT POWER: 28 dBm
CHANNEL WIDTH: 40 MHz
ANTENNA GAIN: 22 dBi

- SPECS:**
- 5GHz WIDE BAND OPERATING FREQUENCY
 - POINT-TO-MULTIPOINT LINKS (PTMP)
 - DEDICATED MANAGEMENT RADIO

UBIQUITI ISOSTATION 5AC
INSTALLATION HEIGHT: 3 M (10 FT)
OUTPUT POWER: 25 dBm
CHANNEL WIDTH: 40 MHz
ANTENNA GAIN: 15.5 dBi

- SPECS:**
- 45° ISOLATION ANTENNA
 - SUPERIOR THROUGHPUT UP TO 450 MBPS
 - HIGH CAPACITY AND SCALABILITY
 - CAPABLE OF HIGH-SPEEDS

UBIQUITI MESH PRO
INSTALLATION HEIGHT: 2 M (6 FT)
MAXIMUM POWER: 20 dBm
POWER SUPPLY: 24 V, 0.5A
ANTENNAS: 2.4 GHz, 5 GHz

- SPECS:**
- OMNIDIRECTIONAL 360° COVERAGE
 - LONG RANGE SYMMETRICAL TRANSMISSION UP TO 183 METERS
 - 802.11AC WAVE 1 WIFI
 - 2.4 GHz (802.11N) BAND WITH A 450 MBPS THROUGHPUT RATE
 - 5 GHz (3X3 MIMO) BAND WITH A 1.3 GBPS THROUGHPUT RATE
