# New Mexico State University

Agricultural Science  
**Center at Farmington**

# ***FACILITIES MASTER PLAN REPORT***

Executive Summary | July 2023

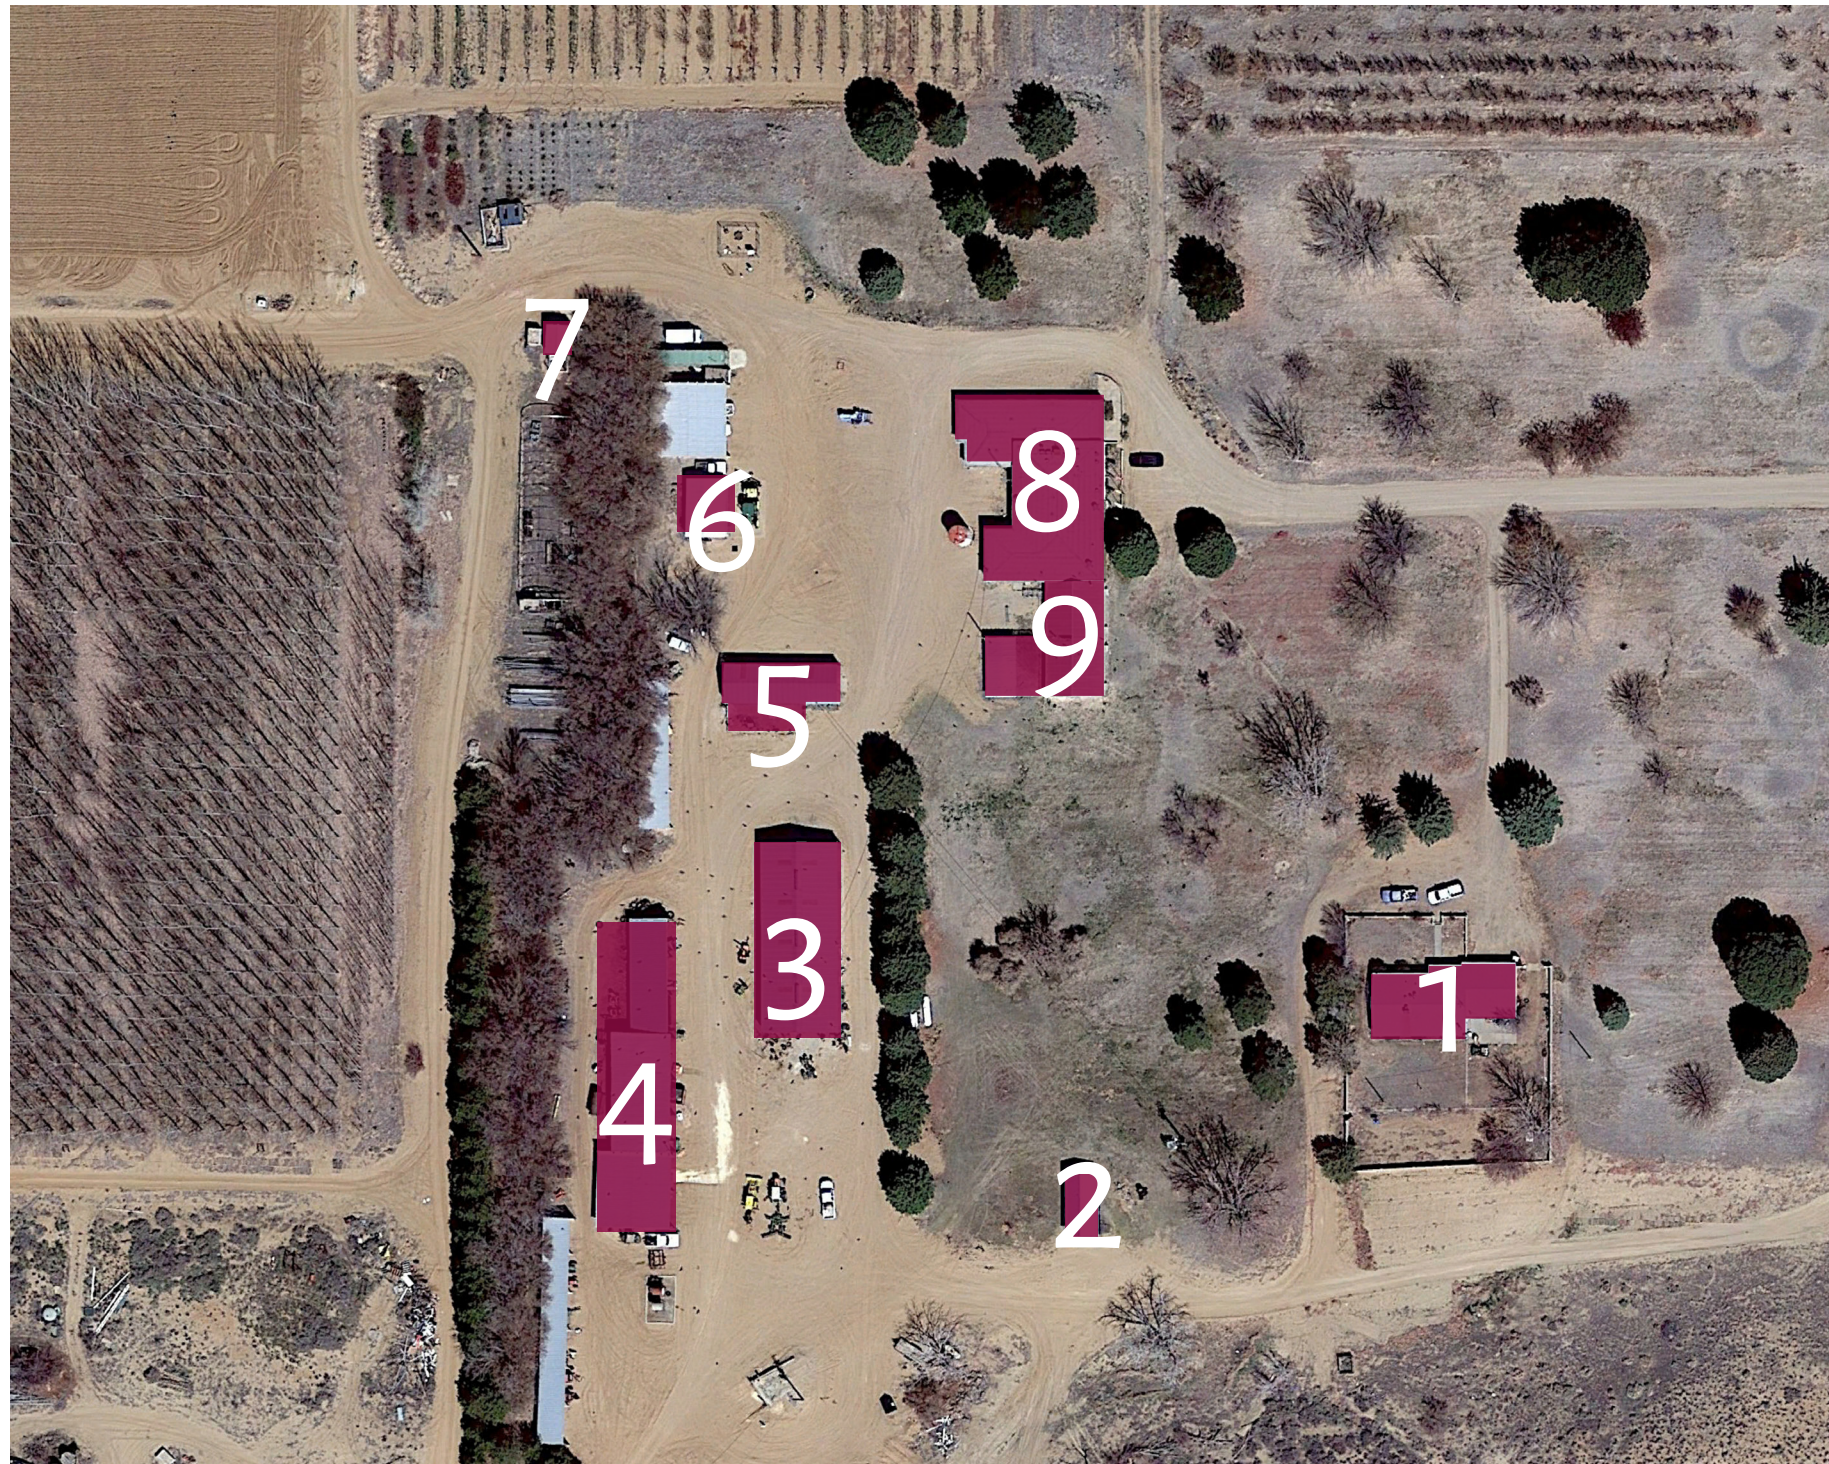
### Agricultural Science Center at Farmington

1. Residence 406A (FCI Score 1.229)
2. Science Center, Student Trailer 406J (FCI Score 0.504)
3. Shop 406B (FCI Score 0.220)
4. Implement Storage 406I (FCI Score 1.756)
5. Seed/Fertilizer Storage 406E (FCI Score 0.032 )
6. Pesticide Storage 406G (FCI Score 0.347)
7. Filter House 406K (FCI Score 0.300)
8. Office & Lab 406C (FCI Score 0.608)
9. Greenhouse 406D (FCI Score 0.003)

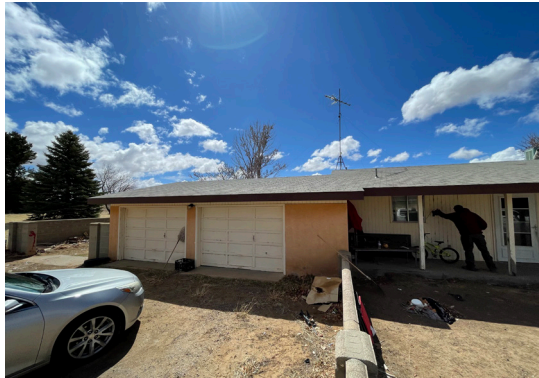
## RESIDENCE 406A

Add a new sewer line and septic tank to house and connect all appliances to it including washer and dryer. The Southeast corner of the CMU garden wall needs all the missing courses to be repaired, and install a need gate at the backyard entrance and vehicle gates. Need a new man-gate to the back yard at Southwest CMU wall, and a need new gate at the Southwest corner of house / CMU wall needs to be installed as well. Need to install a new living room patio door and fix wall framing. The building needs a ADA ramp to front and rear door. The facility new kitchen cabinets and appliances, need new light fixtures throughout house and more lighting at kitchen. Replace carpet in living room and three bedrooms with vinyl plank flooring, and Add new base boards wood and paint. Both Restrooms needs new fixtures, wall tile, repaint all walls, exhaust fans, and repair water damage at hallway ceiling. Replace missing door trims at bedroom door, need propane tank for new H.V.A.C., replace two garage doors with new operators, replace metal fascia, stucco repairs and repaint, remove landscaping next to exterior house walls, repaint siding and soffit, replace rotted soffit, new roof and gutters and downleaders, replace all windows with vinyl double pane, concrete apron on all exterior walls, replace one wood post at entry porch and paint all porch area, repaint garage door jambs, repaint siding at West side and all window trims, new patio door from garage to exterior.

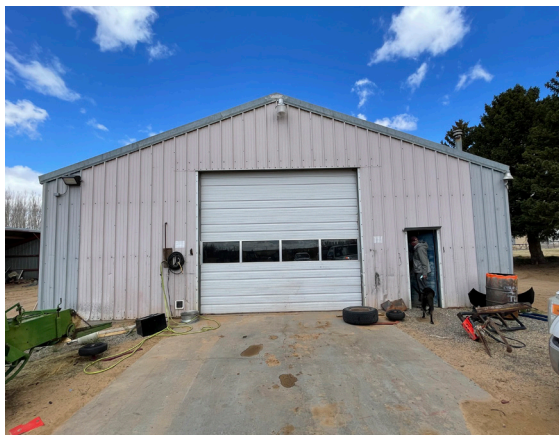
## SHOP 406B

Need new overhead doors with electric openers, replace damaged exterior metal wall panels, ADA access at man doors, need ADA parking, repaint exterior walls, new weatherstripping all doors, repair roof leaks, concrete apron with regrading (add dirt on W side), gutter and downleaders, need vehicle exhaust system and hose for fumes in shop side during winter, repair rusted wall panels, repaint all door jambs, replace all acrylic skylights, need shelving at shop side, need new lighting LED high bay throughout.

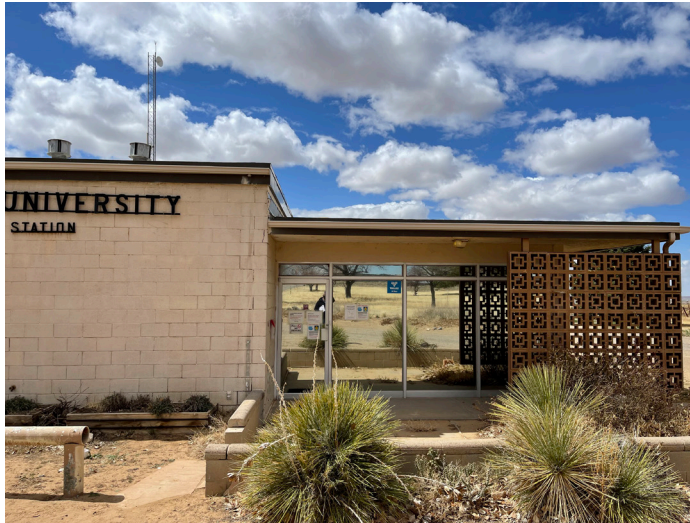
## OFFICE AND LAB 406C

Need yo add a French drain for headhouse floor sink. Existing roof leaks need to be repair includ- ing roof blisters. The building needs a new roof with gutters and downleaders especially along North side since downleaders at missing locations. The stucco soffit along North side of building has to be removed and rebuilt in its entirety as it is loose and sagging in various areas. A concrete apron is needed all around the building with a needed regrading for positive drainage away from building, and remove landscaping all around the building that is adjacent to the exterior walls. Repaint all exterior CMU walls, repair cracked all mortar joints and all exterior HM doors and frames. Need ADA access to building, replace all lights with LED, replace restrooms with ADA compliant room, and add ADA lockset all around. The facility needs a ADA parking and access at front and rear doors. Need to repaint old water tank.

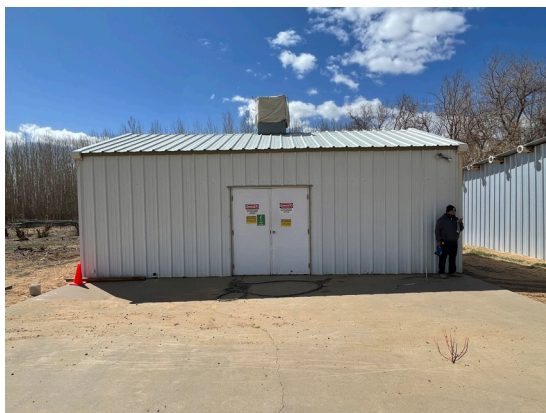
## PESTICIDE STORAGE 406G

Repair existing roof leaks around swamp cooler, replace the heater since is not working, the hand wash sink need to be re-installed since it is loose, and entry door jambs needs to be re-installed since it is loose. Need to repaint the door and frames, and re-weatherstrip doors. Need to drop the inlet since it is clogged (gray water not emptying). Install gutters and downleaders, and repair corner of metal wall panels. Add a concrete apron at three sides and regrade around building to improve site drainage.

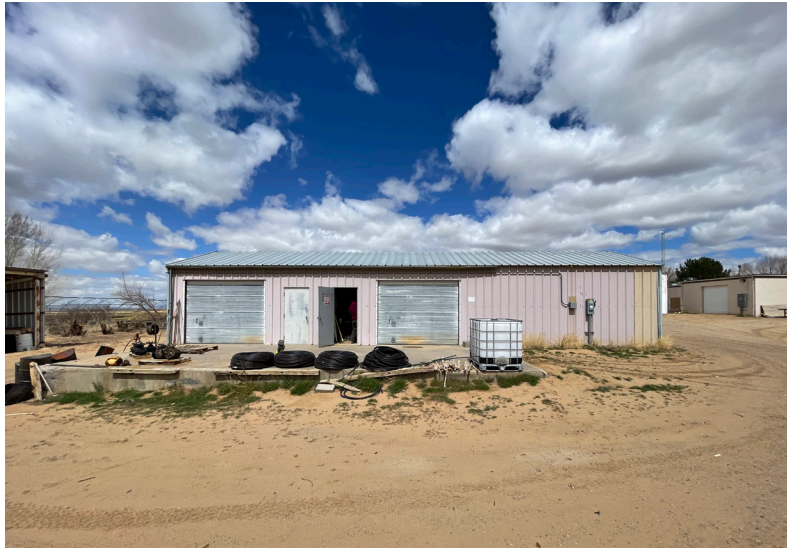
## **SEED/ FERTILIZER STORAGE 406E**

Repair damaged exterior wall panels, and repaint overhead doors and jambs and install new gaskets, . The building need gutter and downleaders on two sides, and the entire building needs to be repainted. Replaced the damaged double doors with hollow metal doors and add ADA hardware at the main door. The facility needs a concrete apron on 3 sides and regrade site away from building to improve site drainage.

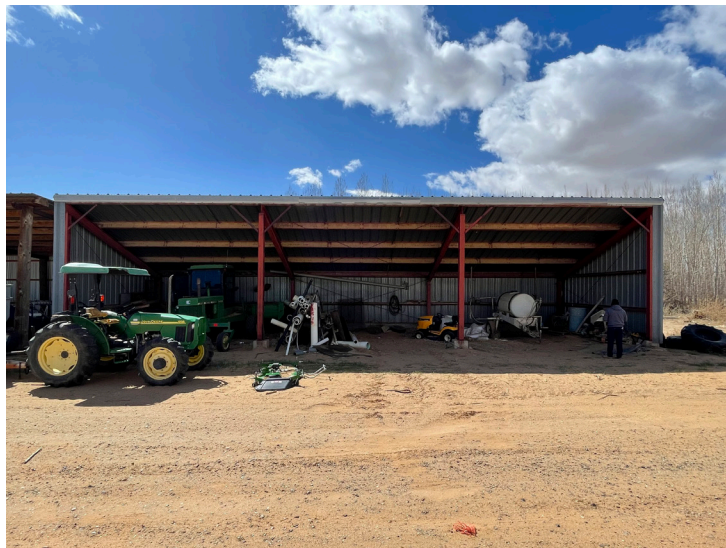
## **IMPLEMENT STORAGE 406I**

Paint exposed steel structure, grade ground level (site) away from metal panels along sides, repair damaged center column, and add gutter and downleaders to the structure.

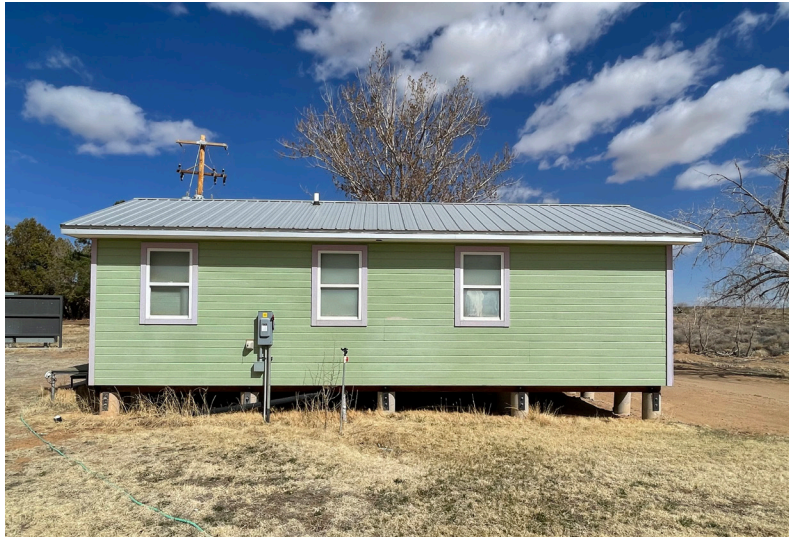
**SCIENCE CENTER/ STUDENT TRAILER 406J**

The building needs a ADA deck with fall protection and ramp installed, add need skirting along the four sides of the building and needs gutter and downleaders installed. Install a concrete apron around the building and regrade away from building at North, East, and West side of the building. On the South side the building needs retaining wall to infill are. The buildings needs to repaint door jambs, need to install ADA hardware at all doors, and a ADA restroom. The exterior needs a paint job, and reseal all exposed wood columns and beams in porch. Needs an ADA parking and accessible route.

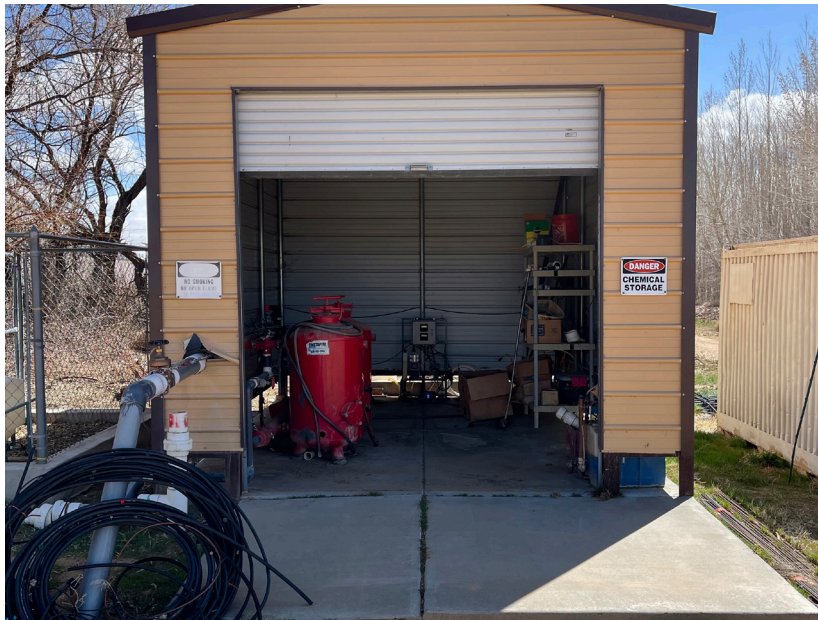
**FILTER HOUSE 406K**

Need to repair damaged roof panel at SE corner of the structure, it needs gutters and downleaders installed, and regrade away from the building to provide positive storm drainage.

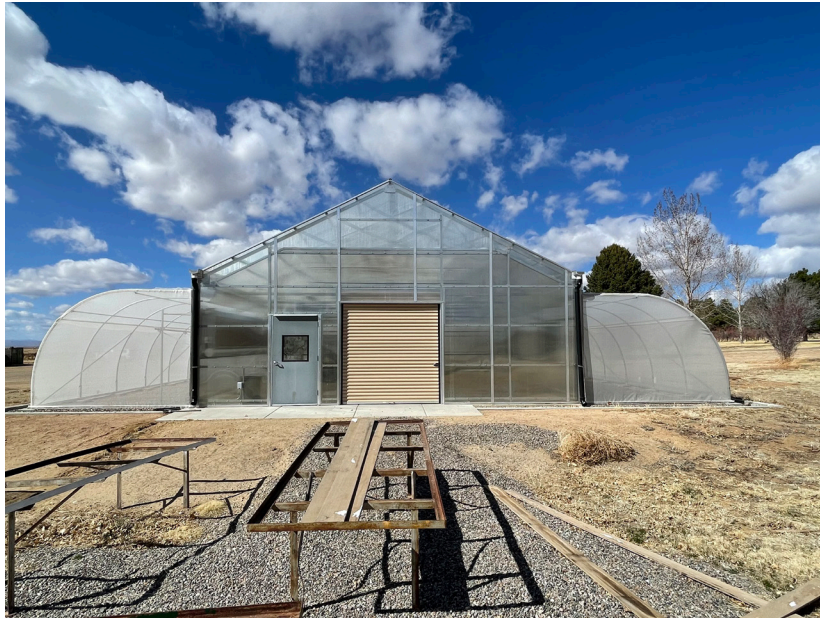
**GREENHOUSE 406D**

The greenhouse need one downleader installed and to prevent further erosion on the site along side-walk the area needs regrading.

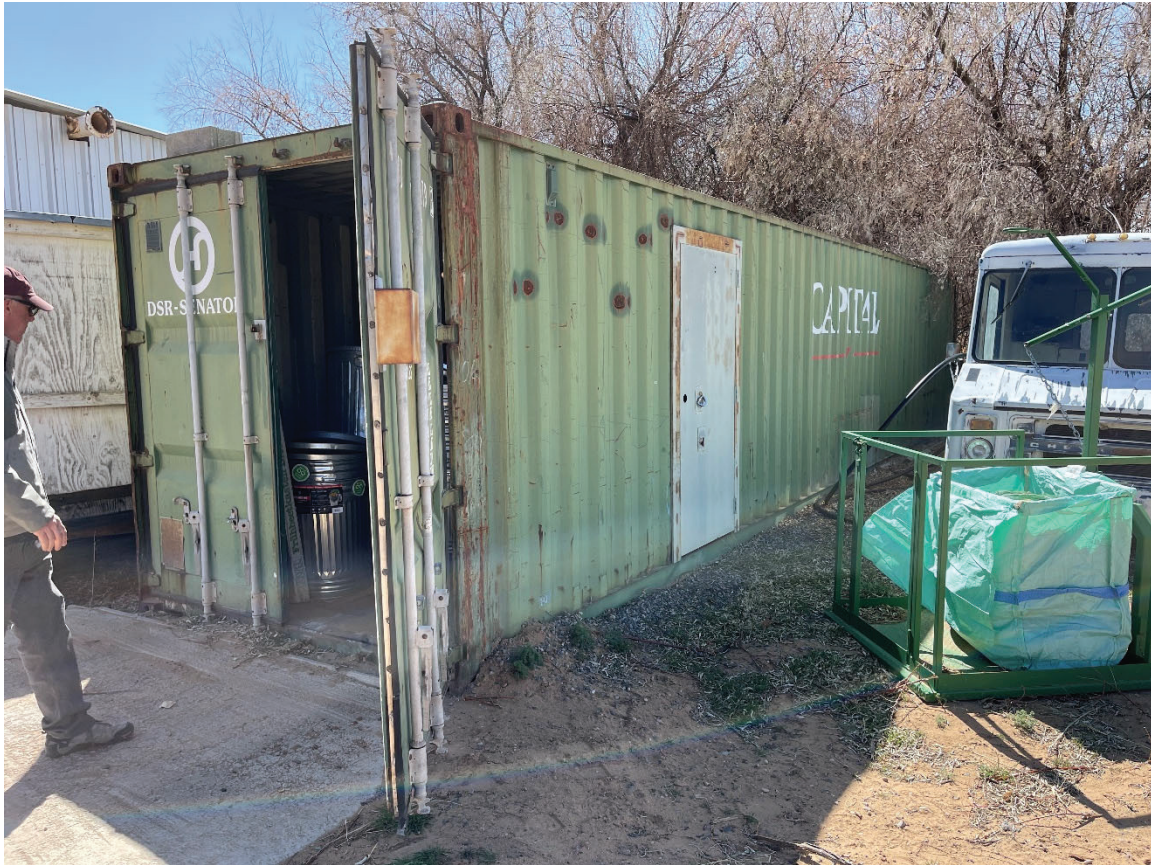
Boxcar tool storage:

Needs: repainting, concrete stoop at man door, ADA access hardware at man door.

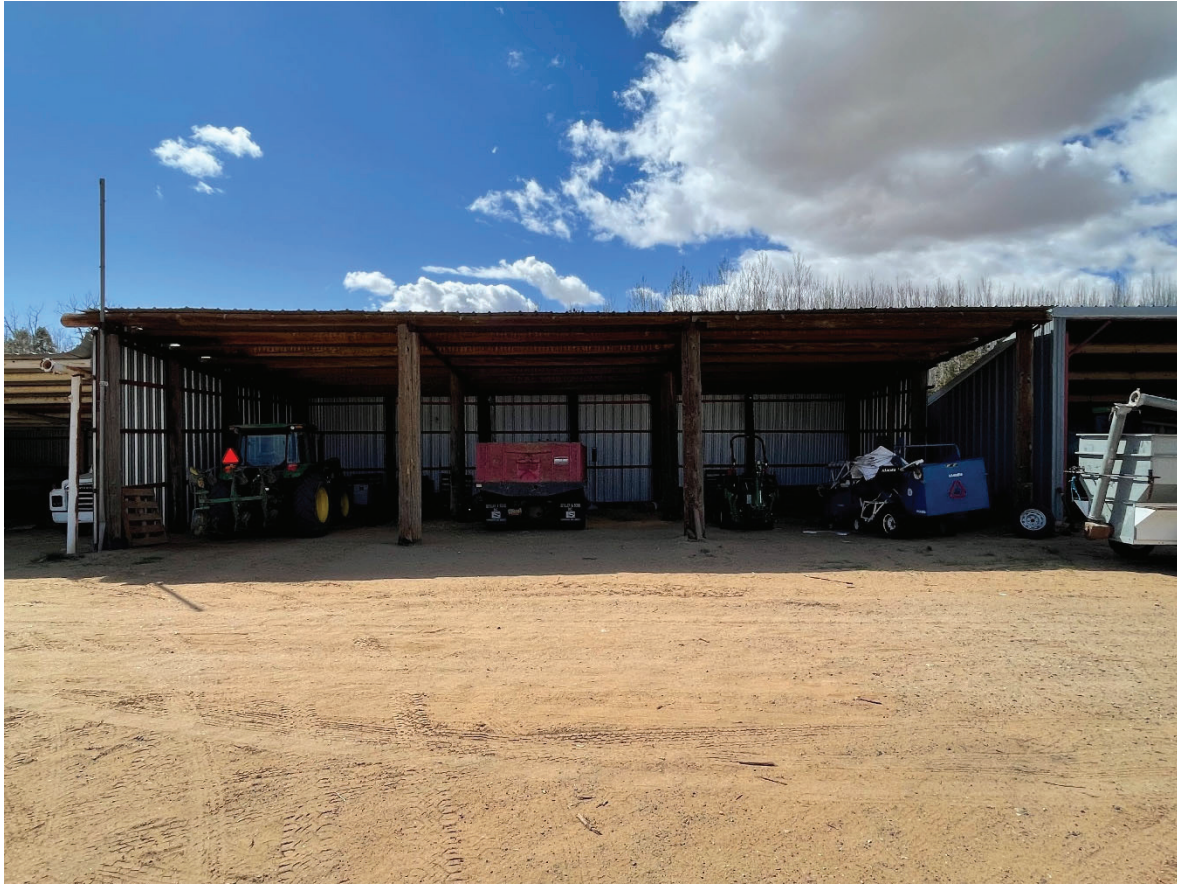
**Implement storage A:**

Needs: Regrade back side, paint exposed steel joists, reseal wood columns, reattach loose wall panels along top edge, rain gutter and downleader.

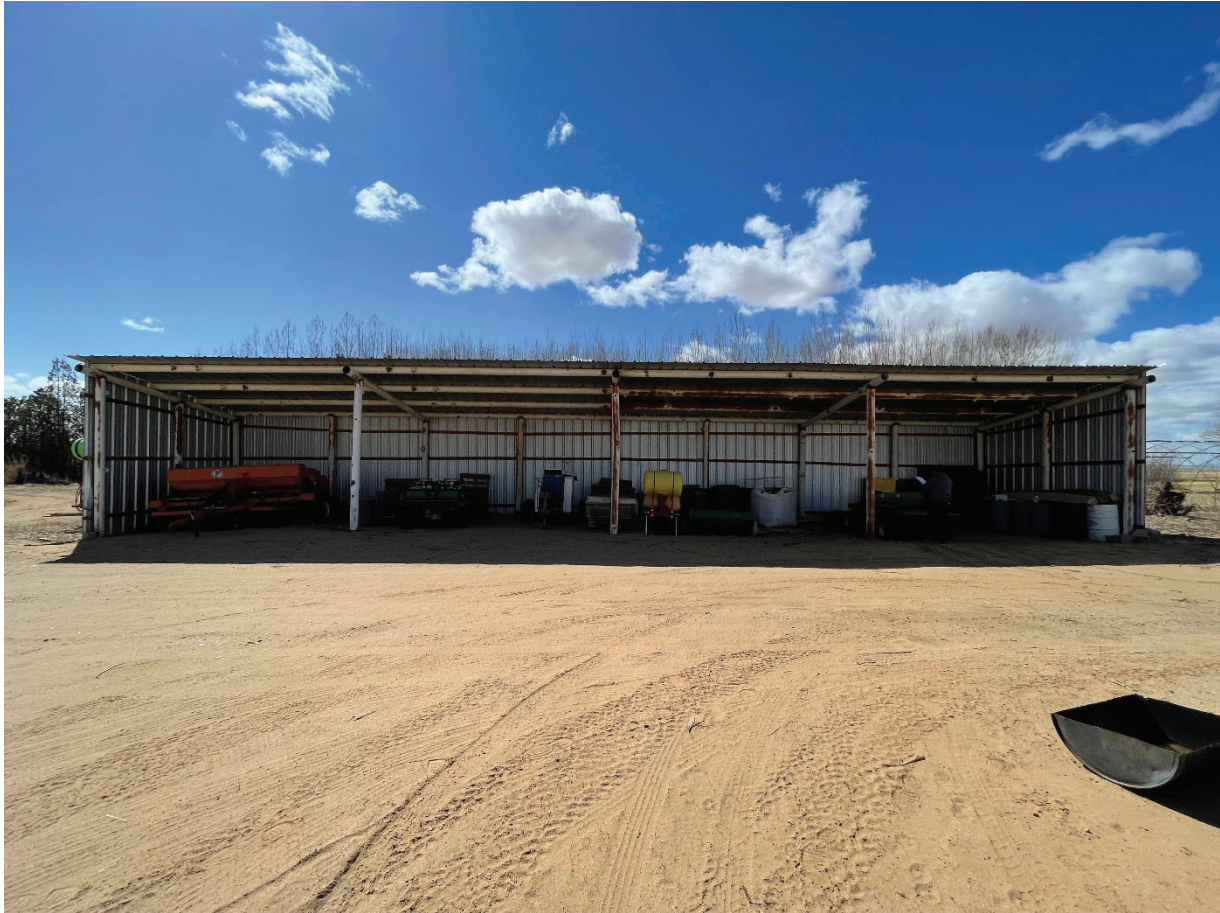
**Implement storage B:**

Needs: Repair damaged center column, bollards at each front column, paint exposed steel structure, regrade 3 sides to provide positive drainage, rain gutter and downleader.

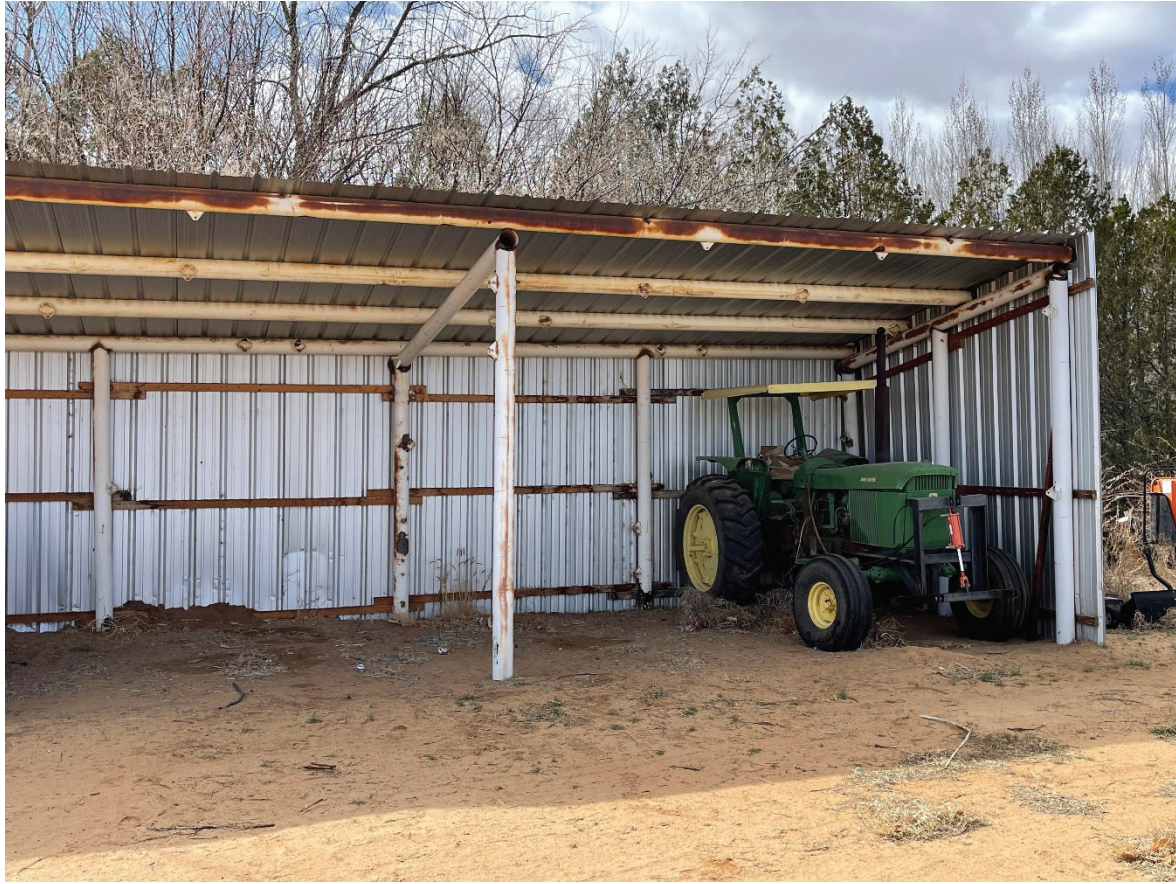
**Implement storage C:**

Needs: Remove trees along back, bollards at each front column, paint exposed steel structure, regrade 3 sides to provide positive drainage, rain gutter and downleader.

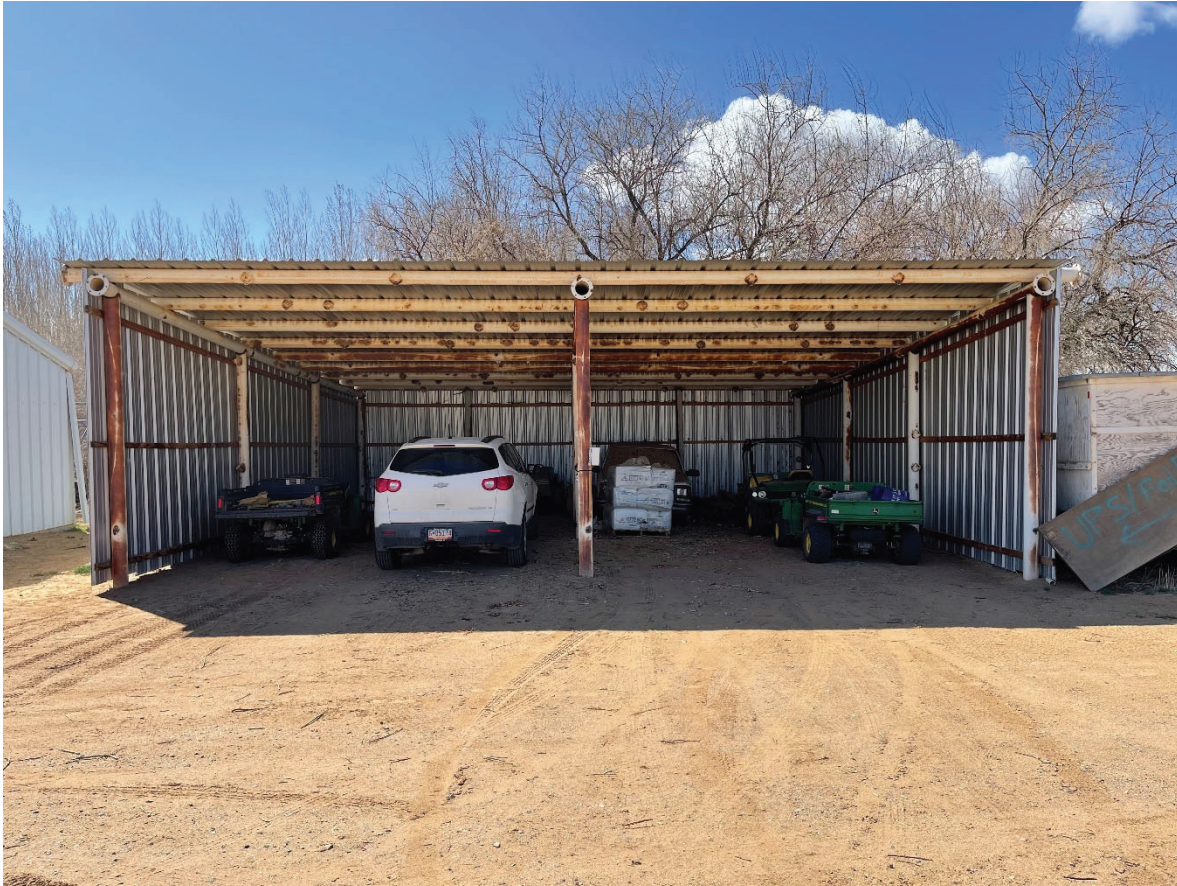
Vehicle storage:

Needs: Remove trees along back, bollards at front column, paint exposed steel structure, regrade back side to provide positive drainage, rain gutter and downleader.

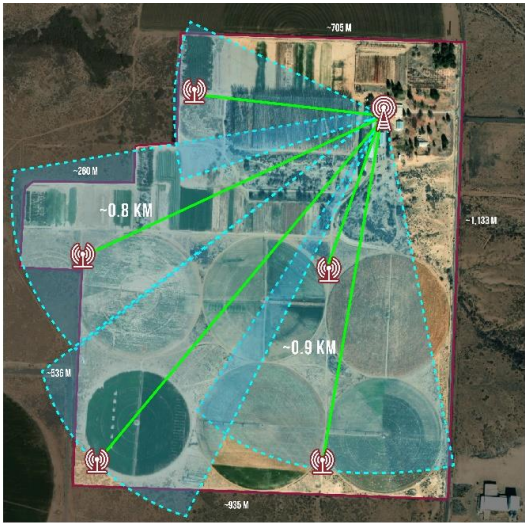
UBIQUITI ROCKET 5AC

**UBIQUITI ROCKET 5AC PtMP (2)**  
 INSTALLATION HEIGHT: 8 M (26 FT)  
 OUTPUT POWER: 28 dBm  
 CHANNEL WIDTH: 40 MHz  
 ANTENNA GAIN: 22 dBi

- SPECS:
- 5GHz WIDE BAND OPERATING FREQUENCY
  - POINT-TO-MULTIPOINT LINKS (PTMP)
  - DEDICATED MANAGEMENT RADIO

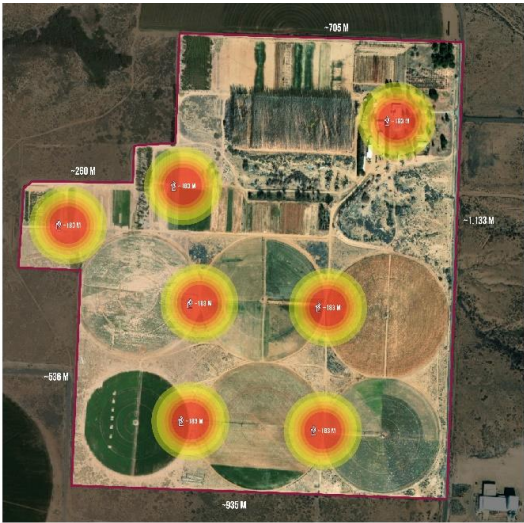
UBIQUITI ISOSTATION 5AC

**UBIQUITI ISOSTATION 5AC**  
 INSTALLATION HEIGHT: 3 M (10 FT)  
 OUTPUT POWER: 25 dBm  
 CHANNEL WIDTH: 40 MHz  
 ANTENNA GAIN: 15.5 dBi

- SPECS:
- 45° ISOLATION ANTENNA
  - SUPERIOR THROUGHPUT UP TO 450 MBPS
  - HIGH CAPACITY AND SCALABILITY
  - CAPABLE OF HIGH-SPEEDS
