Agricultural Science Center
at Los Lunas

BOOK 10 OF 12

FACILITIES MASTER PLAN REPORT

Executive Summary | July 2023

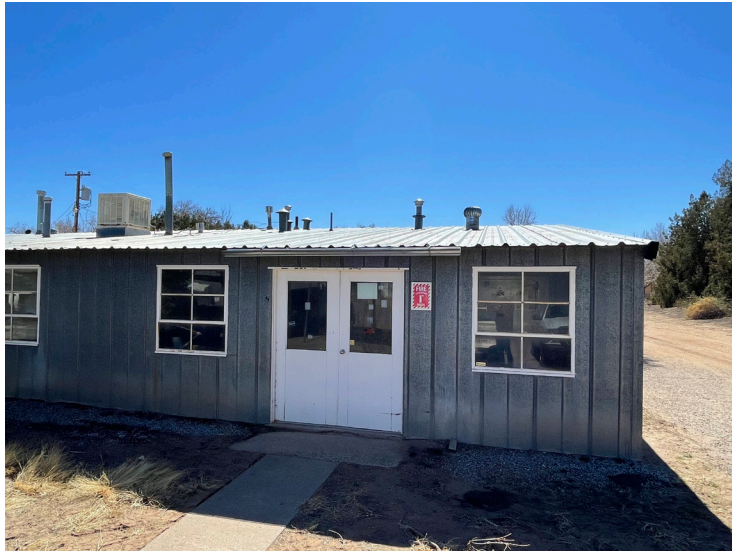
HEADHOUSE-GREENHOUSE 403G

The site needs regrading along greenhouse walls for positive drainage away from walls. Existing stucco is de-laminating and needs to be re-applied and painted. Replace damaged glass panels, existing space heater in not connected inside green house and need requires reconnection. The top operable pane of the windows are not working, multiple frozen movable mechanisms need repairs, office / headhouse needs complete renovation (strip all down to steel structure and rebuild). Anew new roof with gutters and downleaders is needed. The building meeds an ADA accessible route and concrete landing.

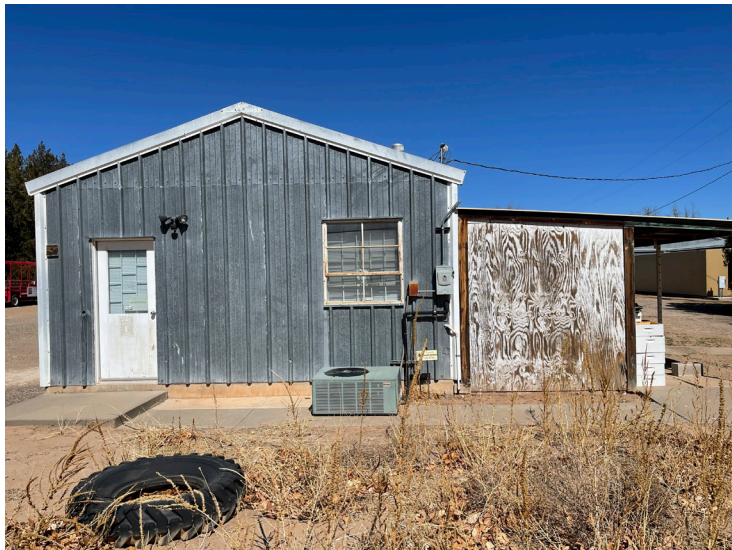
TISSUE CULTURE LAB 403H

the building needs an ADA accessible route and ramp to entry doors, add ADA lockset, and repaint entry doors. Interior doors need ADA lockset, and the building needs ADA restroom upgrades. Need to re-compact soil around septic tank, add erosion control and concrete apron all around, and regrade to provide positive flow away from building. . Demolish wood storage addition due to rotted wood, uneven floor, and trip hazards. The building needs gutters and downleaders,

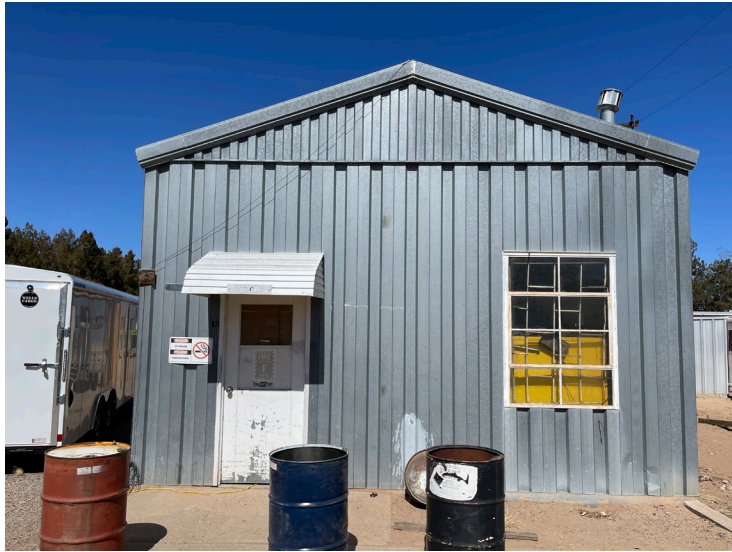
OLD SHOP 403J

Need gutter and downleaders, replace damaged exterior wall metal panels, repaint front door and frame, and repaint entry canopy. Add a new ADA lockset at entry door, replace the weatherstrip fat th front door, and replace sliding door hardware. Add a new a concrete apron and regrade for positive flow away from building.

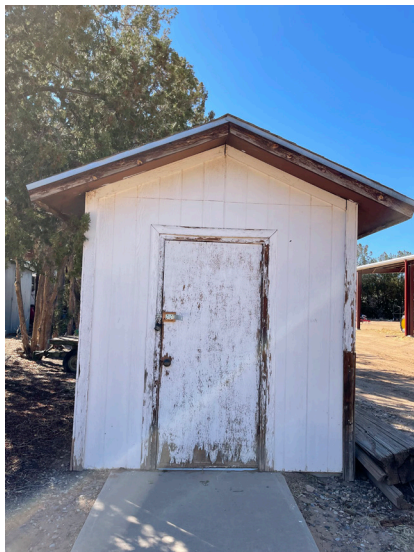
PUMPHOUSE 403P

Replace entry door and rotted wood trim, repaint the outside walls, replace and add new fascia board and paint, add gutter and downleaders, Needs erosion control fill dirt, a concrete apron and regrade for positive flow away from building.

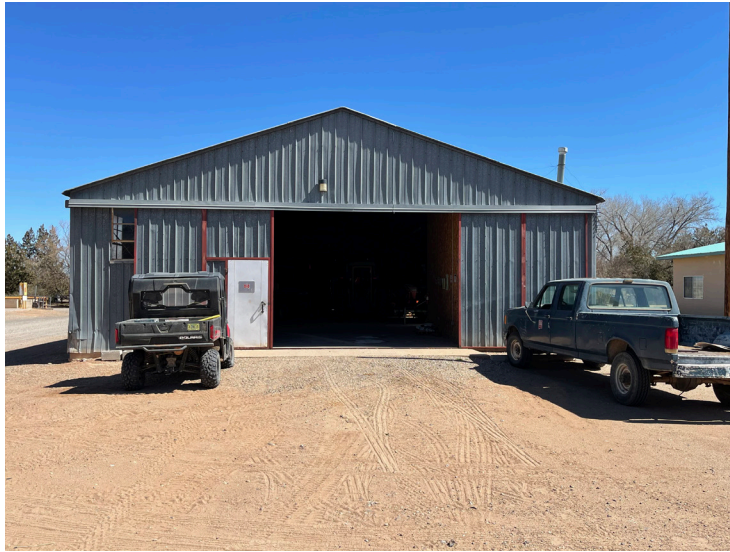
MACHINERY STORAGE 403I

Perform necessary roof repairs, add gutters and downleaders, and repair damaged metal wall panels. Add appropriate ADA lockset at storage - tool-room, sliding door needs repairs, and replace all loose wall panel screws throughout. Add a new concrete apron and regrade around the building for positive flow away from building.

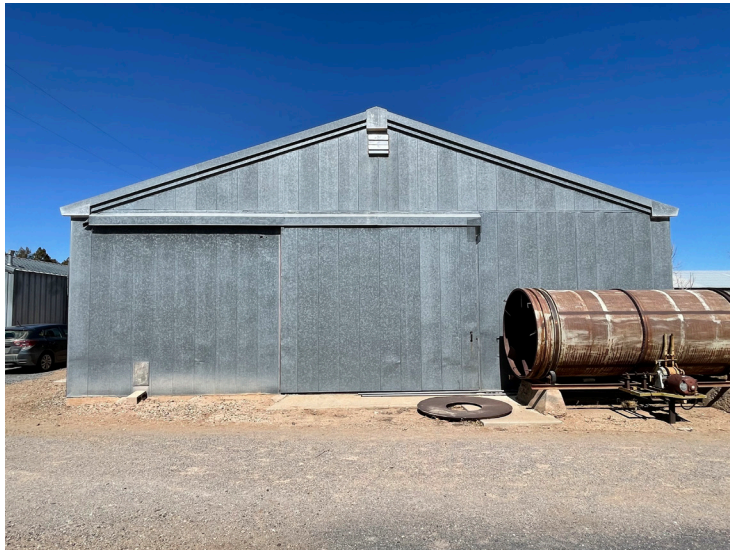
SEED BARN 403B

Replace all windows with double pane units, repair roof leaks, sliding doors need new sliding hardware, and repair damaged exterior wall panels. Need to seal all wall penetrations, and replace door inside sliding door. Install ADA accessible route to side main door via ramp from main building, need to add ADA lockset, and ADA restroom upgrades are needed. Need to repaint doors and frames. Remove landscaping along edge of building and add a new concrete apron and regrade around the building for positive flow away from building.

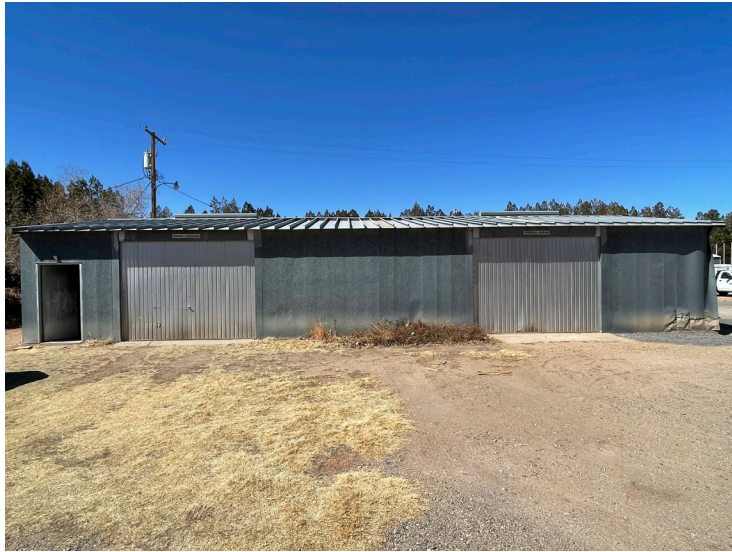
FERTILIZER STORAGE 403F

Repair or replace rusted lower edges at exterior wall panels, repair damaged panel corners throughout, and repair broken overhead door, and install new weatherstrip at all overhead doors. Replace damaged door panels at one overhead door and add appropriate ADA lockset at main doors. Add a new concrete apron and regrade for positive flow away from building.

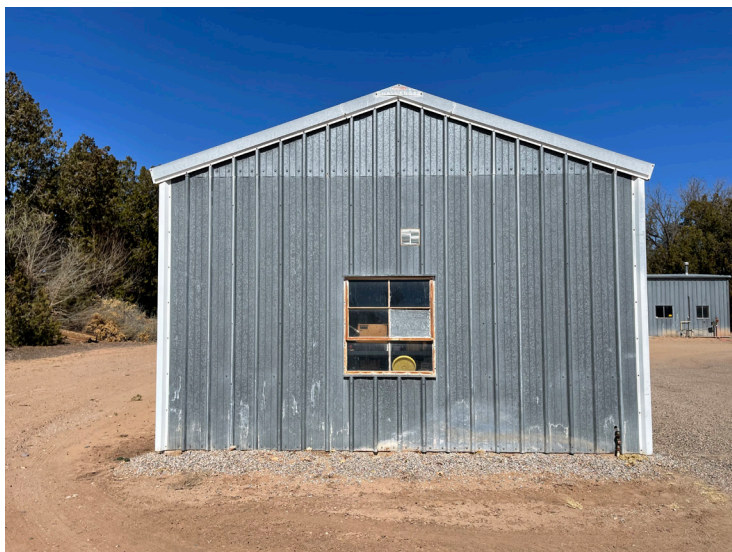
STORAGE BUILDING 403M

Need to add an ADA accessible route and landing to the main door and installed with ADA lockset,. Repaint door and frame and install new weatherstripping at main door. Repair roof leaks, sliding doors need new sliding hardware, repair damaged exterior wall panels, and seal all wall penetrations. The building needs new gutters and downleaders. Add a new concrete apron and regrade for positive flow away from building.

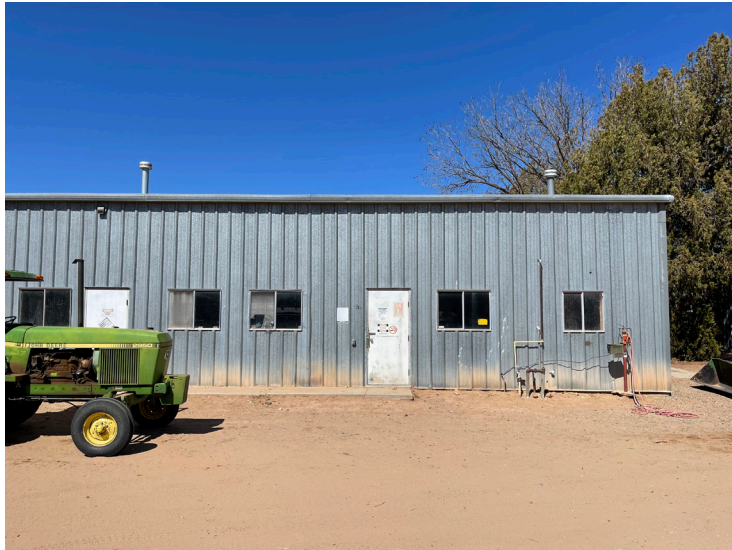
NEW SHOP 403N

Replace windows and screens, and add ADA lockset at doors. Add a concrete apron around the building and regrade for positive flow away from foundation. Replace one interior space heater that is not working. Clean all roof gutters, reseal and weatherstrip the overhead doors, refasten all loose metal wall panel screws, replace damaged overhead door panels, repair roof leaks.

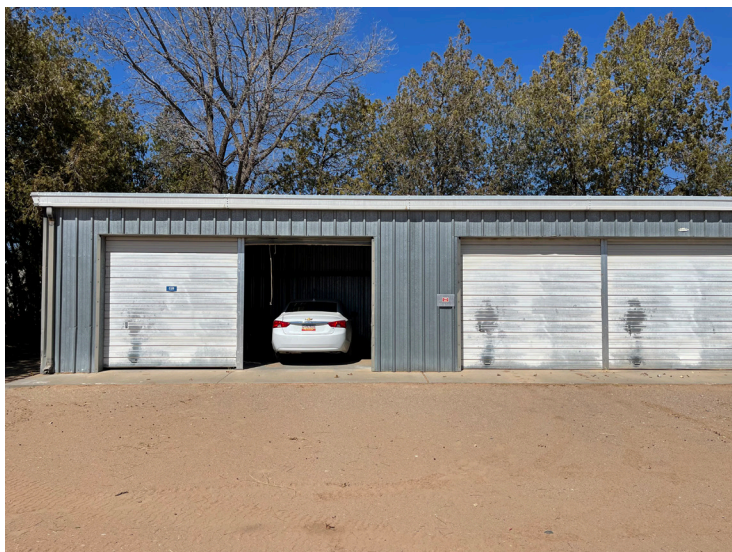
VEHICLE STORAGE 403K

Need steel pipe bollards filled with concrete at each overhead door, add concrete apron around three sides and regrade for positive flow away from foundation. Repaint all overhead doors and new install seals at all doors, and repair 3 existing damaged overhead doors. Roof leaks needs repairs, clean gutters, repaint main doors and provide ADA lockset. Regrade for positive flow away from foundation.

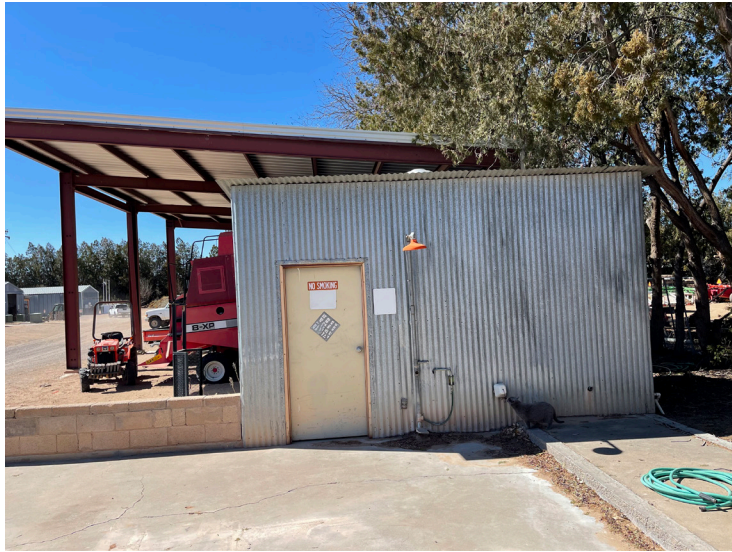
WASH RACK 403A

Need gutters and downleaders, replace eyewash station, repair roof leaking and repair damaged ceiling and wall panels. Add a concrete apron around the sides and regrade for positive flow away from foundation.

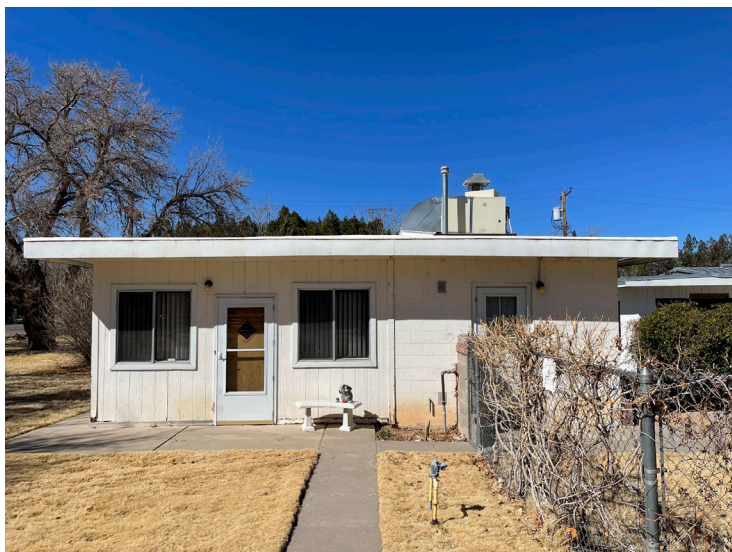
FORMANS RESIDENCE 403D

Needs to add a new single single-ply TPO roof, existing soffit needs repairs and repaint. Repoint cracks in mortar joints, and then new exterior wall paint job. Add gutters and downleaders to manage roof drainage, add a concrete apron around three sides and regrade for positive flow away from foundation. Need repair of cracked/spalling edge of slab, and replace rotted wood and repaint wood siding and boards,. The facility needs an ADA access ramp to utility room entry door and need to install ADA lockset at entry doors.

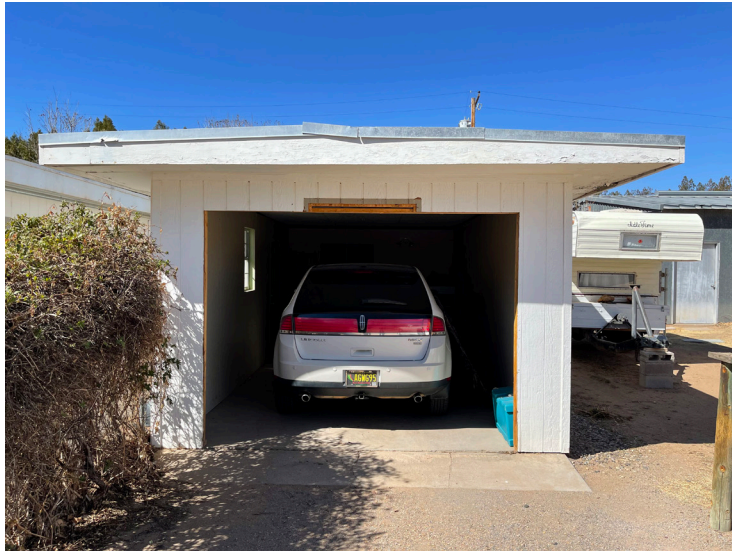
GARAGE 403E

Needs to add a new single single-ply TPO roof, existing soffit needs repairs and repaint. The fascia needs replacement of rotted wood, repoint cracks in mortar joints, and then new exterior wall paint job. Add gutters and downleaders to manage roof drainage, add needs concrete apron around three sides and regrade for positive flow away from foundation. Replace all rotted wood and repaint wood siding and board throughout.

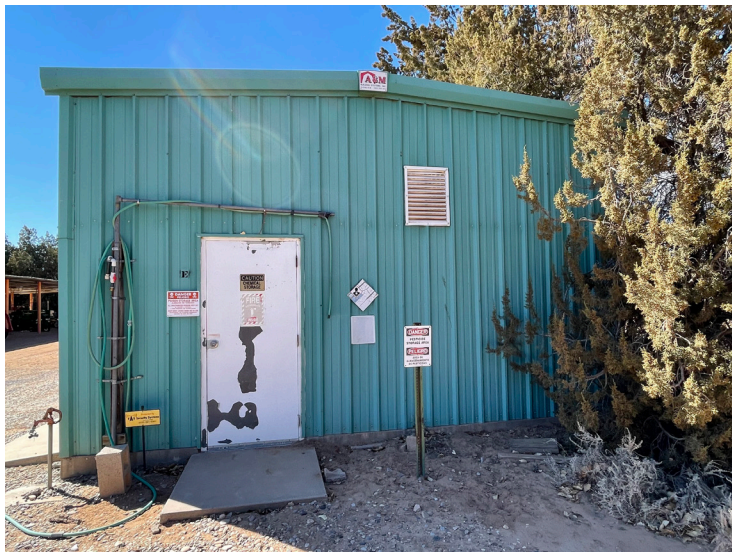
PESTICIDE STORAGE 403R

Need erosion control and add a concrete apron, add gutter and downleader, repaint entry door and overhead door, and remove vegetation from back of the building. The doors need an ADA lockset, while the overhead door gasket and weatherstripping at main door need replacing.

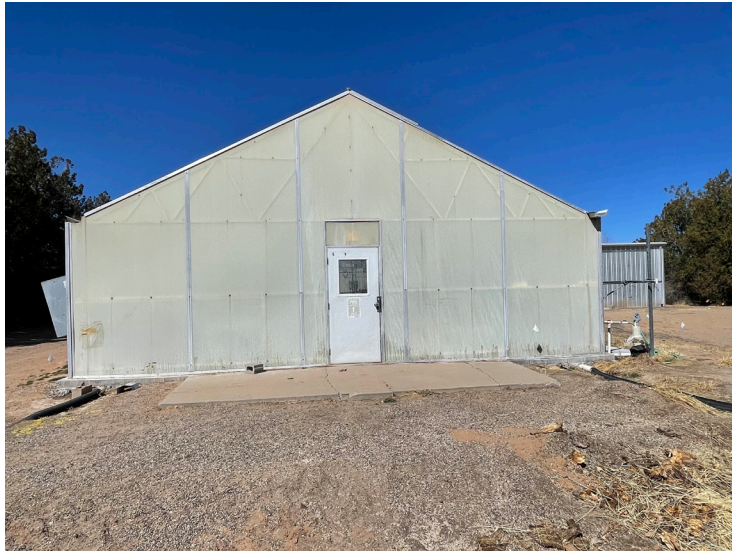
GREENHOUSE 403Q

Concrete landing and sidewalk at South entry needs replacing, needs downleaders, regrade site away from building, repair gutter ends, ADA lockset at the doors.

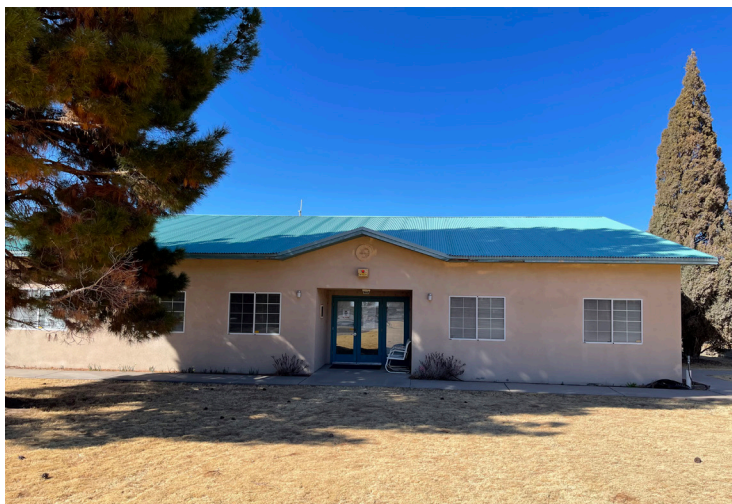
OFFICE BUILDING 403C

Exterior wall EIFS repairs are needed, then repaint all exterior walls. Replace rotted fascia board and paint, replace rotted soffit and repaint, and add need gutters and downleaders. The building needs concrete apron all around and the removal of all landscaping next to building. Replace west entry door-trims and provide ADA ramp and landing at this door. Replace all window screens, re-weatherstrip all exterior doors, and repaint east entry door and jambs-trims. The building needs new exterior light fixture at south entry. Replace interior carpet, repair roof leaks, replace stained ceiling tiles, doors need ADA lockset inside, and replace all lights to LED. The restroom needs a drain and water line insulation jacket, men's restroom missing ADA door clearance, kitchenette counter not ADA height and missing wire pulls, server room no ADA clearances, braille signs missing throughout, conference room counter height not ADA

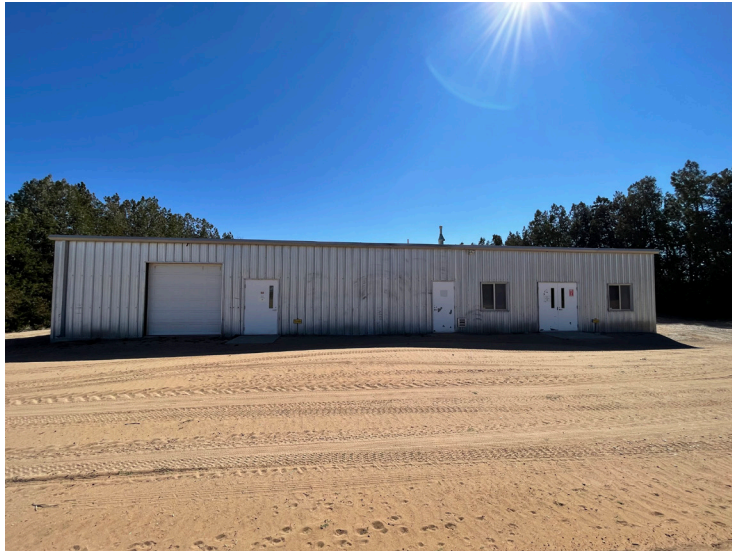
NEW HEADHOUSE 403S

Repaint all exterior doors both sides, add a concrete apron all around to improve drainage and regrade site to create positive drainage from building. Repair damaged exterior wall panels, and add new weatherstripping on all exterior doors, building insulation cover fabric repairs inside. , Needs an ADA hi-lo drinking fountain.

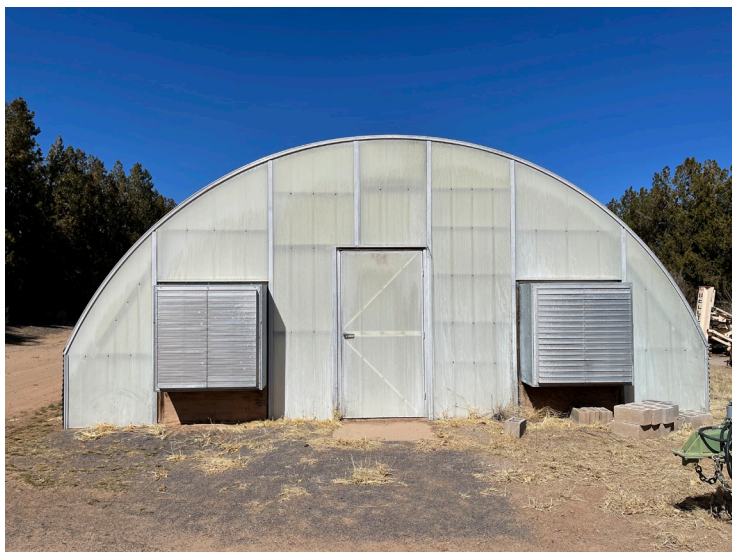
TEMPORARY GREENHOUSE 403T

The site need regrading for positive flow away from building, need ADA landing and hardware at entry door, and a concrete apron all around to improve site drainage. Replace rotted wood at air manifold, seal edge between Lexan and corrugated metal panels.

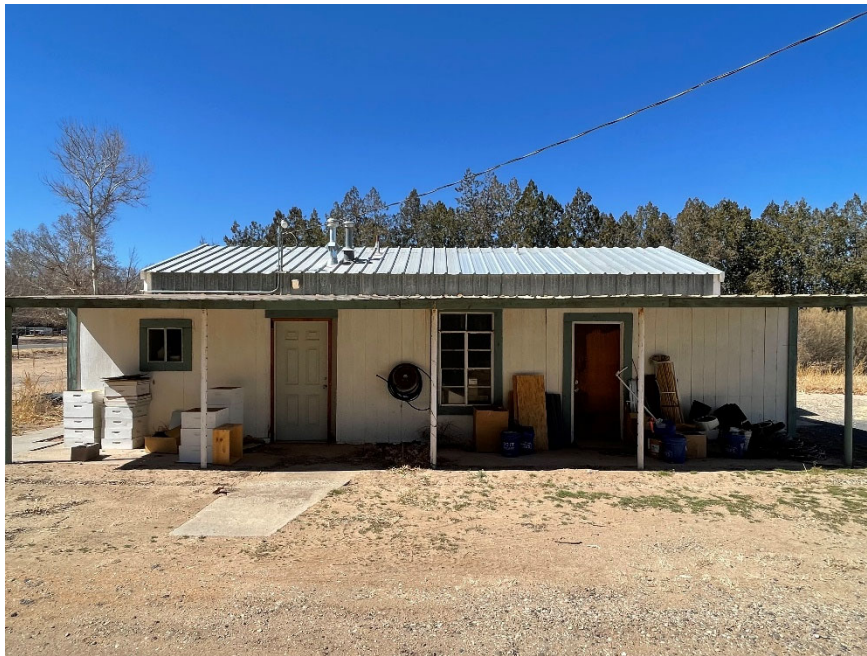
- Storage next to tissue culture lab. Rotted wood structure, multi-level floors, tripping hazards, new doors needed, etc. Building is beyond feasible repair.

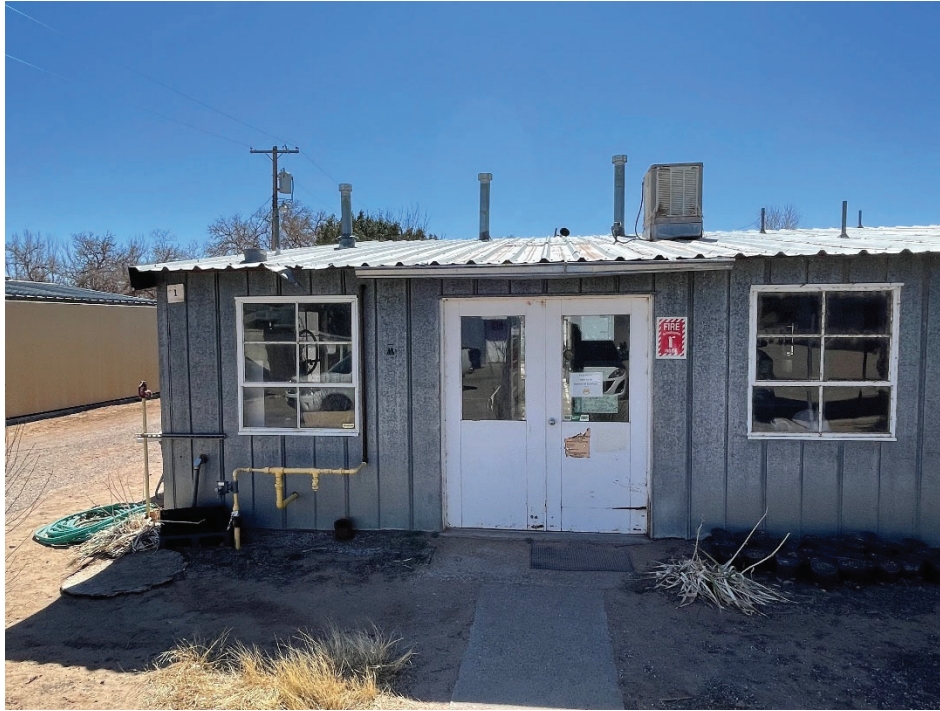
Head house remodel, reusing skeleton (very low ceiling along North side). Worth the savings vs flexibility for current and future?

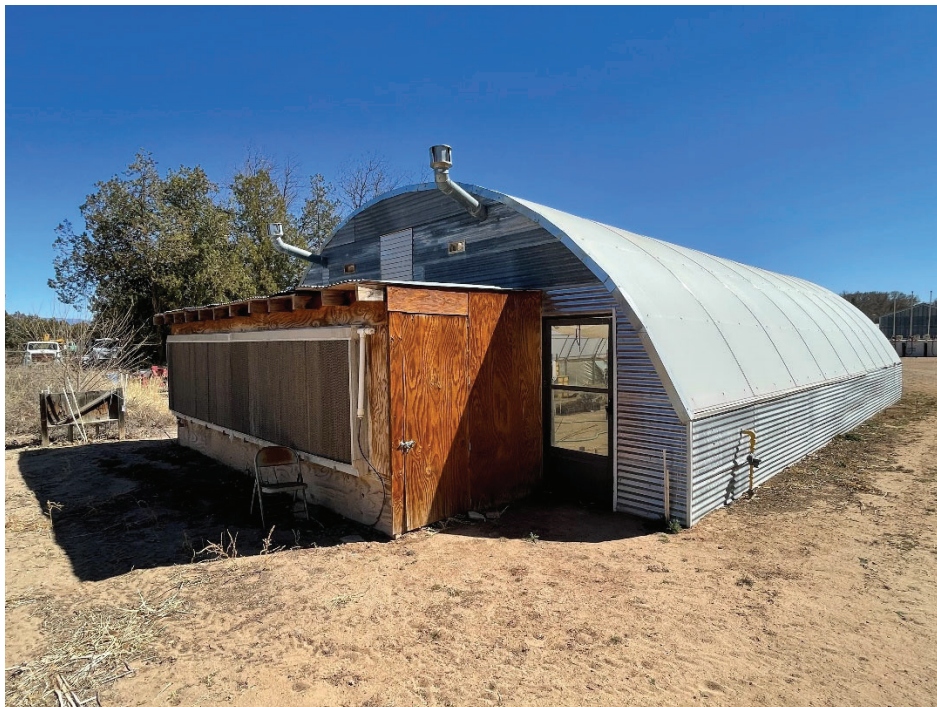
Green house plenum building, rotted wood. Building is beyond feasible repair if planning to continue use.

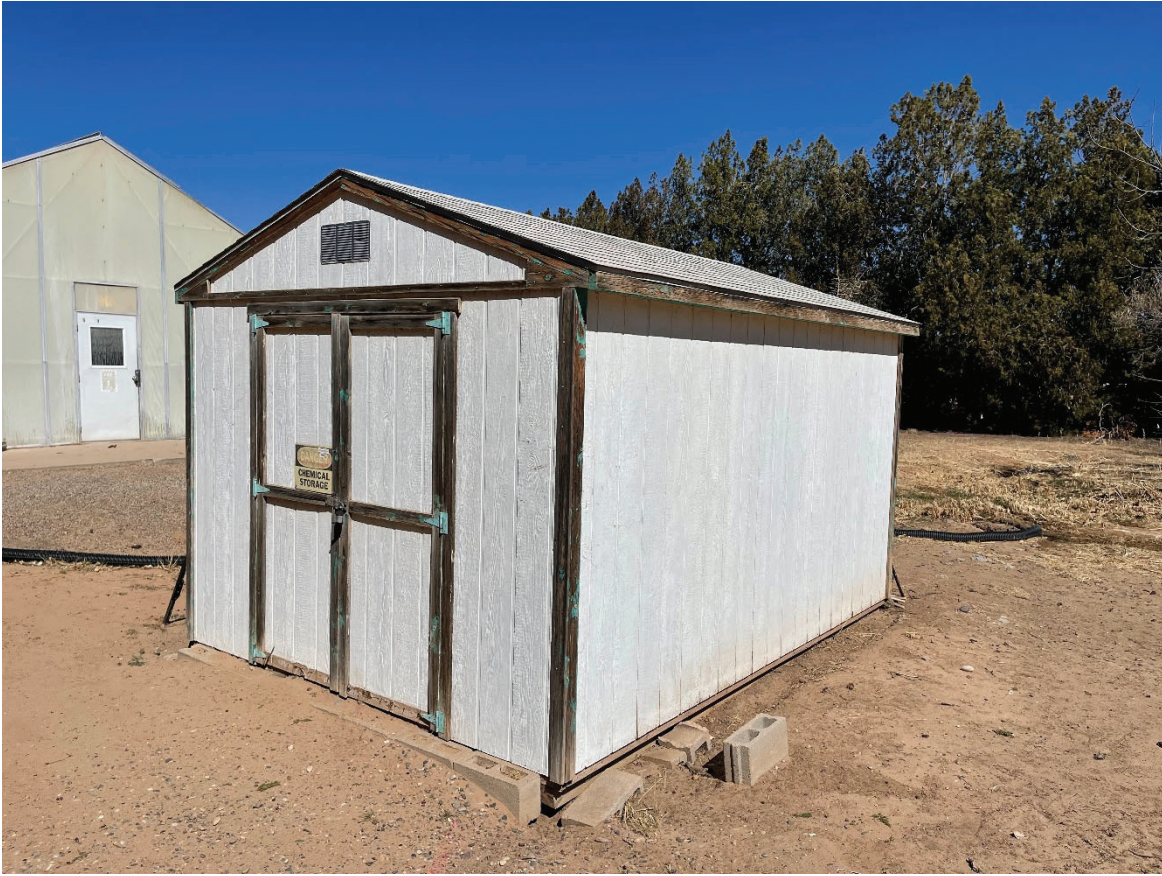
Chemical storage wood shed:

Needs: Repair rotted siding and trim, repaint all exterior surfaces, rain gutters and down leaders, regrade 3 sides.

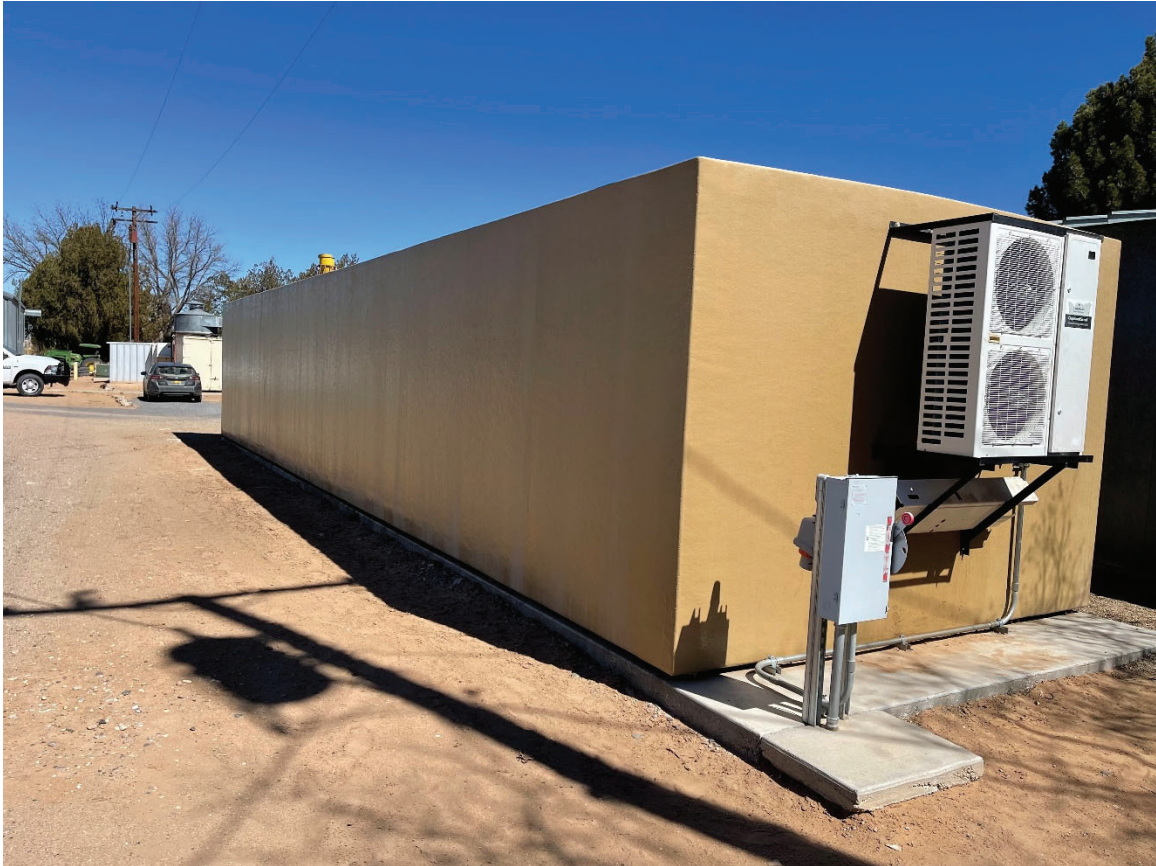
Cold storage:

Needs: Bollards around electrical disconnect.

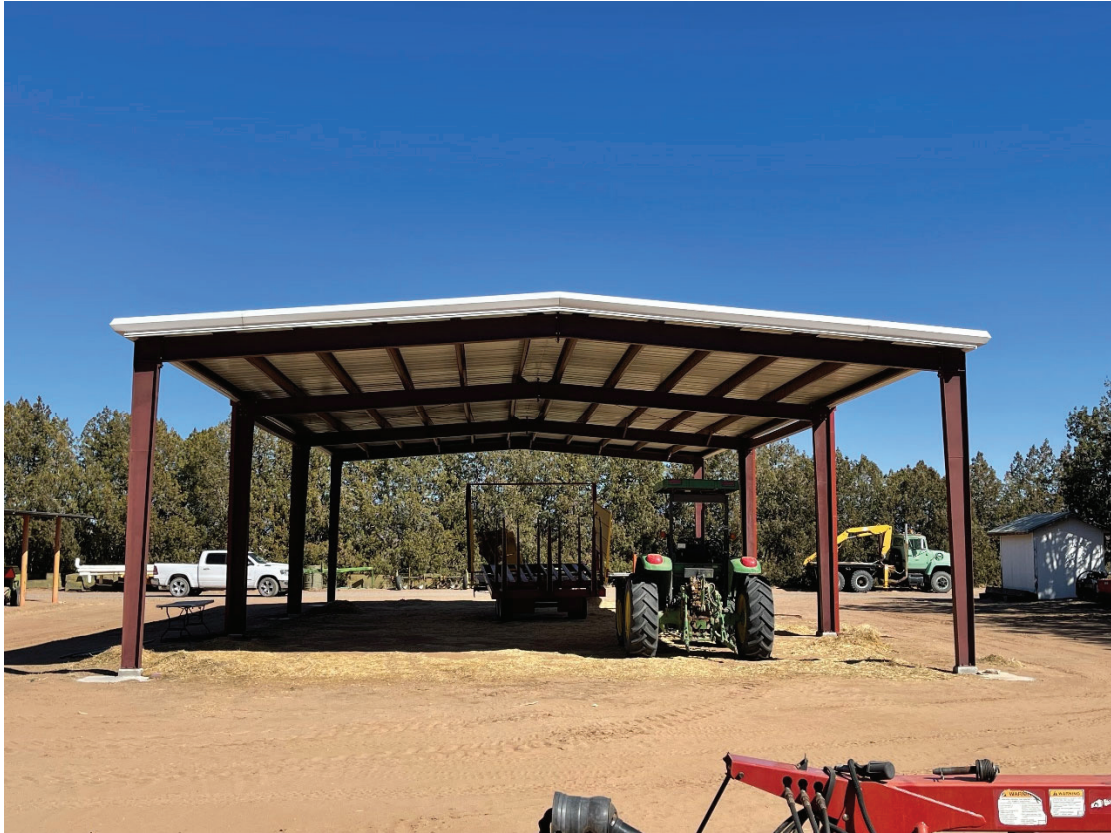
Hay shade:

Needs: Paint all exposed steel columns and moment frames, concrete bollards around columns.

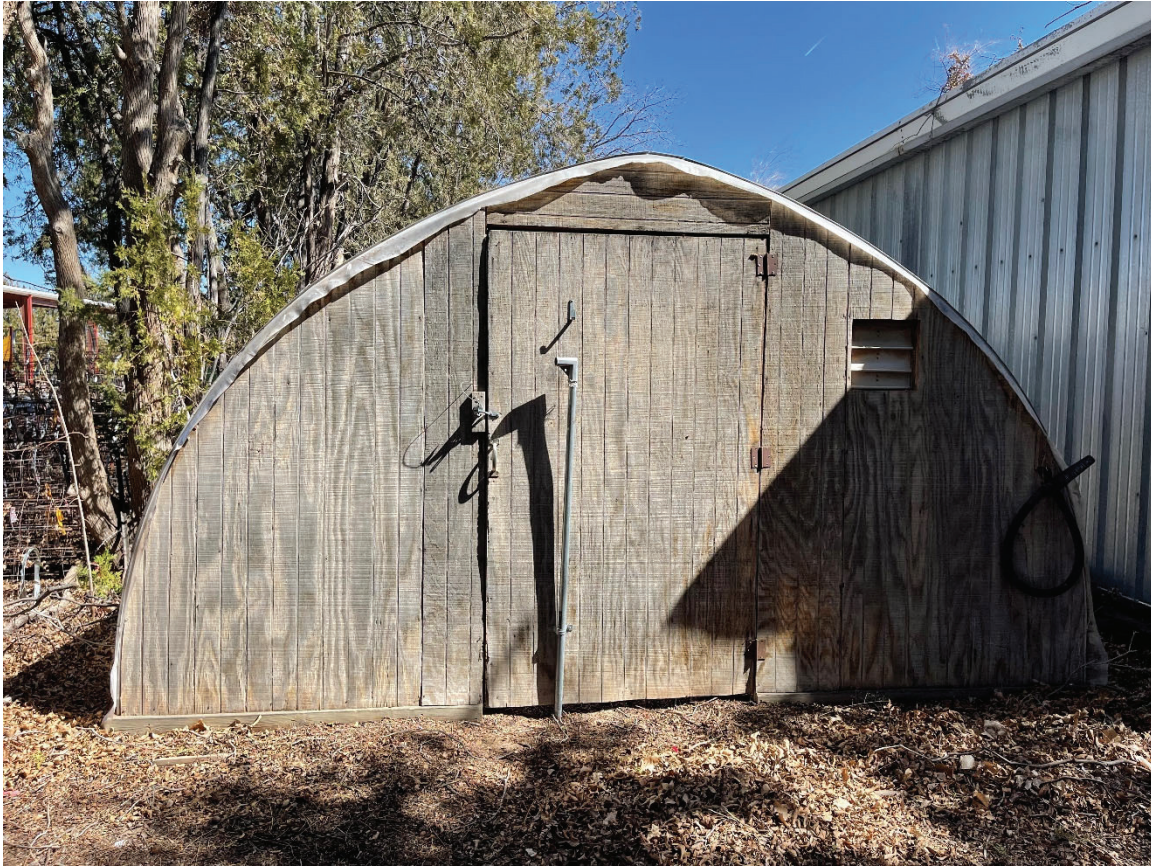
Hoop House:

Needs: Replace rotted wood at ends, repair plastic sheathing.

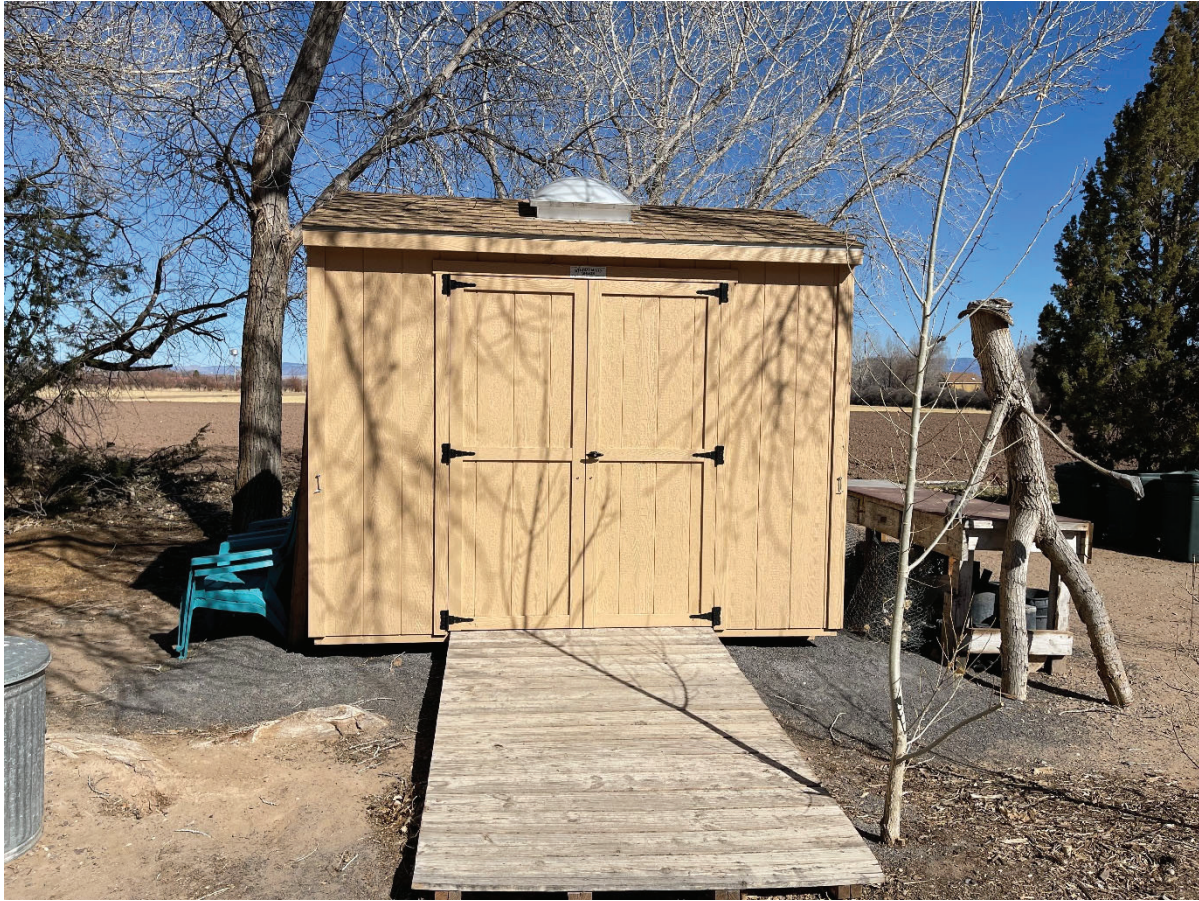
Tool storage wood shed:

Needs: Refasten and reseal wood entry stoop, rain gutters and down leaders, regrade 3 sides.

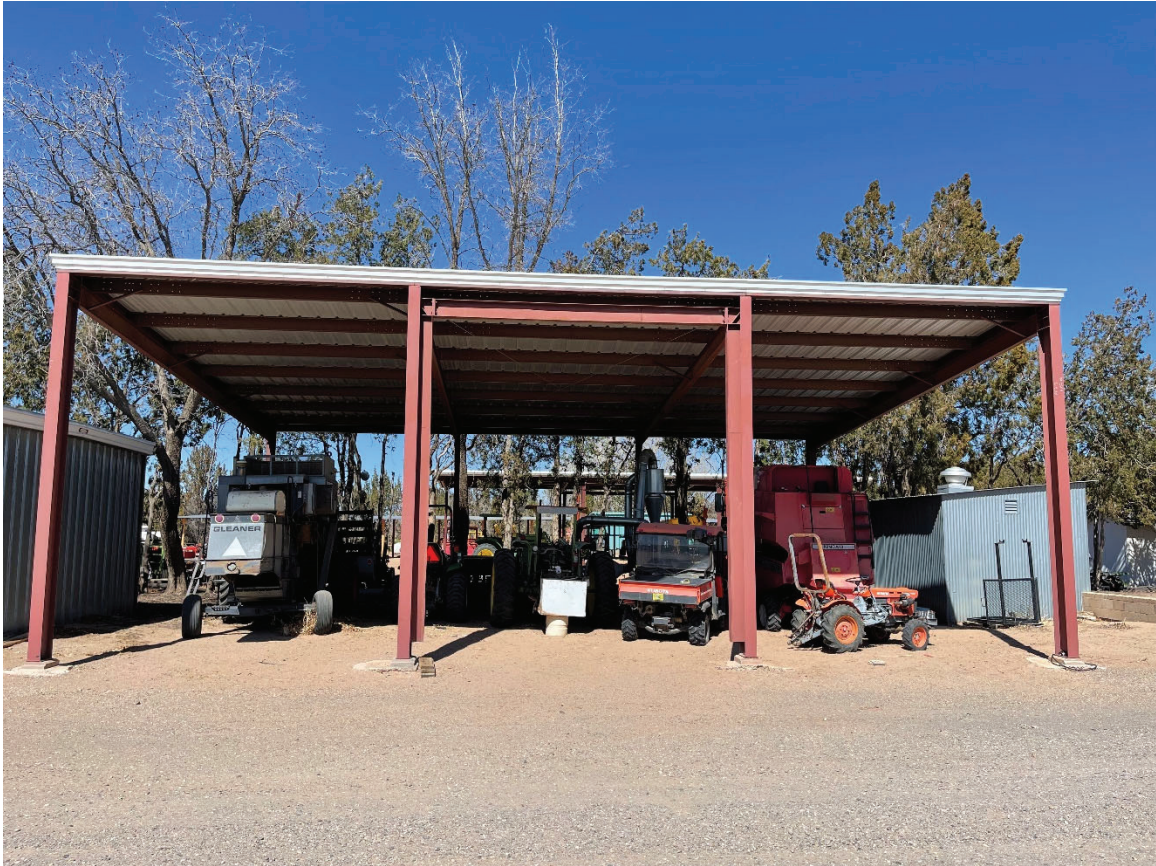
Tractor shade:

Needs: Clean rain gutter and down leaders, regrade all back side, paint all exposed steel columns and moment frames, concrete bollards around front columns.

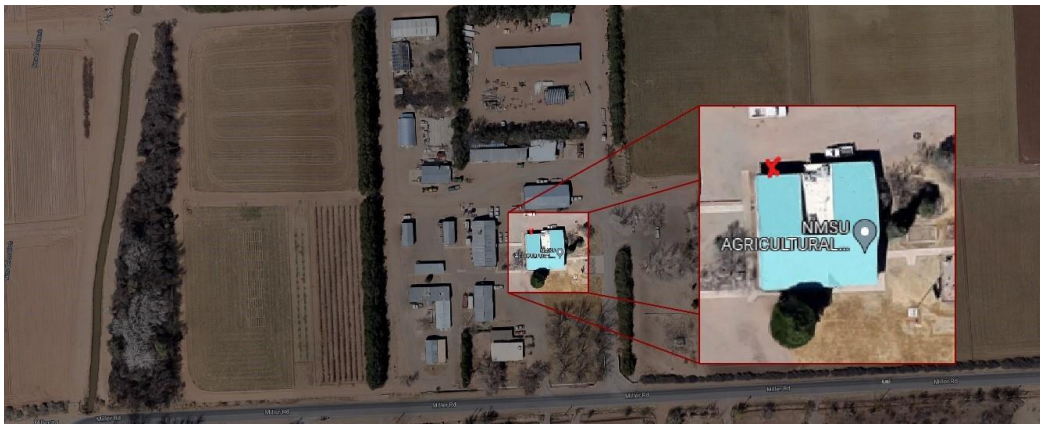
IT Spaces/Network Closets

The DMARC comes in from the north side of the Main Office to the center of the building into a distribution closet. A federal agency shares the closet, but it's secure and cooled. Wireless coverage is good in the main office and requested Auxiliary buildings.

Network space is needed at this ASC and needs to meet standards. It is our recommendation to build out an IT/network space for this ASC. If there is no room that can be modified into this space, it is our recommendation to build a separate IT/network space outside, close to the existing DMARC, that is cooled, isolated only for IT needs, has proper lighting, floor loading, power, network racks and equipment, airflow, and meets standards.

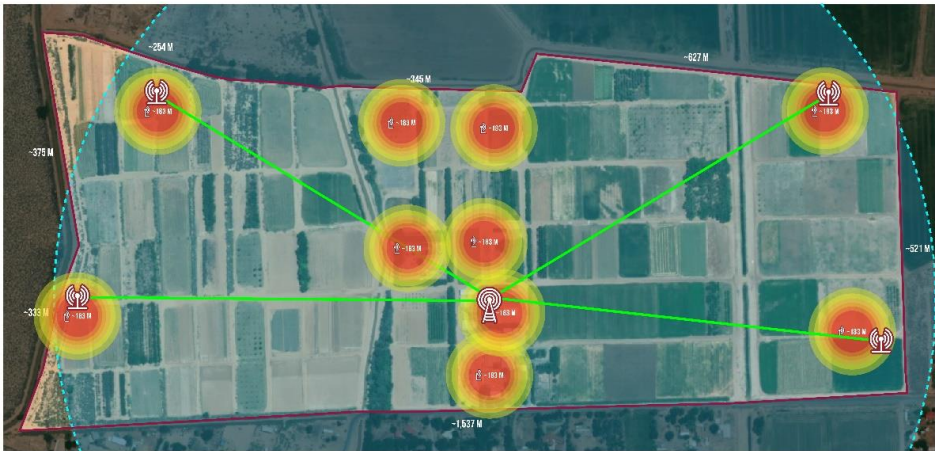
UBIQUITI ROCKET 5AC P1MP (2)
INSTALLATION HEIGHT: 8 M (26 FT)
OUTPUT POWER: 28 dBm
CHANNEL WIDTH: 40 MHz
ANTENNA GAIN: 22 dBi
