NMSU Alcalde Sustainable Agricultural Science Center

BOOK 2 OF 12

FACILITIES MASTER PLAN REPORT

Executive Summary | July 2023

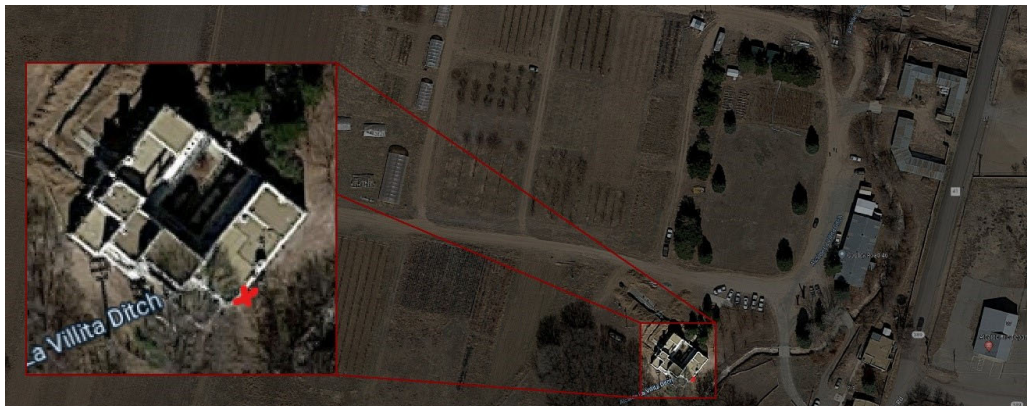
The main office building was rewired almost 20 years ago, and should be rewired. Cat 5e network cables run underneath this building. Auxiliary buildings have exposed network cables but wireless is installed in most building.

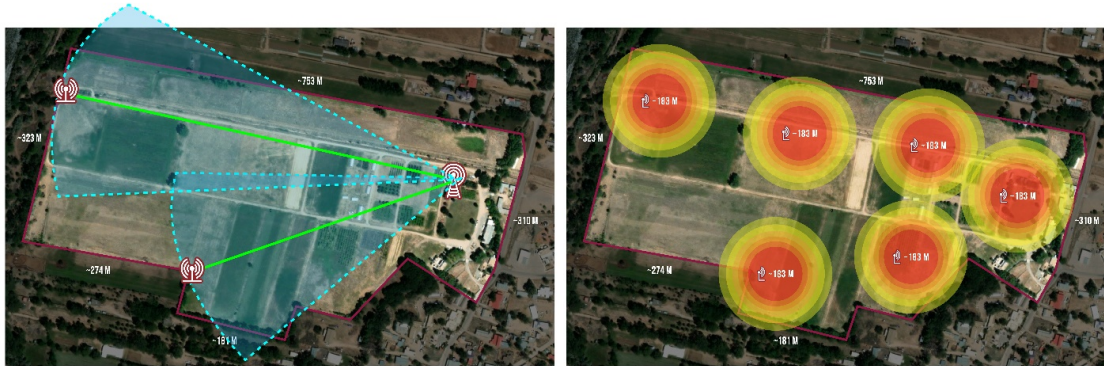
This ASC should have a minimum of two cameras, one showing the entrance/exit when vehicles arrive, and one on the main office building. This ASC would benefit from multiple cameras across the center to deter theft and increase visibility. Different locations at the center would allow for cameras to be installed and configured.
