New Mexico State University

FACILITIES MASTER PLAN REPORT

Executive Summary | July 2023

NMSU Agricultural Science Center at Artesia -DEFICIENCIES LIST

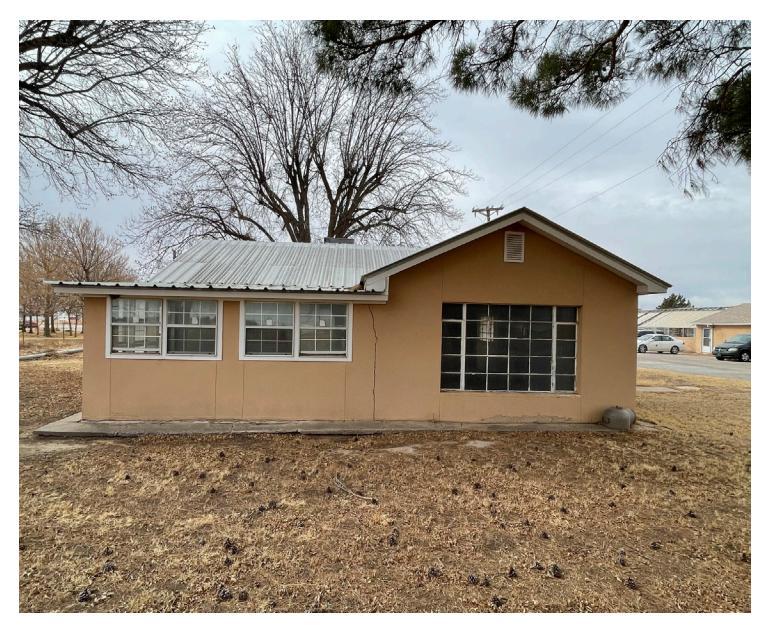
RESIDENCE 346 B

(Candidate for demolition and replacement)

The building shows differential settling and requires site needs regrading away from building. The building windows needs insulated windows, and it is in needs extensive stucco repairs, needs gutters and downleaders, replacement and repaint fascia and outriggers, wood porch posts need repairs and repaint, house needs ADA access and modifications.

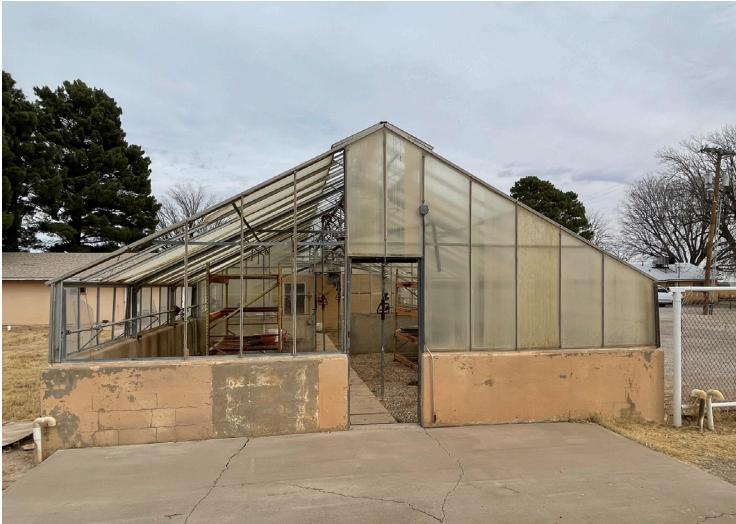
GREENHOUSE 346C

(Candidate for demolition and replacement)

Pony walls around the Greenhouse perimeter need to be re-stucco. CMU joints are cracking and require repair, and greenhouse walls show significant moisture damage that need replacement both interior and exterior sides. Lexan panels at the greenhouse need to be replace since they are broken and all greenhouse operable panels are frozen. The building needs ADA access to and from the greenhouse.

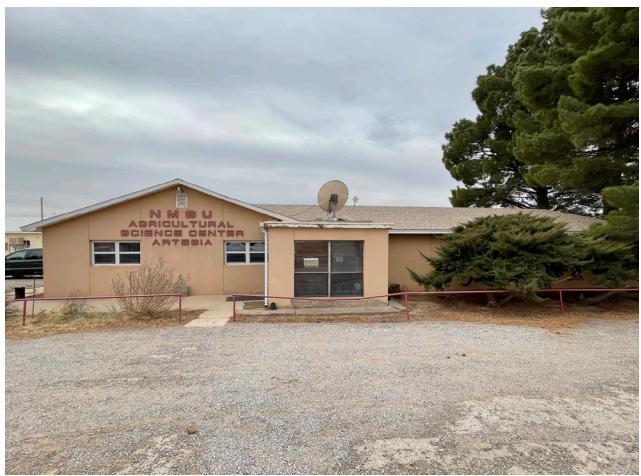
OFFICE 346 A

(Candidate for demolition and replacement)

The building shows severe building settlement along East side, substantial civil work to regrade all site required to direct water away from building since there is no positive water drain from building on North and East sides. Throughout the building the stucco coat over the cmu walls are cracking and delamination, additionally walls needs crack repairs and to be repainted. The building soffits needs repairs and repaint. The concrete apron along exterior walls on areas where existing landscaping needs repairs as its too close to the house or missing and removal of all landscaping close to exterior walls is needed. The building needs gutters and downleaders, repair rotted fascia boards and repaint, and replace damaged concrete apron at main entry. Access to the front door needs ADA compliant access (currently not available due to site settlement), interior E walls severe settlement cracking, interior restrooms not ADA (need to be rebuilt and redesigned), vestibule entry door needs ADA hardware.

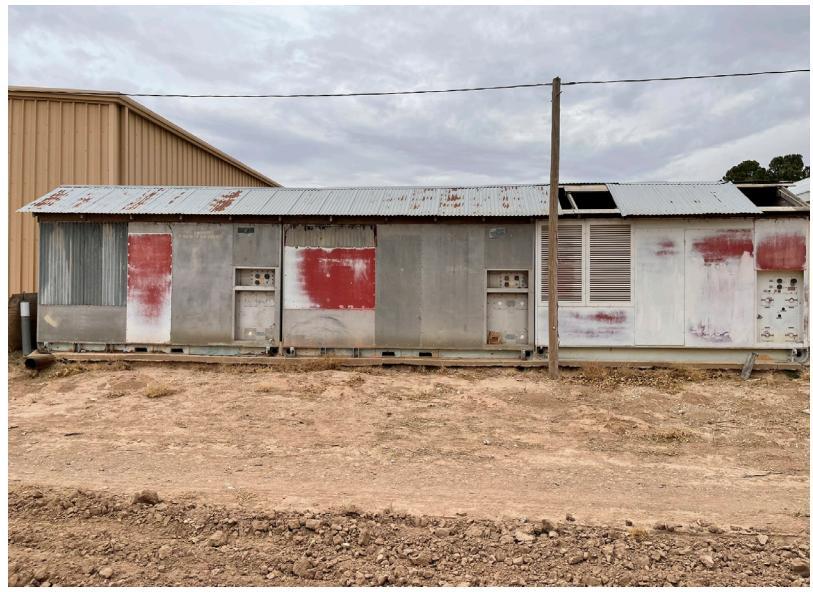
SHOP ANNEX 346F

Candidate for demolition and replacement (structure foundation is eroded)

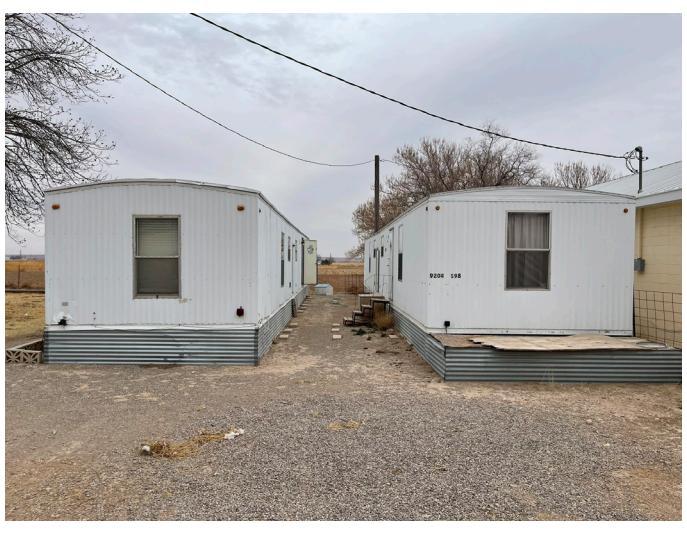
PECOS HILTON A346K

Need new skirting, new gutters and downleaders, repair damaged exterior wall panels, need ADA access ramp and deck at entry and rear door, regrade for erosion and add concrete apron all around. The restroom are not ADA accessible, need ADA hardware at entry and back doors, plywood platform rotted needs replacement and painting.

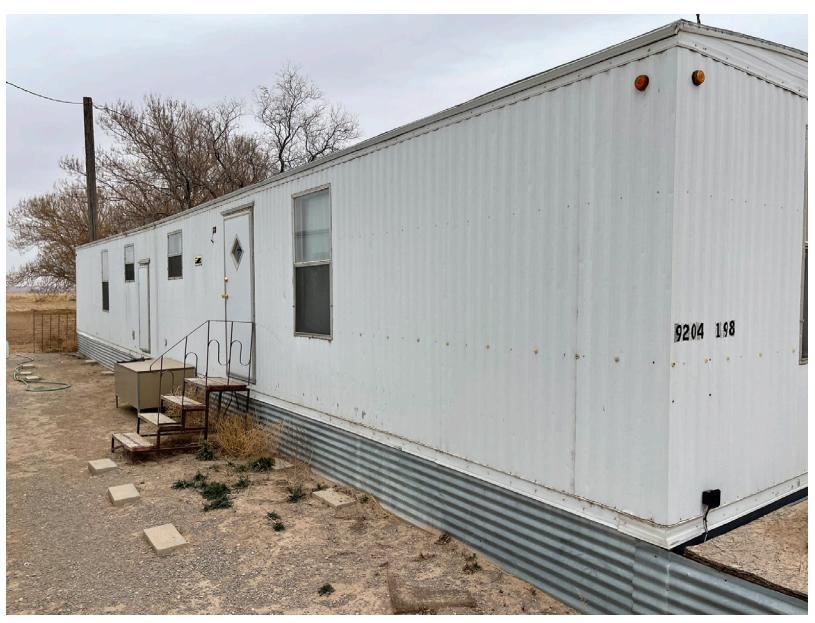
PECOS HILTON B346M

Need new skirting, new gutters and downleaders, repair damaged exterior wall panels, need ADA access ramp and deck at entry and rear door, regrade for erosion and add concrete apron all around. The restroom are not ADA accessible, need ADA hardware at entry and back doors, plywood platform rotted needs replacement and painting.

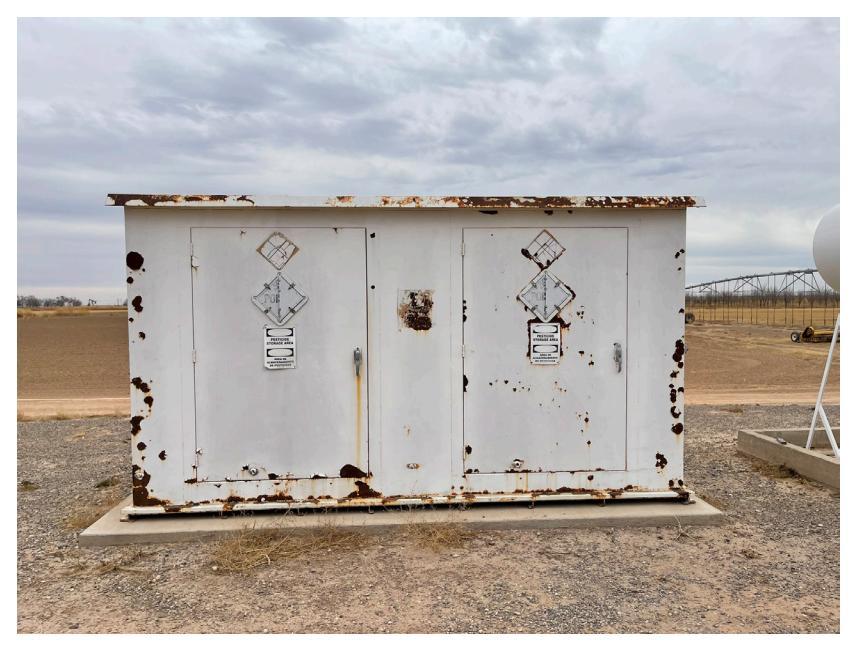
CHEMICAL STORAGE SHED 346J

Need concrete stoop and ADA ramp, need paint stripped and repainted, repair doors they are not working.

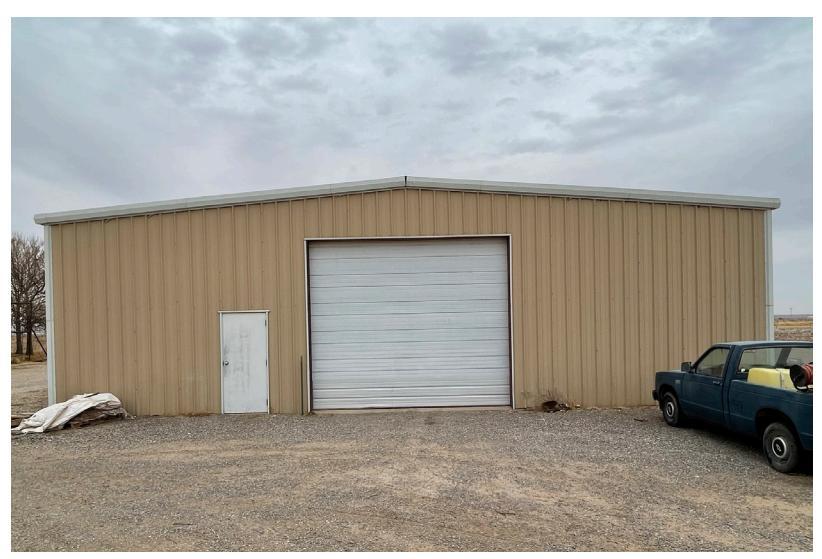
STEEL BARN 346I

Needs to replace overhead doors, replace damaged exterior wall metal panels, needs concrete stoop and sidewalk access to it for ADA at main entry door. Install ADA access hardware at main door, add concrete entry drive at both overhead doors with bollards, and repaint head and jambs at overhead doors. Add soil at eroded corners and install a concrete apron all around. The building needs gutters and downloaders, repaint entry main doors, requires roof leak repairs, and there is a need for regrading to provide positive drainage away from buildings.

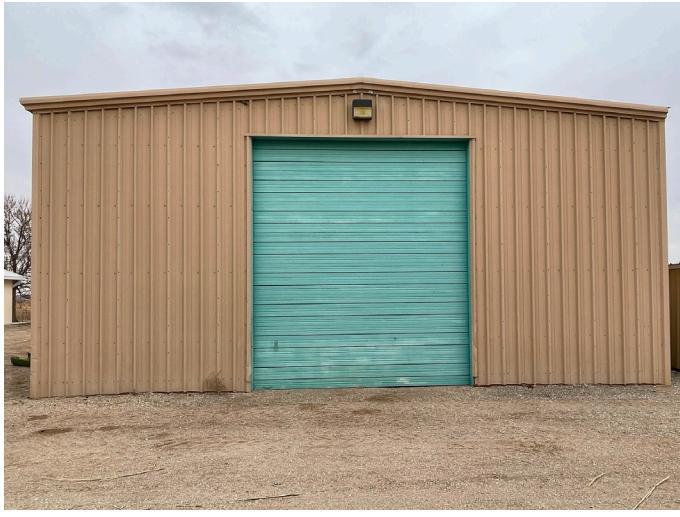
MACHINE STORAGE 346E

Needs to replace overhead doors, replace damaged exterior wall metal panels, needs concrete stoop and sidewalk access to it for ADA at main entry door. Install ADA access hardware at main door, add concrete entry drive at both overhead doors with bollards, and repaint head and jambs at overhead doors. Add soil at eroded corners and install a concrete apron all around. The building needs gutters and downloaders, repaint entry main doors, requires roof leak repairs, and there is a need for regrading to provide positive drainage away from buildings.

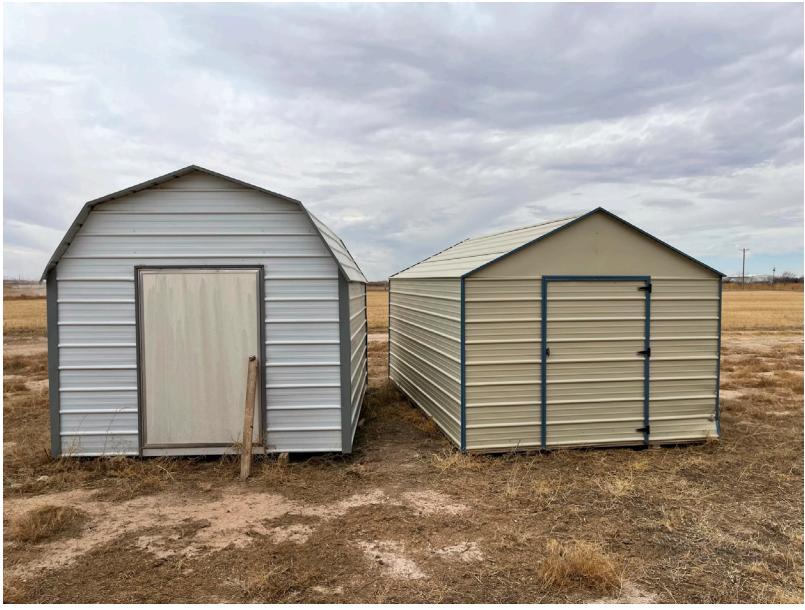
STORAGE SHEDS 346G

(Not classified as building by HEB as they do not have 2 utilities)

Need repairs at corners, add concrete landing with ramp at doors, can use new gutters and downleaders, and regrade away from foundation for positive flow and minimize future damage.

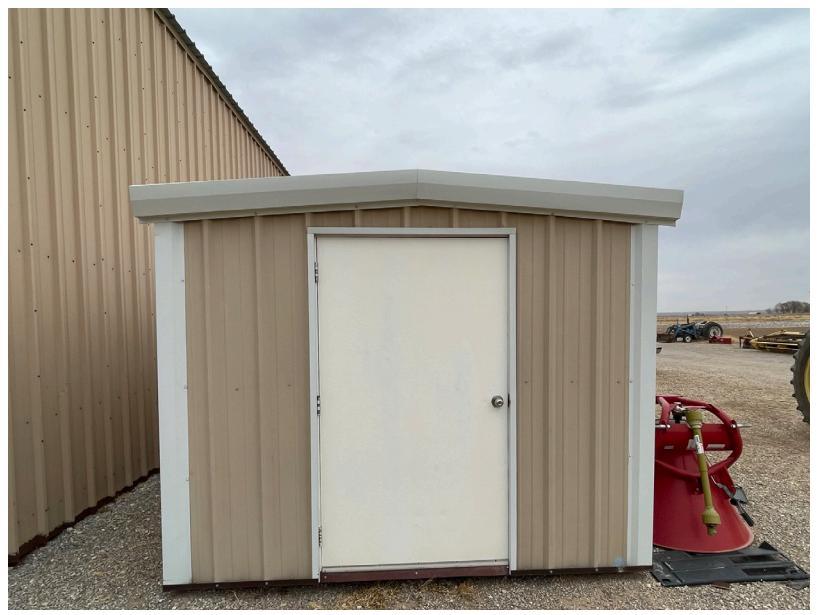
SHED 346H

Needs ADA accessible landing with ADA ramp and concrete, regrade all around to stop erosion and add concrete apron all around, entry door needs ADA hardware, and need gutters and downleaders.

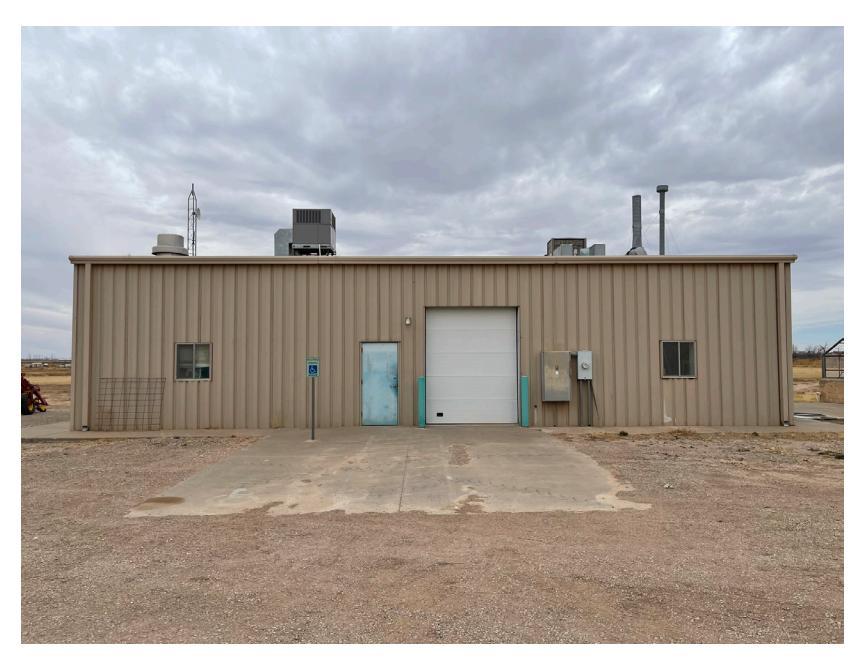
LAB 346L

Needs all exterior doors repainted and weather-stripped, repaint overhead door jambs, reseal all windows trims and needs new glazing gaskets, replace all interior lighting with LED, repair roof leaks, and restripe ADA striping at adjacent parking space.

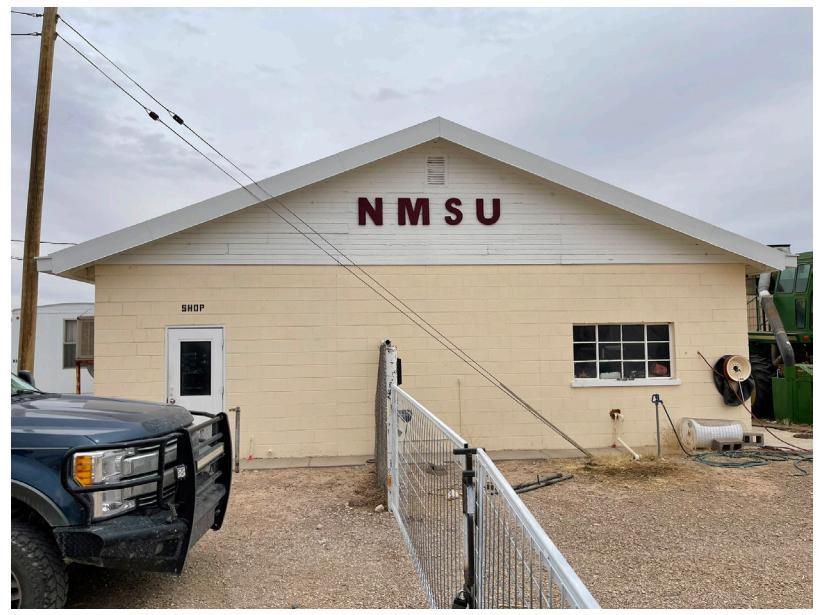
SHOP 346D

Repair rotted wood fascia and gable ends and repaint, repair rotted wood at overhead door jambs and repaint.

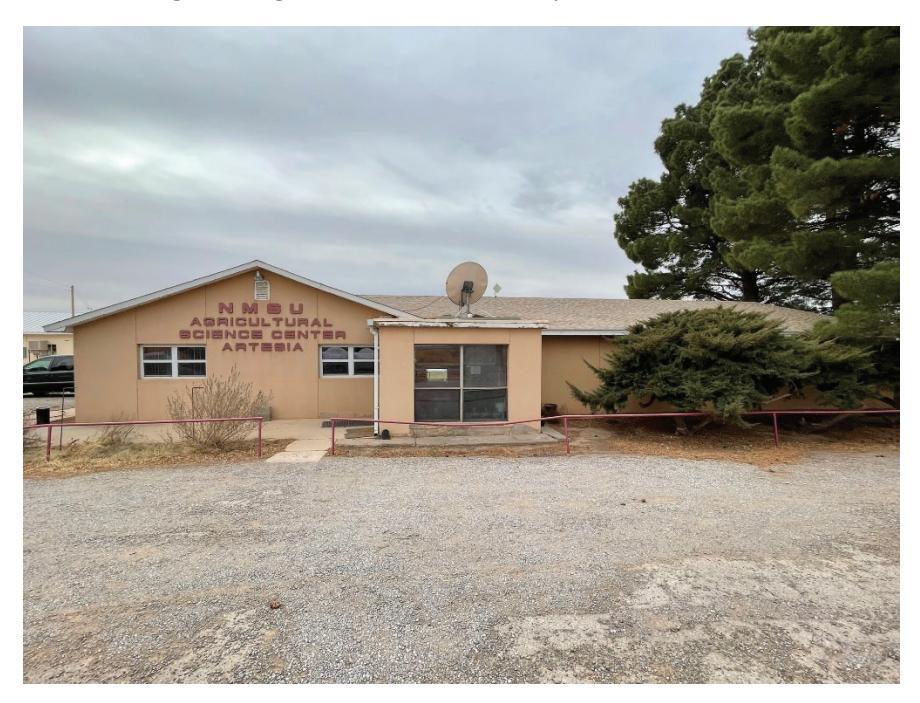
Main office building has differential settlement and is in a low spot on the site allowing for water collection along its foundation. Building and site work regrading are beyond feasible repair

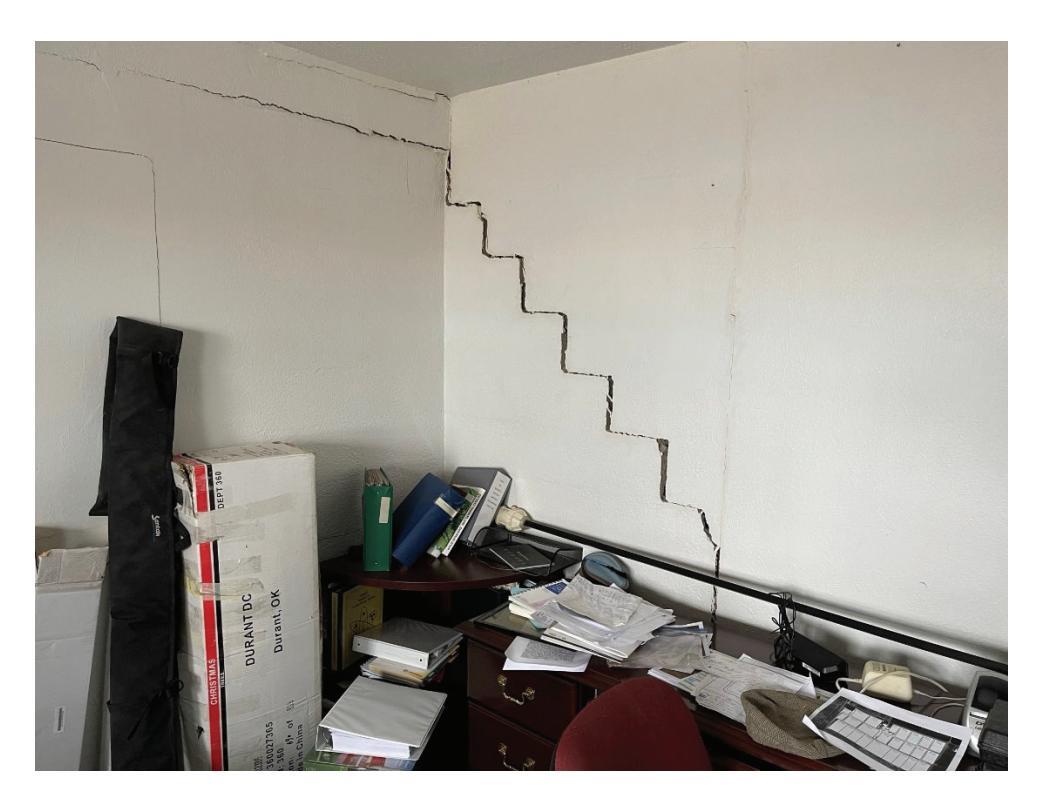
View of settlement at interior office.

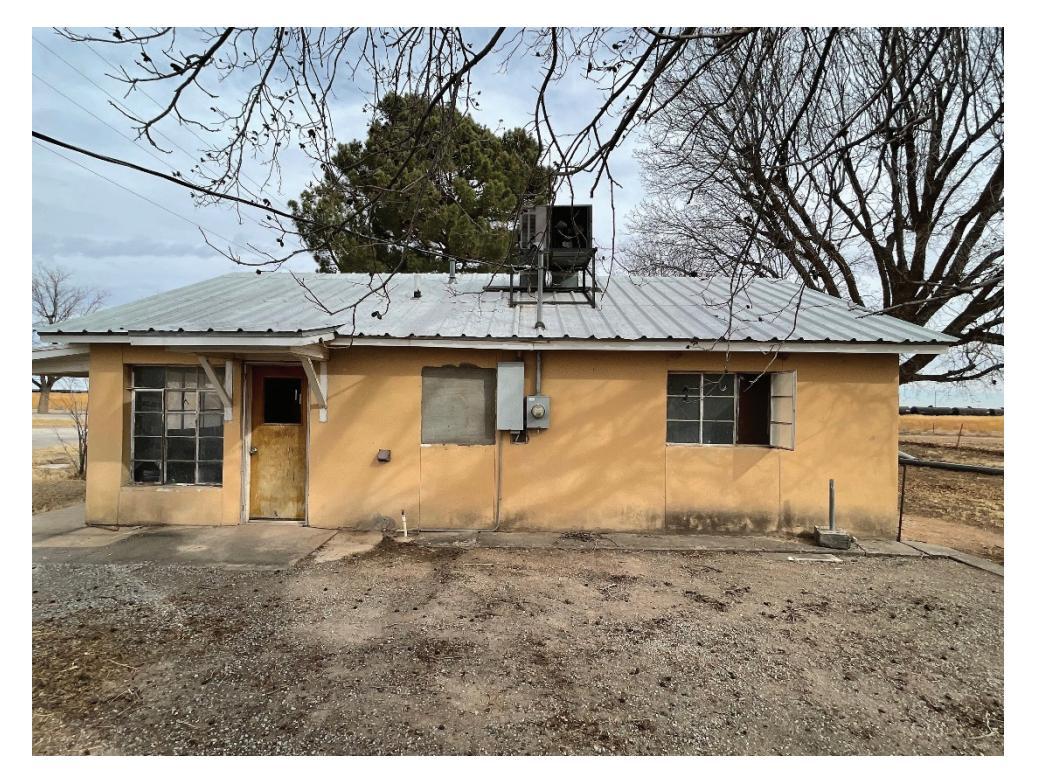
View of old house that is condemned.

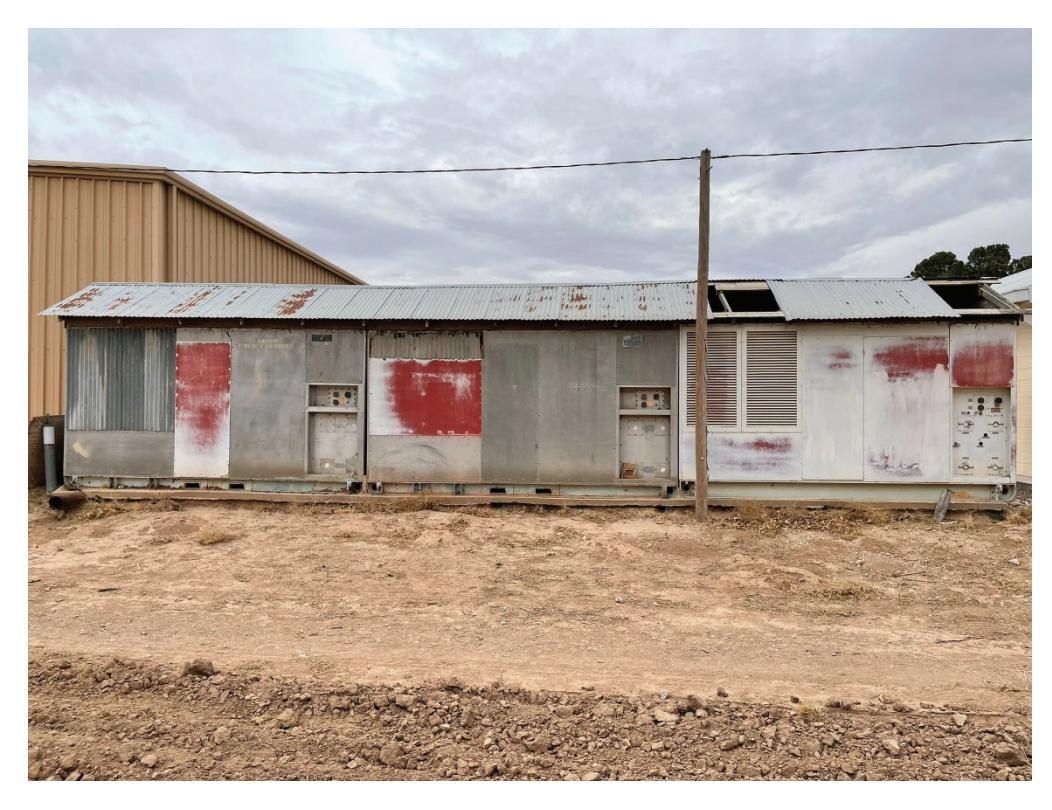
NASA Storage building needs foundation stabilization due to erosion along with roof superstructure repairs and new roof. Building beyond feasible repair.

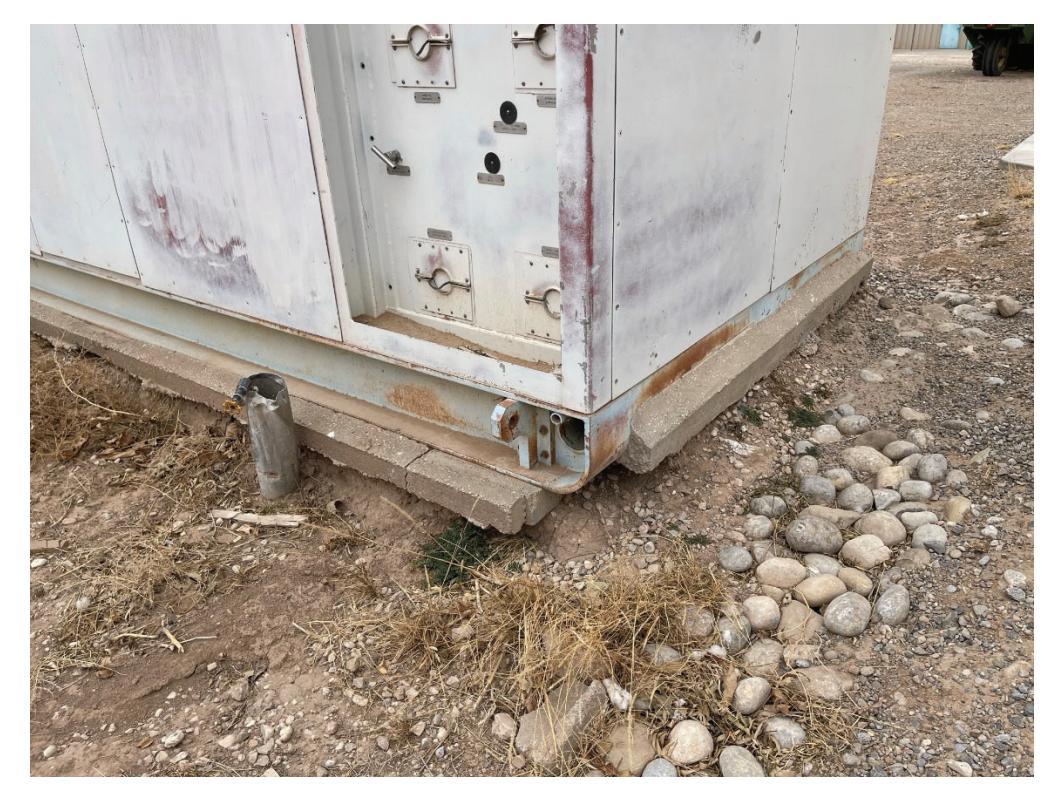
View of typical erosion along foundation slab

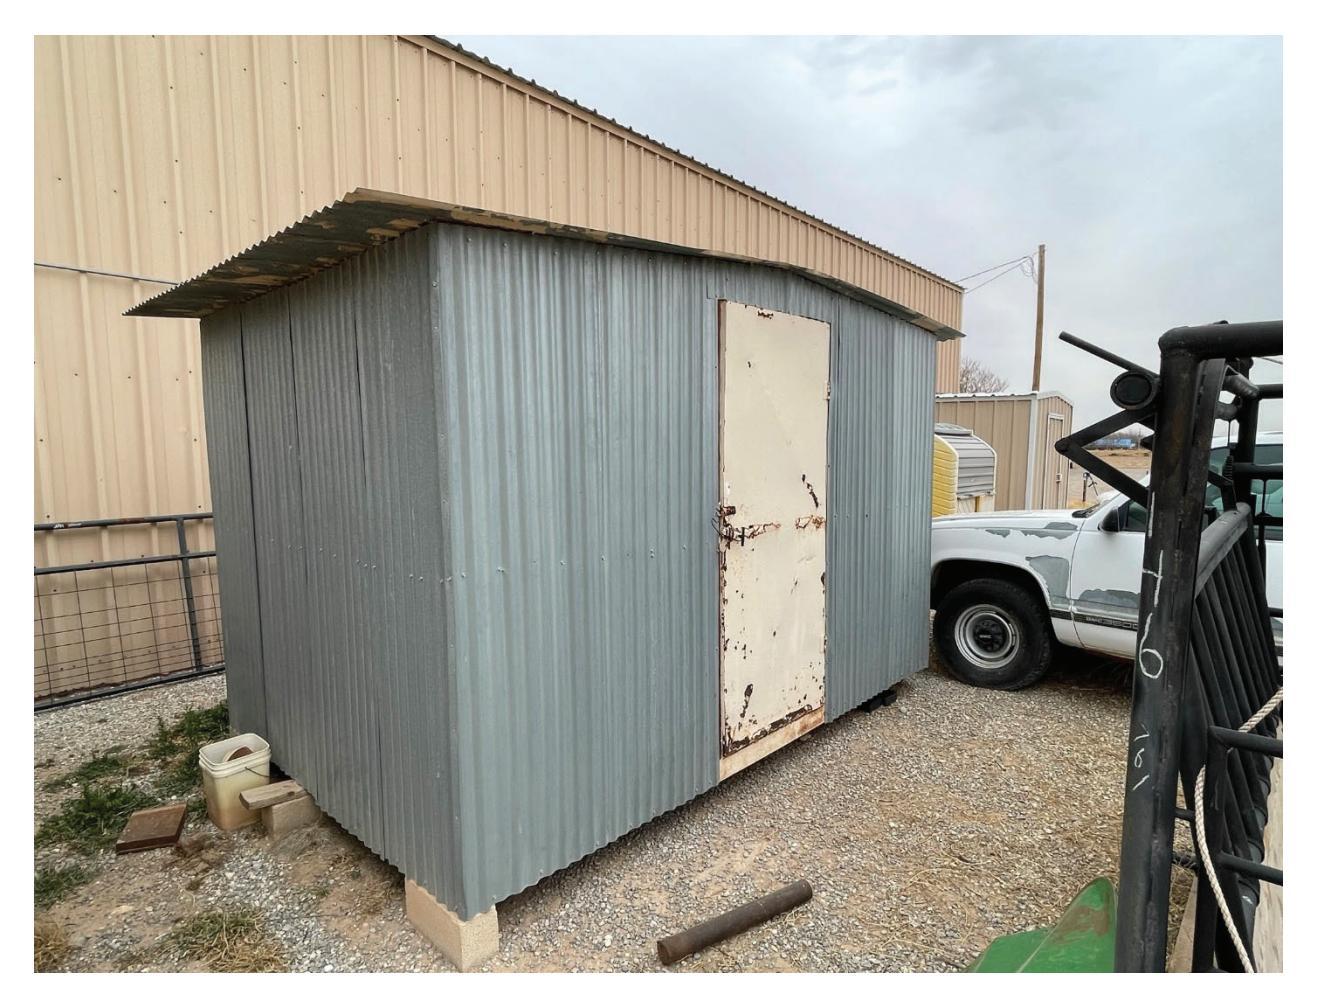
Storage Shed: Needs: Entry stoop, new entry door and hardware, rain gutters and down leaders.

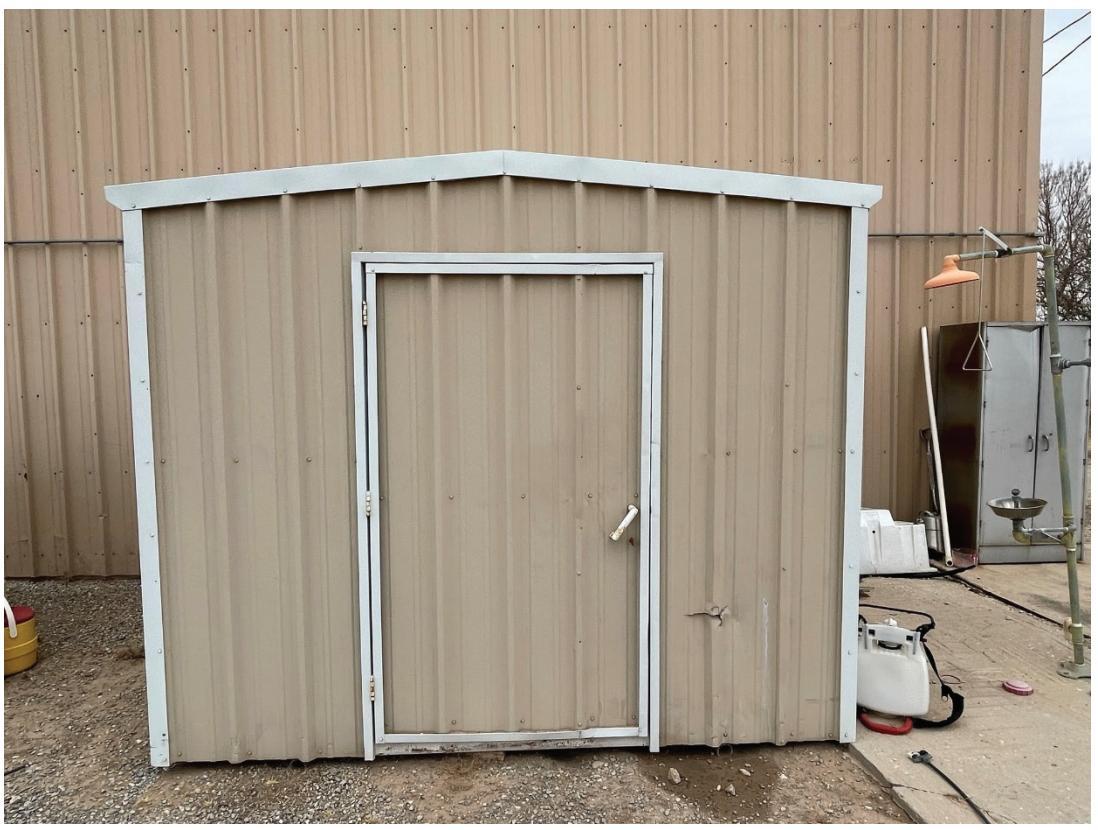
Storage Shed by wash area:

Needs: Entry stoop, repair damaged wall panels, rain gutters and down leaders, replace eye wash station, .

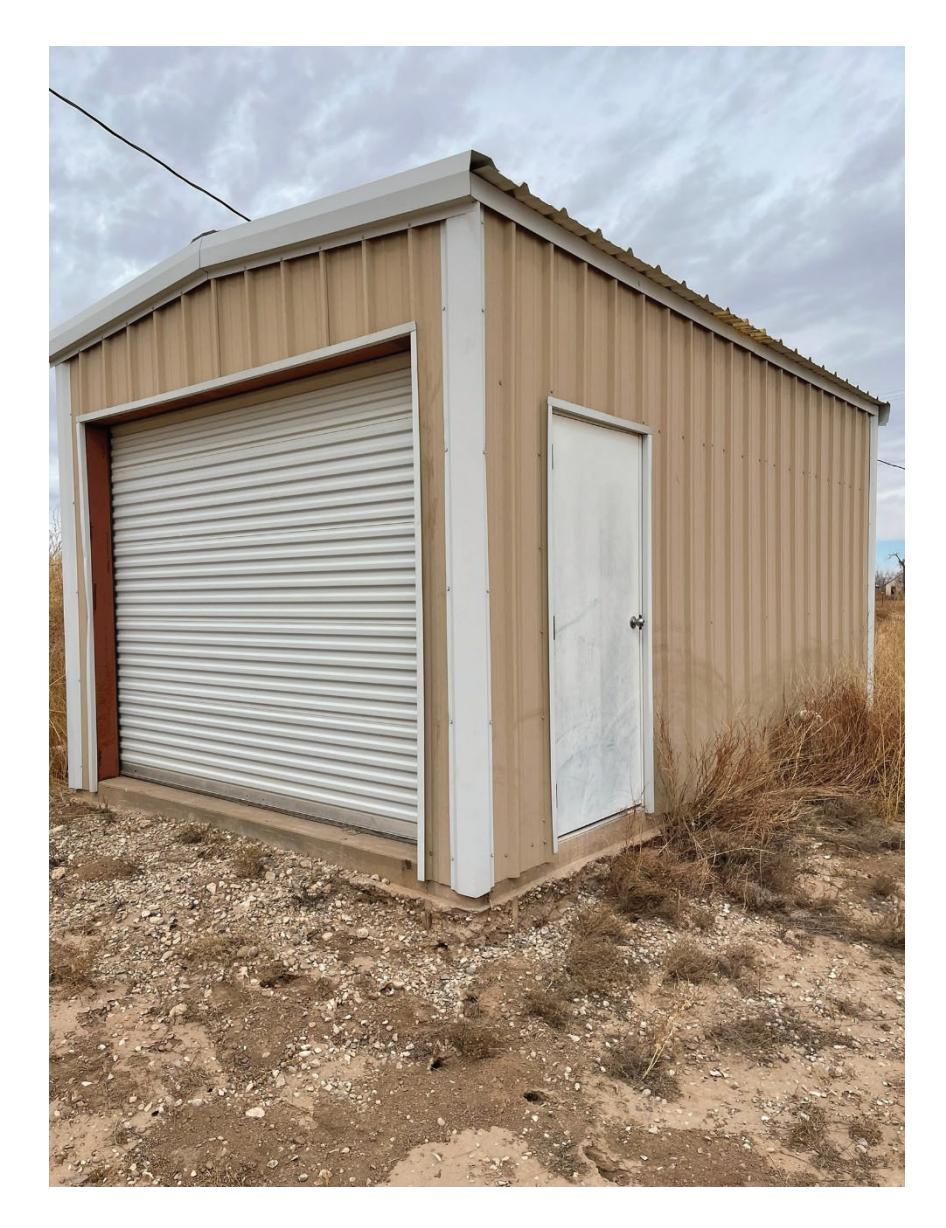
Pump Storage Shed:

Needs: Entry stoop, concrete apron all around, rain gutters and down leaders, regrade all around.
