FACILITIES MASTER PLAN REPORT

Executive Summary | July 2023

NMSU CORONA RANGE AND LIVESTOCK RESEARCH CENTER County Road CO2O - #4 University Rd, Corona, N.M. 88318

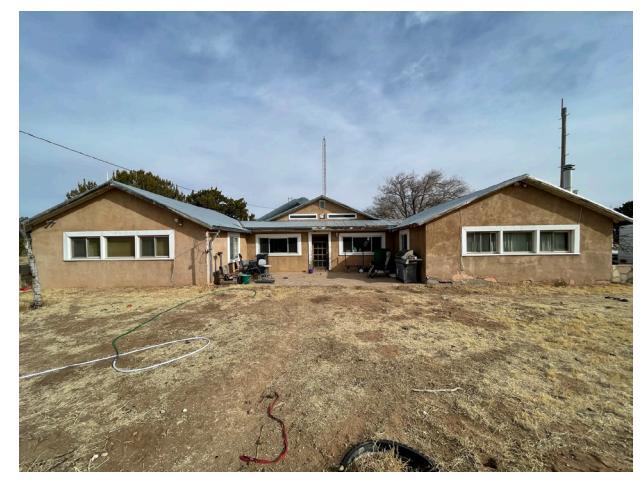
HEADQUARTERS RESIDENCE 418H

Replace corrugated metal roof panels, repair wood fascia and outriggers and soffit and paint, need gutter and downleaders, concrete apron on all sides, regrade to provide positive flow away from building, repair stucco cracks and repaint, replace rotted wood and repaint all exposed wood trims, repaint all exterior wood doors and replace rotted wood trim at doors, need ADA ramps to entry door and patio door, install missing fascia boars, repair concrete steps leading to basement, repaint basement doors, repaint steel storm door assembly, repair interior plaster spalling and repaint, replace entry gates, remove landscaping next to house

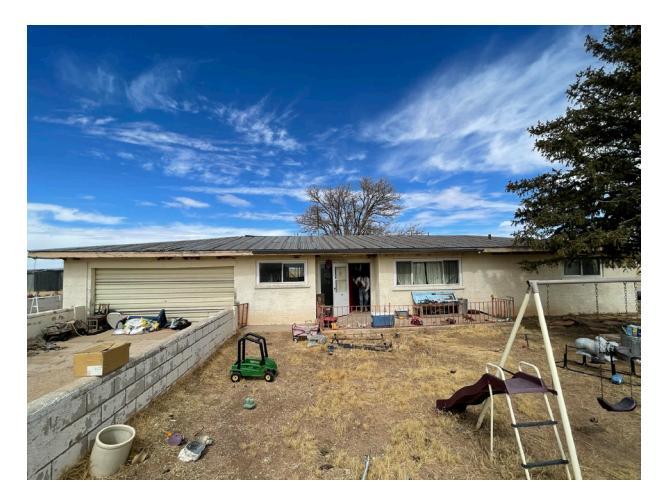
NORTH CAMP RESIDENCE 418I

Site walls are unstable and need to be demo and replace, a new sewer line for whole house is needed including a new septic tank. The building needs a new roof, gutters and downleaders. A new soffit, and fascia board are also required. The site needs to be regraded away from house for positive drainage and a need concrete apron along all sides of house will help management of erosion and drainage. Remove landscaping away from house, and a new garage door assembly, will improve the building. The exterior walls need EIFS system repairs, replace rotted wood around garage doors and repaint. Need ADA ramps at the front and rear doors, new refrigerated AC and ductwork is required, new entry gate, new kitchen cabinets and appliances, new windows and screens, new light fixtures at all house, new restroom fixtures at main restroom room, including new flooring.

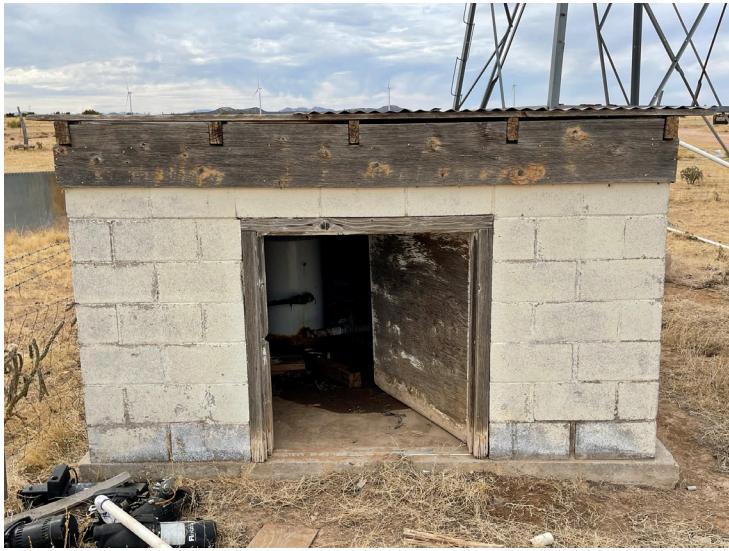
NORTH CAMP PUMP HOUSE 418F

This building is a candidate for demolition and replacement due to been unfit for human use due to low roof structure.

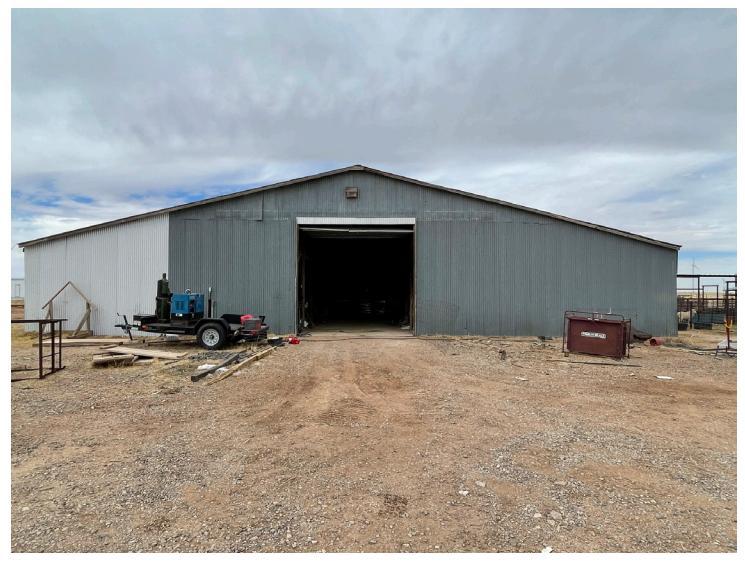
NORTH CAMP BARN 418P

This building is a candidate for demolition and replacement due to structural modifications.

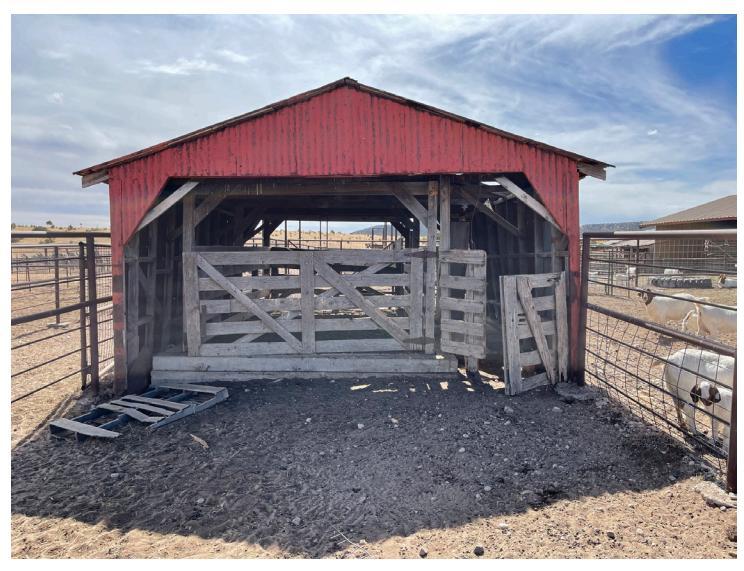
SCALE BARN 418N

This building is a candidate for demolition and replacement due to extensive rot on the wood structure.

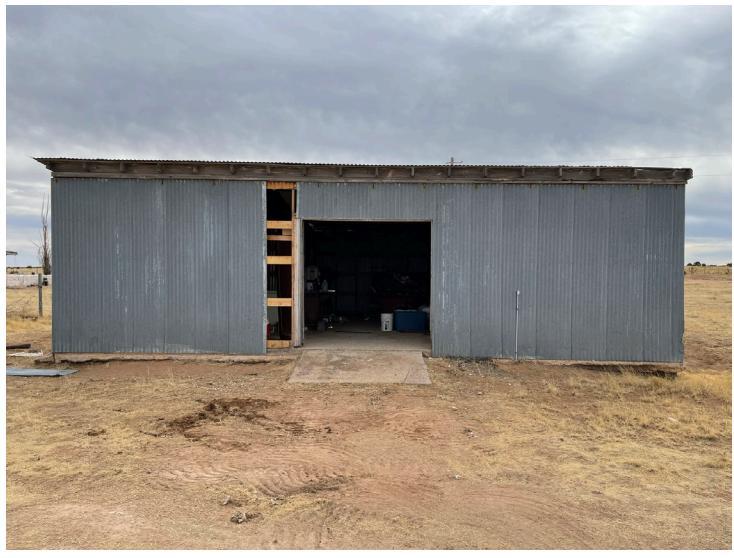
NORTH CAMP STORAGE 418D

This building is a candidate for demolition and replacement due to foundation erosion and rotted wood structure.

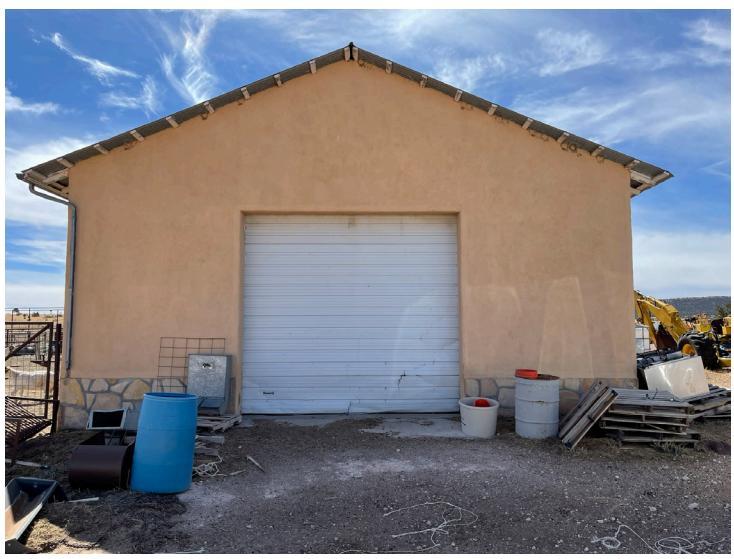
HAY BARN 418E

The building needs roof repairs, gutters and downleaders, a concrete apron along all sides needs to be added and site grading away from the structure, and replace missing roof panels along South side rake. Need to replace doors along East elevation, repair and repaint roof outriggers at soffit, install missing wood fascia board, and new overhead door assembly on both sides.

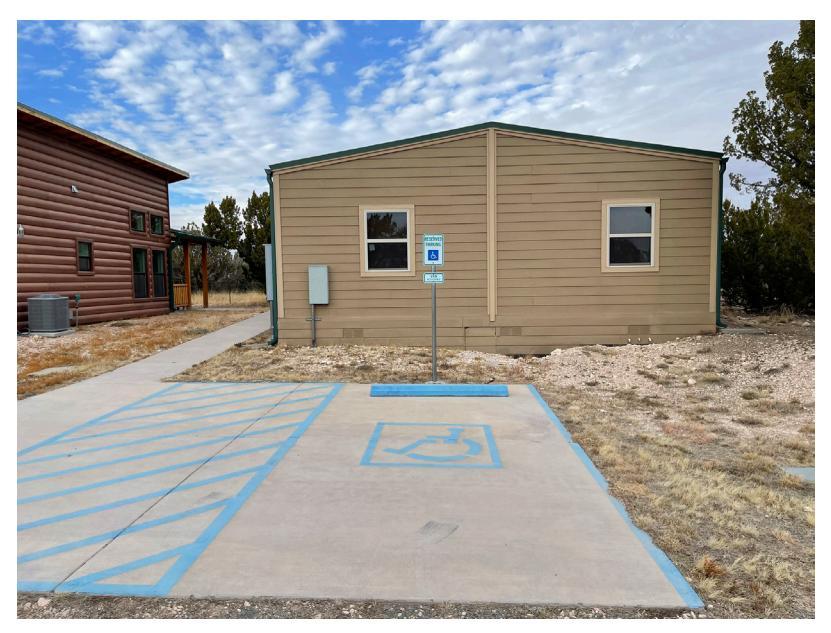
CABIN 650

Reseal wood slat soffit at entry and porch deck, repaint deck railings, replace rotted and warped wood planks at deck facia and corner, repaint exterior doors, concrete apron around all sides, regrade for positive flow away from building, and reseal exterior wall cladding lap joints and repaint exterior.

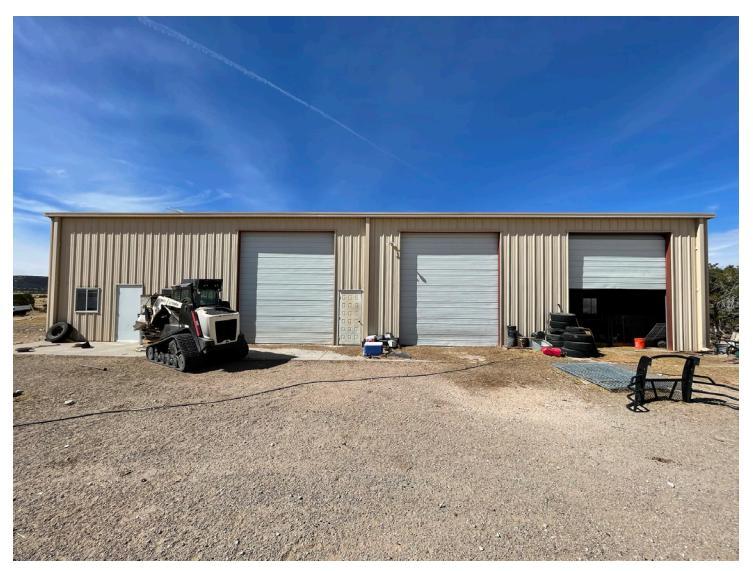
OFFICE 418J

Repaint all exterior main doors, Overhead door jambs, need gutter and downleaders at back, regrade the rear to cover eroded foundation, concrete apron on three sides, new overhead door weatherstripping and sweeps, remove trees and landscaping from next to building, ADA hardware at main doors, replace residential door from North side with hollow metal door, need concrete landing at North and South doors with ADA locksets, landing and accessible route.

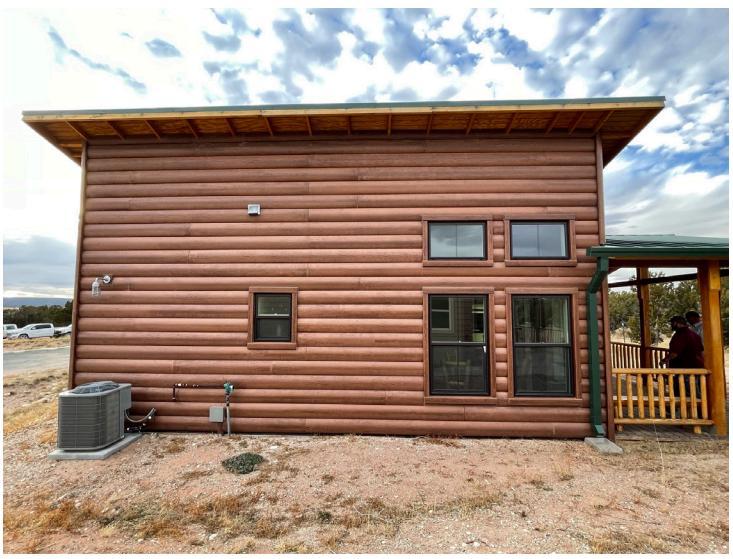
RANCH DORM 670

The building fascia board needs to be resealed, the site needs to be regraded around to provide positive drainage, reseal wood balustrade and columns, concrete apron around all sides, remove all landscape close to building to improve drainage.

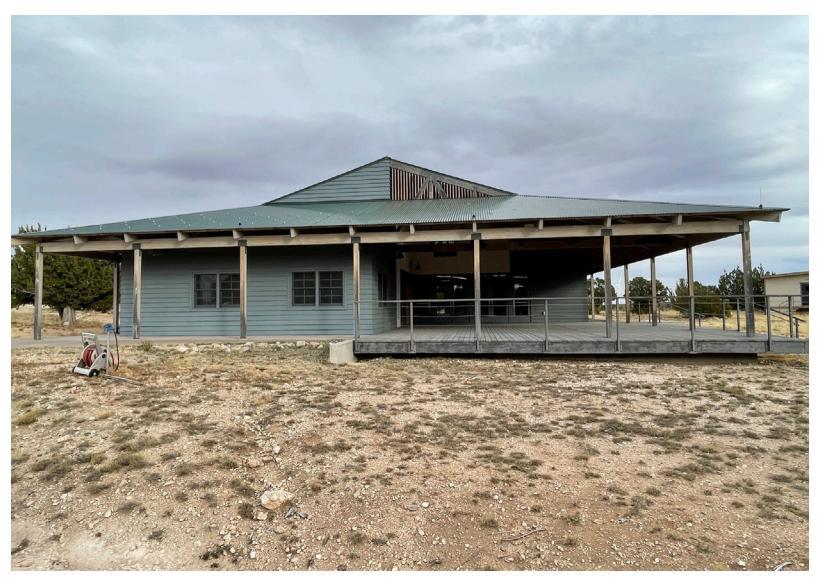
CENTRAL RANGELAND SUSTAINABILITY 634

The building requires to reseal all wood columns and beams at entry veranda, the stucco system needs repairs, reseal wood sliding shutter on the building, and the exterior wall by kitchen needs to be repainted. Additionally, one needs to repair the roof leak at kitchen exhaust fan, and install gutters and downleaders. The existing parking lot needs re-striping.

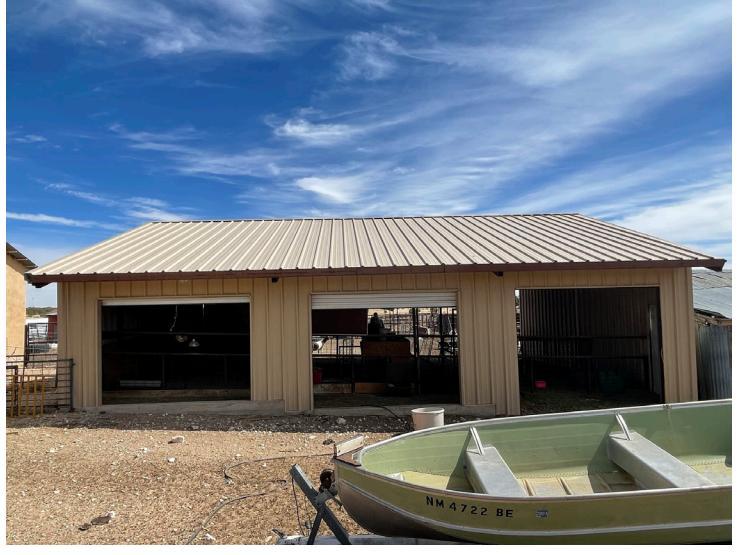
LIVESTOCK BARN 418Q

The building needs gutter and downleaders, an concrete aprons along front and regrade the front of the building for positive flow away from the building, add a concrete landing at main door and add ADA compliance lockset, landing, and accessible route.

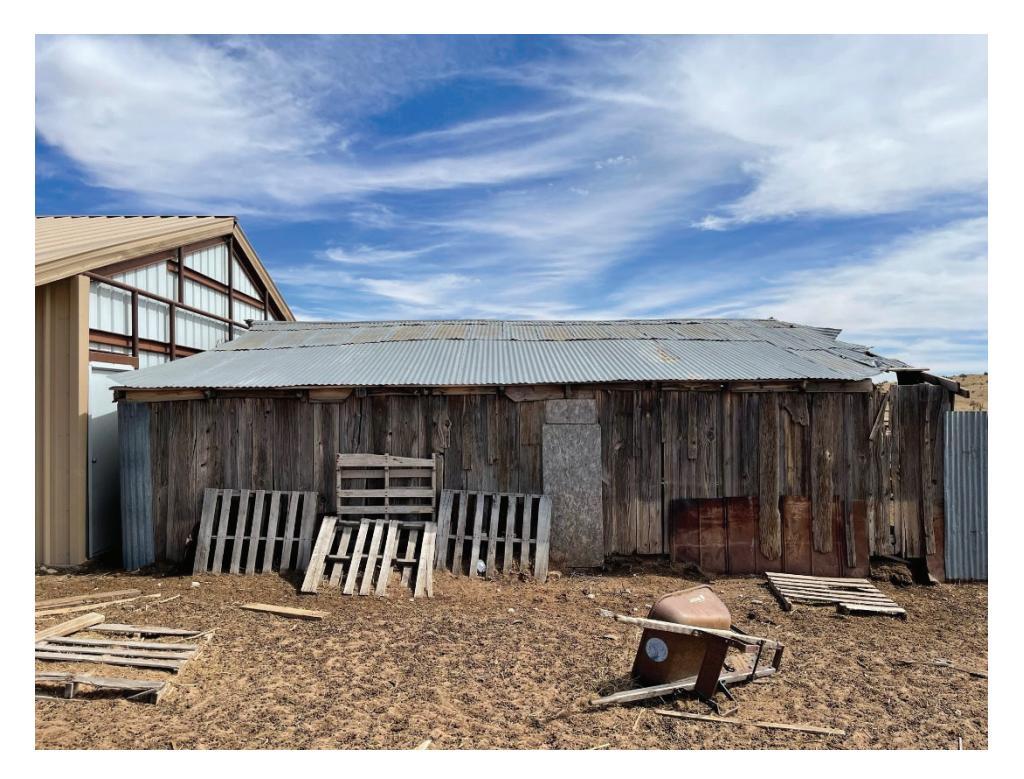
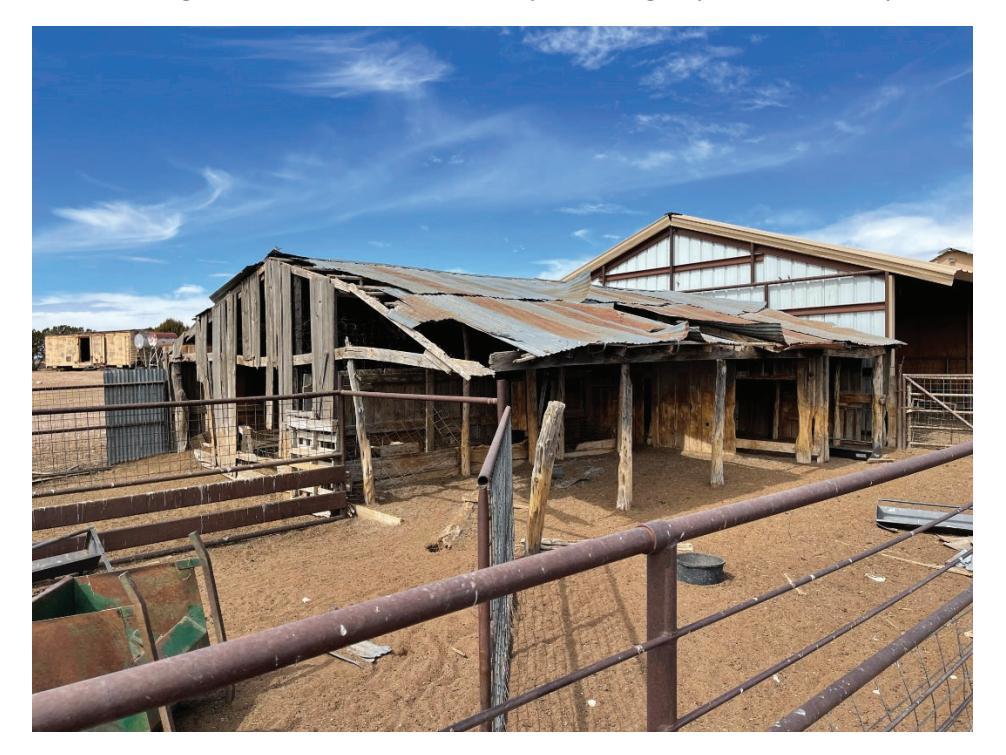
The goat barn is rotted extensively. Building beyond feasible repair.

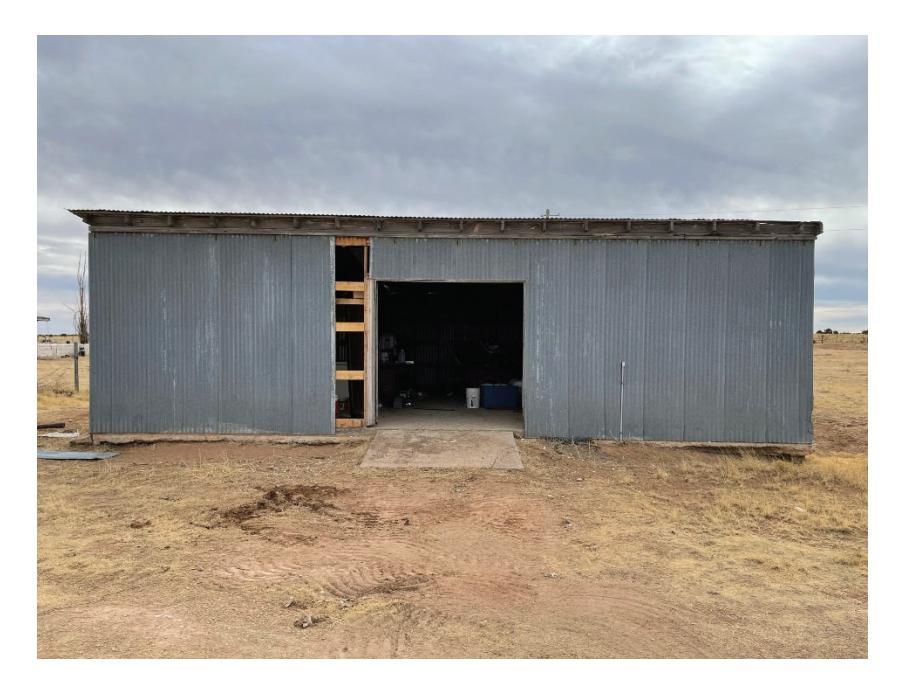
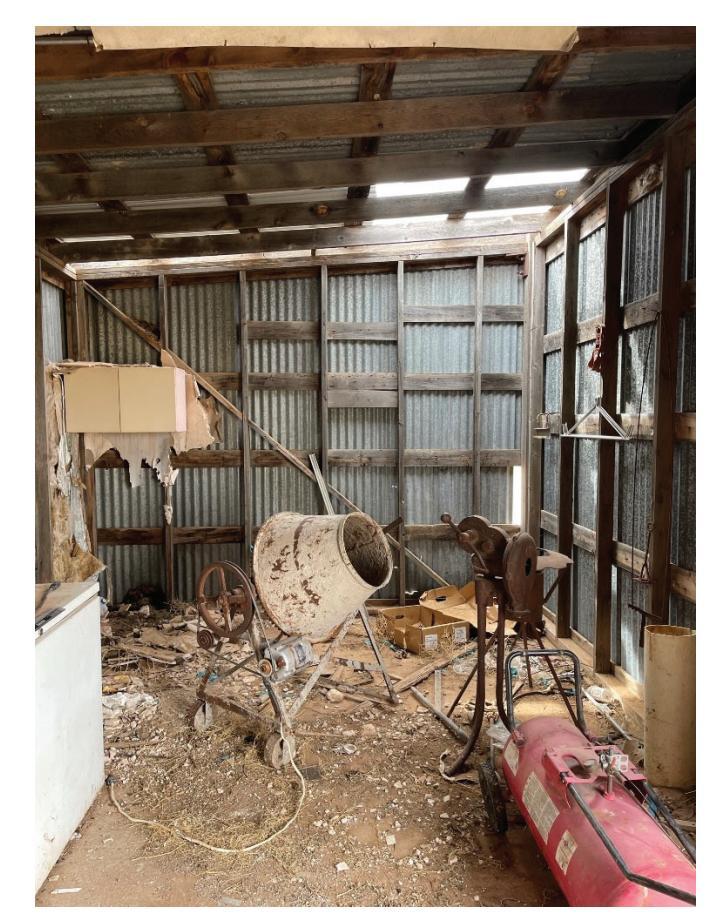
The tool shed is rotted extensively, has erosion undermining foundation. Building beyond feasible repair.

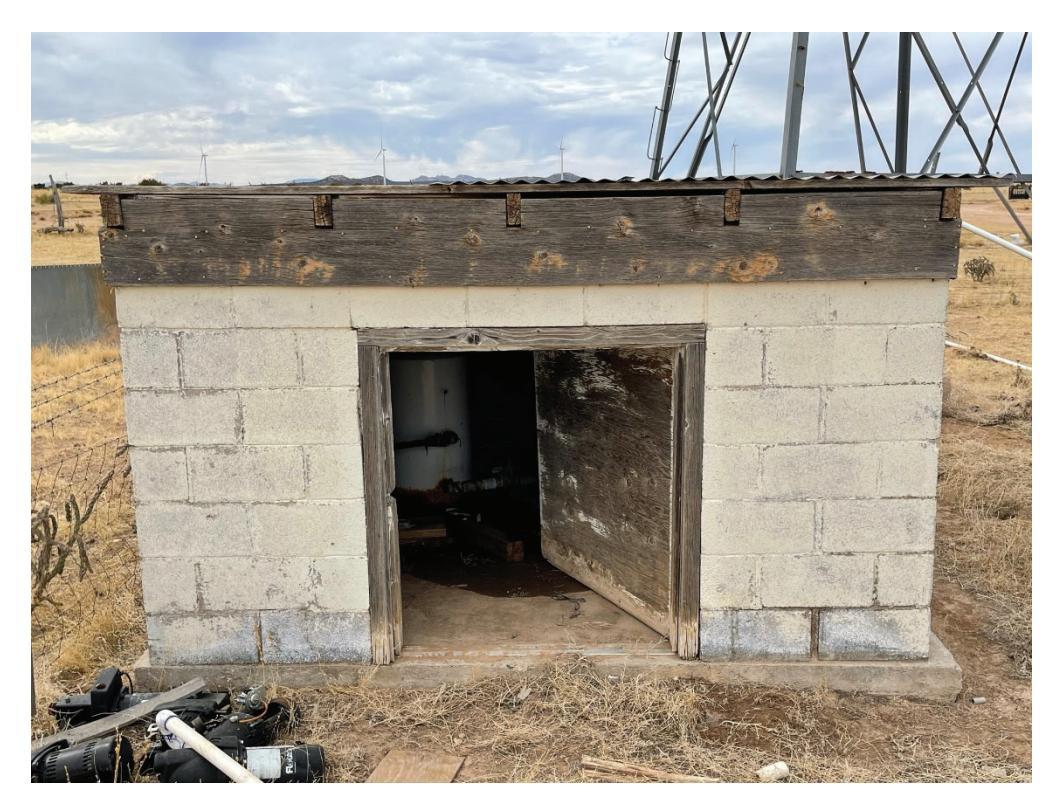
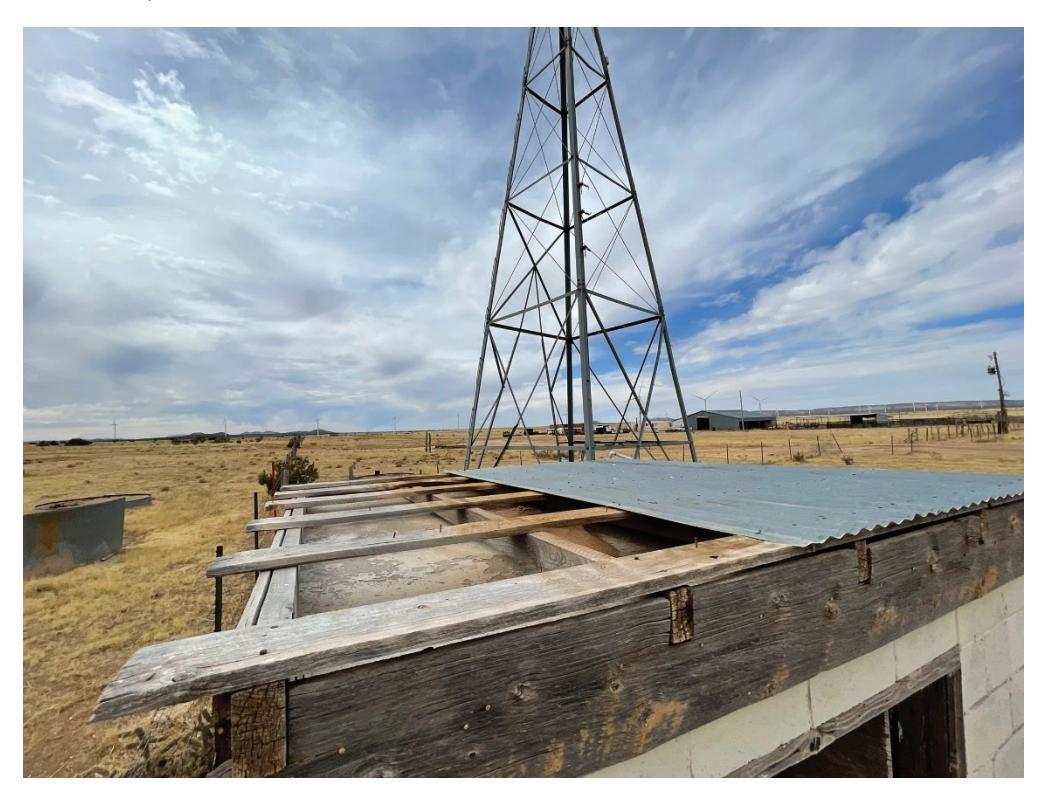
The pump house is inaccessible and has rotted roof structure. Building beyond feasible repair or expansion.

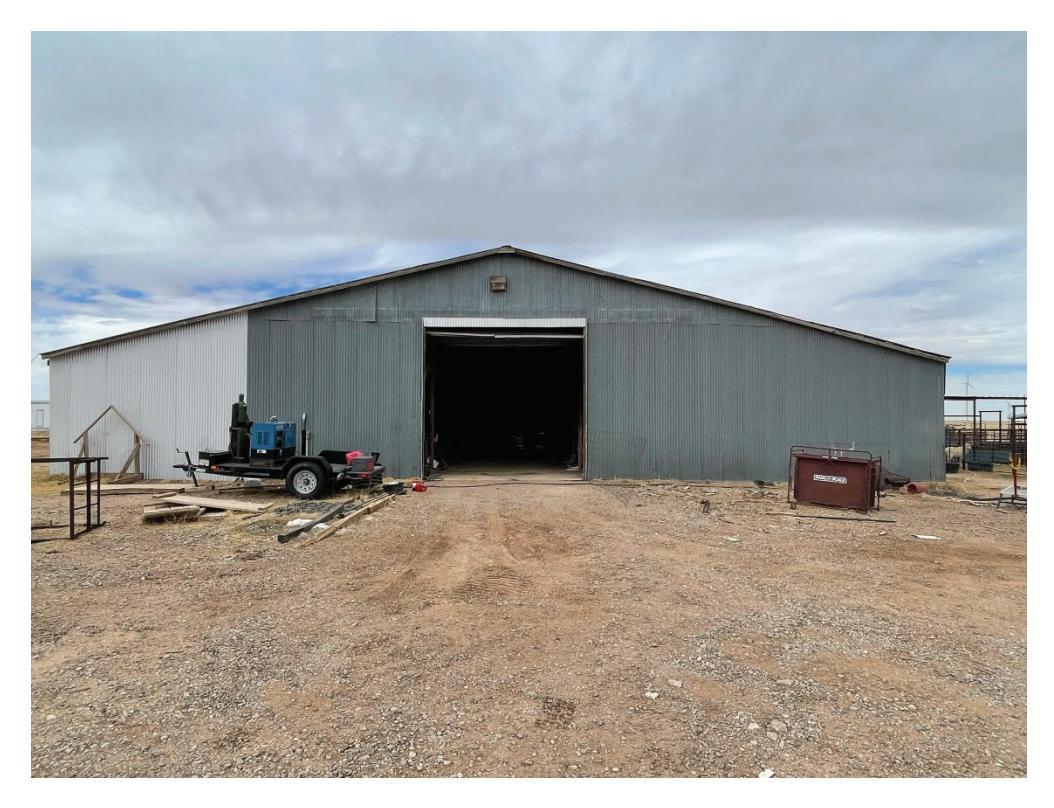
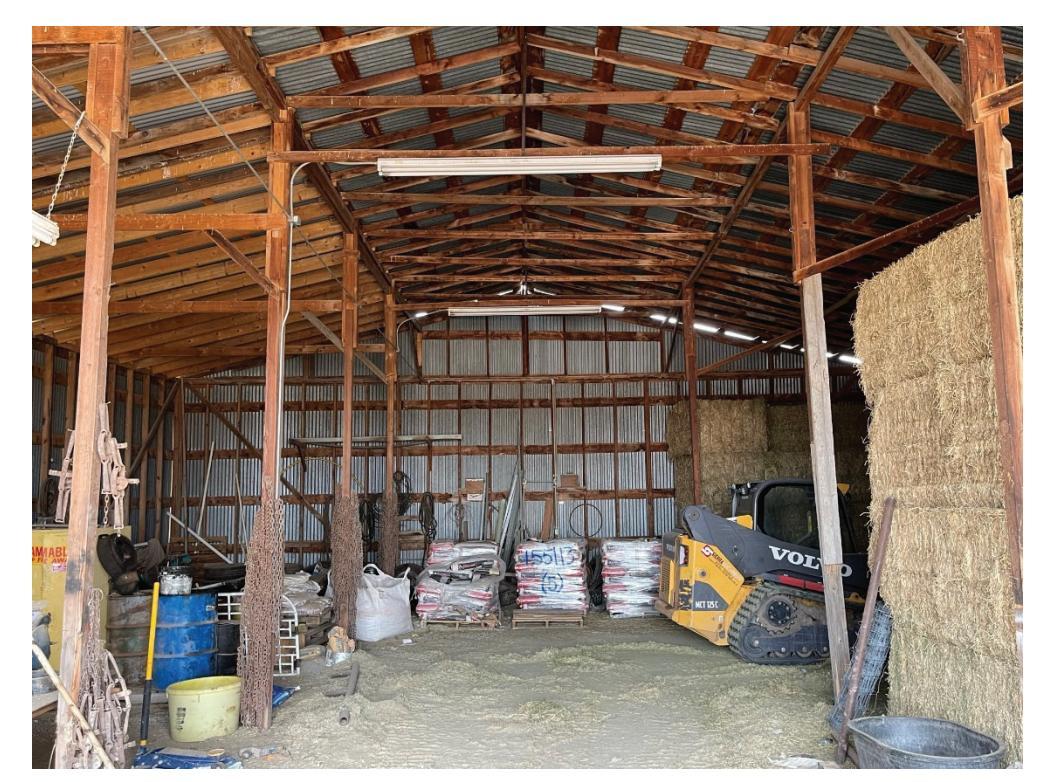
The shop building is inappropriate for current storage function. Structure has been modified and suffered metal roof blowoffs. Building is beyond feasible repair.

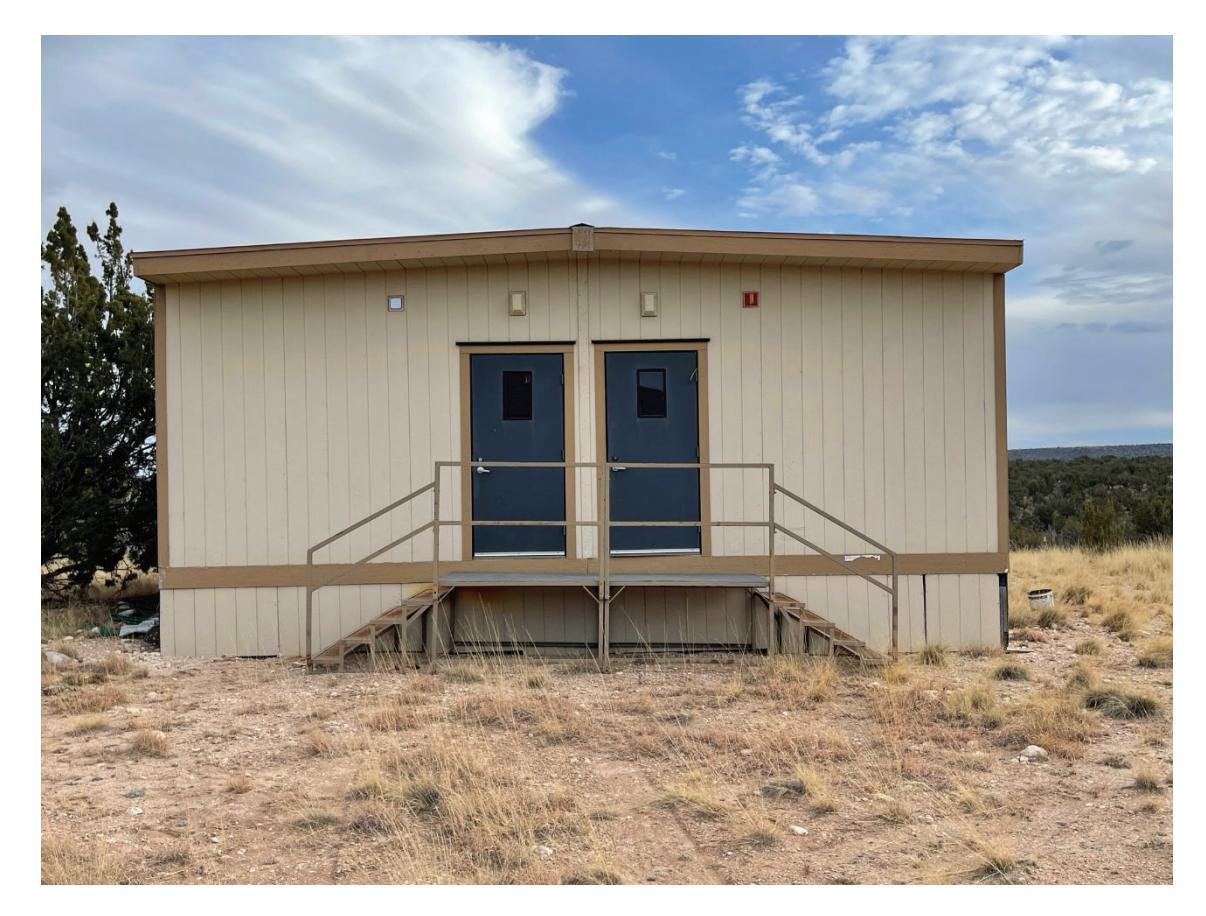
Central camp storage building:

Needs: Skirting repairs, exterior wall siding repairs/repaint, reseal accent bands, repaint side door, new metal R panel roof, replace with ADA door hardware locks, rain gutters and down leaders.

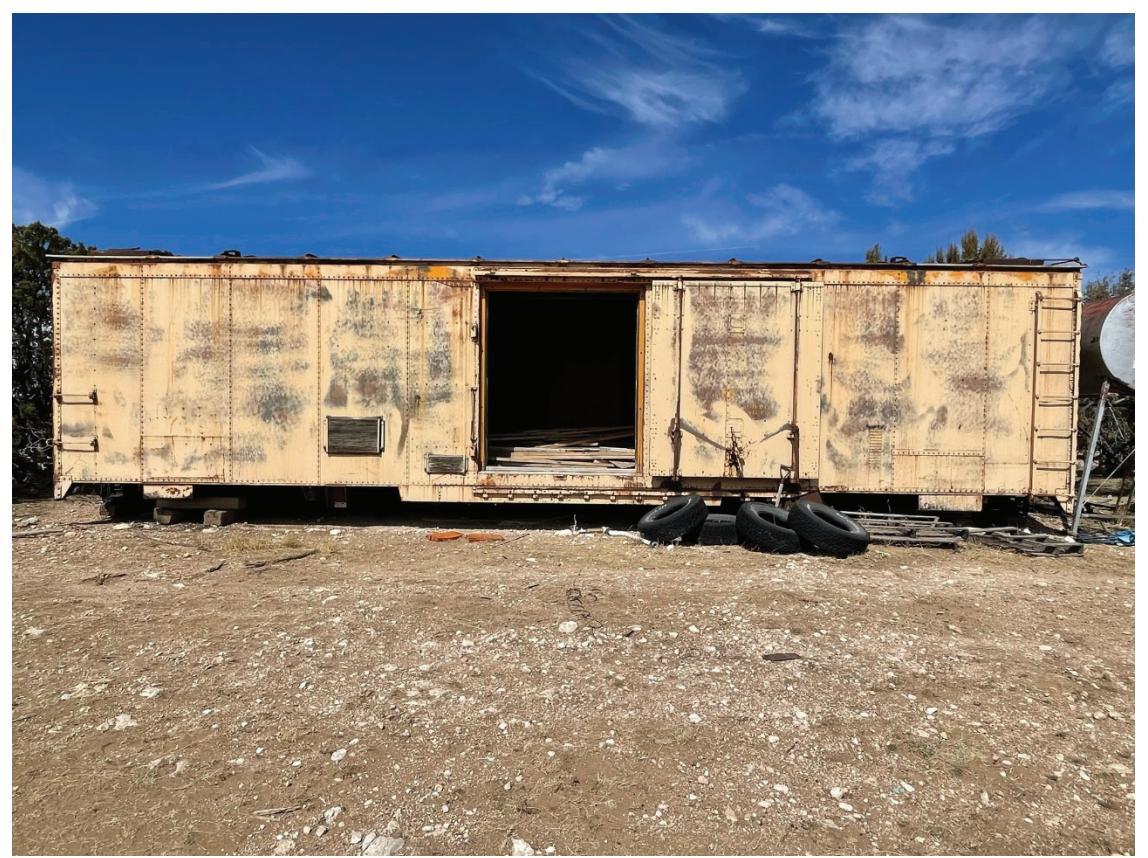
South camp Boxcar Storage: Needs: Repainting, access stairs/ramp at entry.

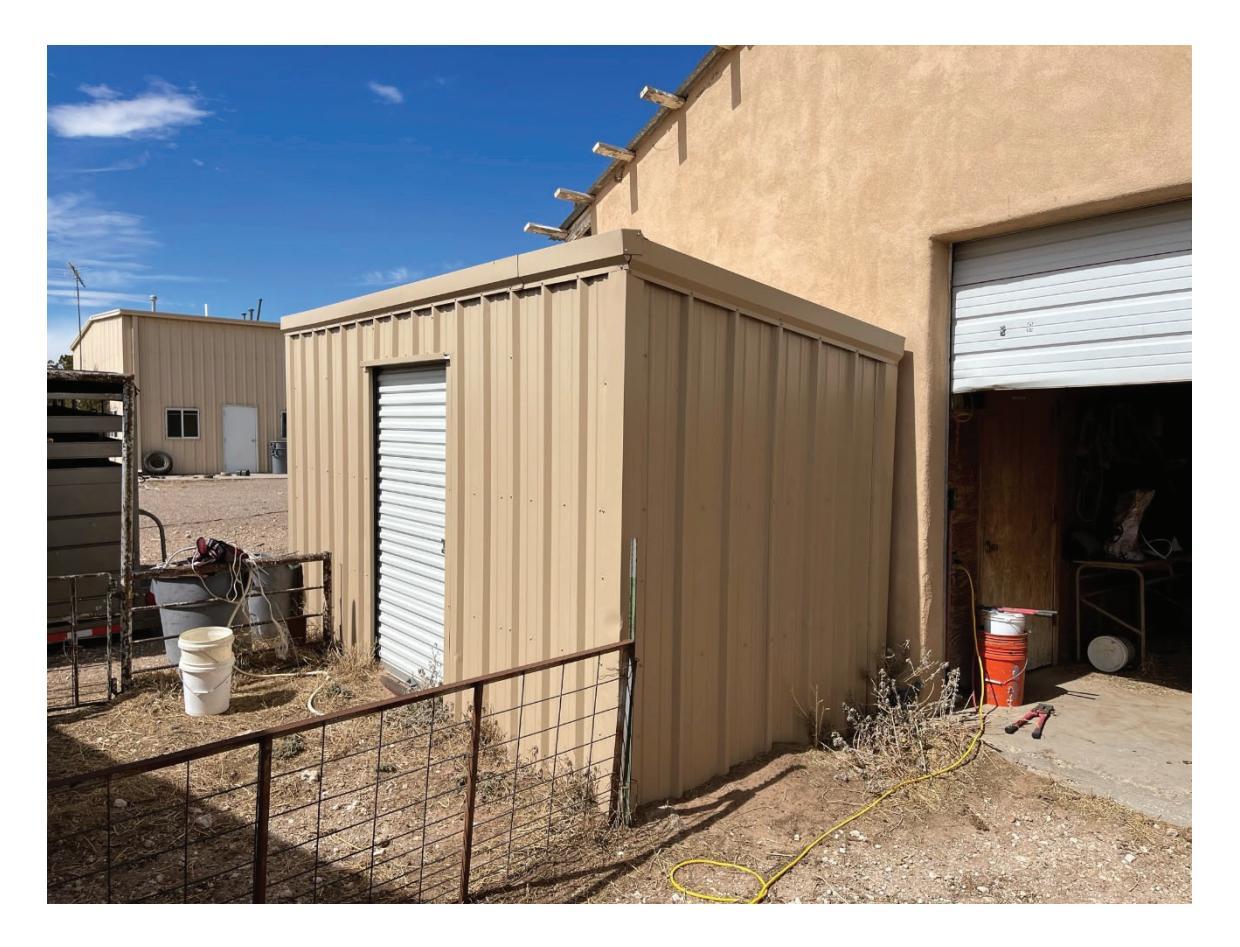
Metal Storage Shed: Needs: concrete entry stoop, rain gutter and down leader.

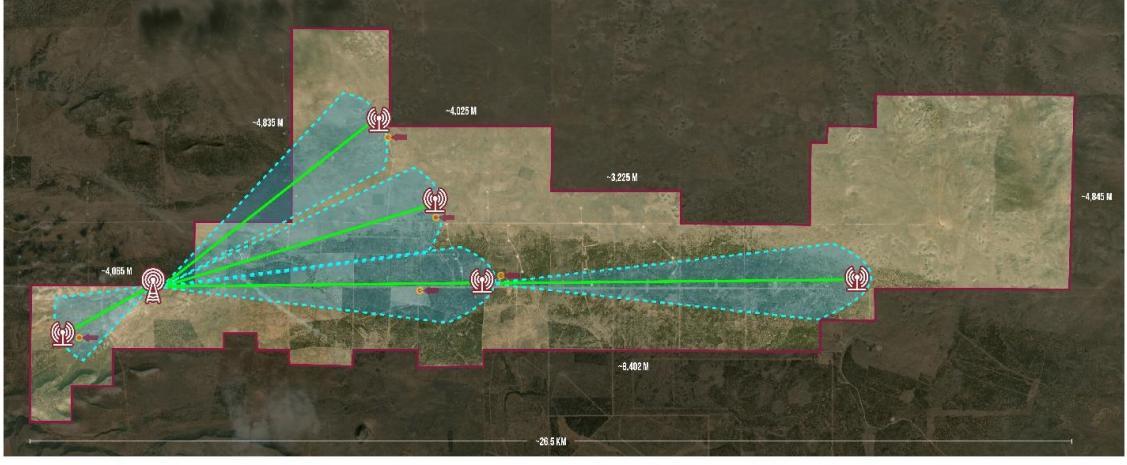
UBIQUITI ROCKET 5AC PTMP (2) Installation Height: 8 m (26 FT) OUTPUT POWER: 28 DBM CHANNEL WIDTH: 40 MHz ANTENNA GAIN: 22 DBI

UBIQUITI ISOSTATION 5AC Installation Height: 3 m (10 ft)

UBIQUITI MESH PRD INSTALLATION HEIGHT: 2 M (6 FT) Maximum Power: 20 dbm Power Supply: 24 V, 0.5A ANTENNAS: 2.4 GHz, 5 GHz
