Fabian Garcia & Leyendecker Plant
Science Research Center

BOOK 9 OF 12

FACILITIES MASTER PLAN REPORT

Executive Summary | July 2023

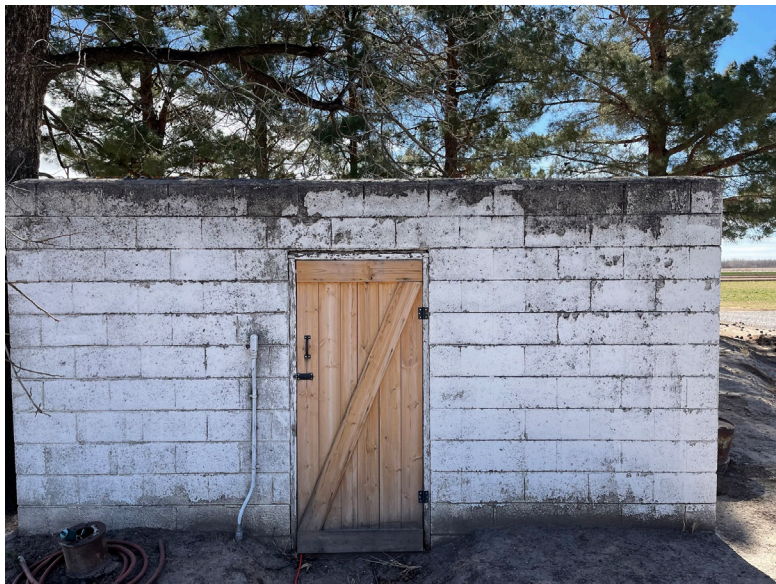
PUMPHOUSE 676.

Overhead doors needs to be replaced. The damaged exterior wall metal panels need replacement and the head and jambs at overhead doors need to be painted. Add a concrete approach aprons at both overhead doors and add soil at eroded corners of the buildings. The building needs a concrete apron all around for drainage control, and regrade to provide positive drainage away from buildings. Gutters and downleaders need to be added, repaint entry main doors, and fix roof leak.

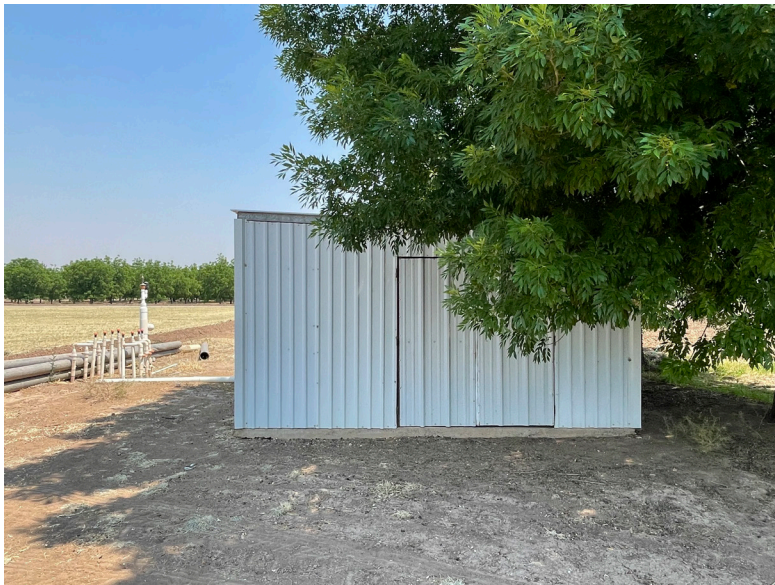
PUMP HOUSE 309

The structure needs a new roof, all exterior wall faces needs to be repainted, an appropriate integrated heating unit need to be installed. The structure needs to be re insulated, rain gutters and down leaders added, and a concrete entry stoops and regrading for positive drainage.

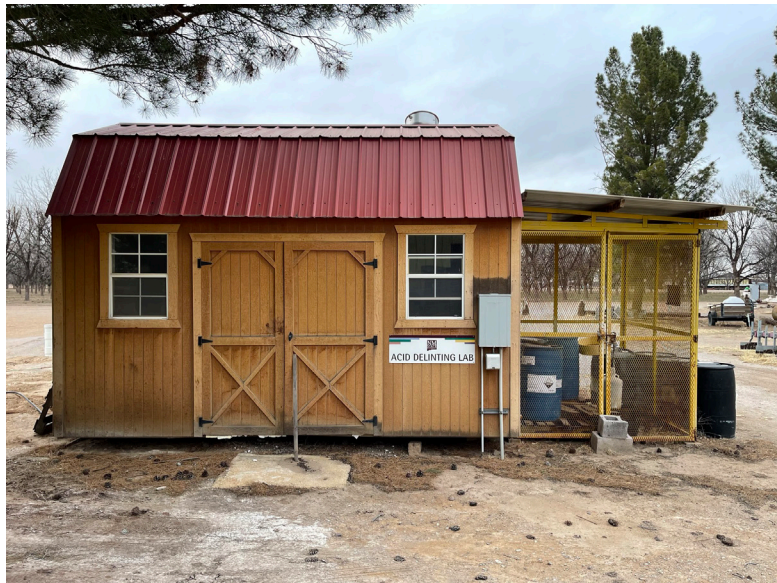
COTTON SEED DELINTING GIN 77

Building needs to be resealed or apply paint to all exterior walls to protect wood, and repaint metal cage. A concrete stoop for safe entry and ADA access ramp, need to be installed including ADA hardware locks at double doors. Need to install gutters and downleaders, and the building needs concrete apron along three sides including grading the site to create positive drainage away from building.

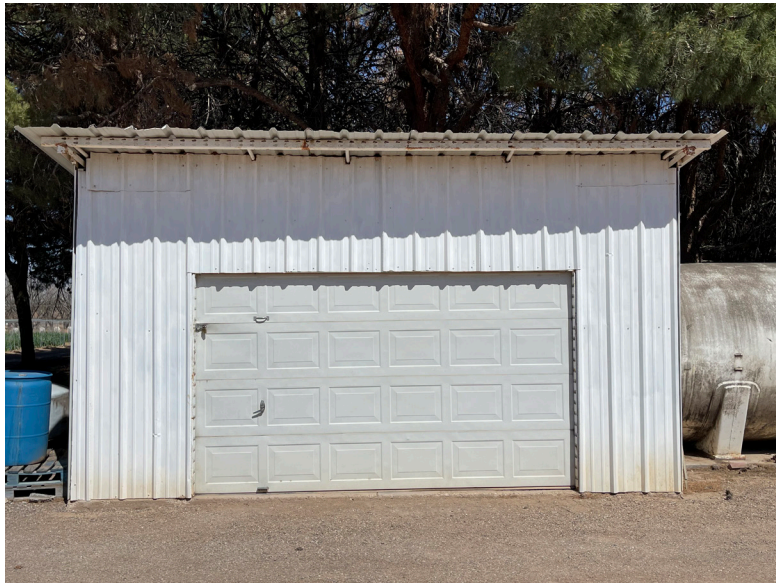
PUMP HOUSE 508

Need gutter and downleader, repaint overhead door jambs and header and steel outriggers at soffit, concrete apron along back side, regrade rear of building to provide positive drainage away from building

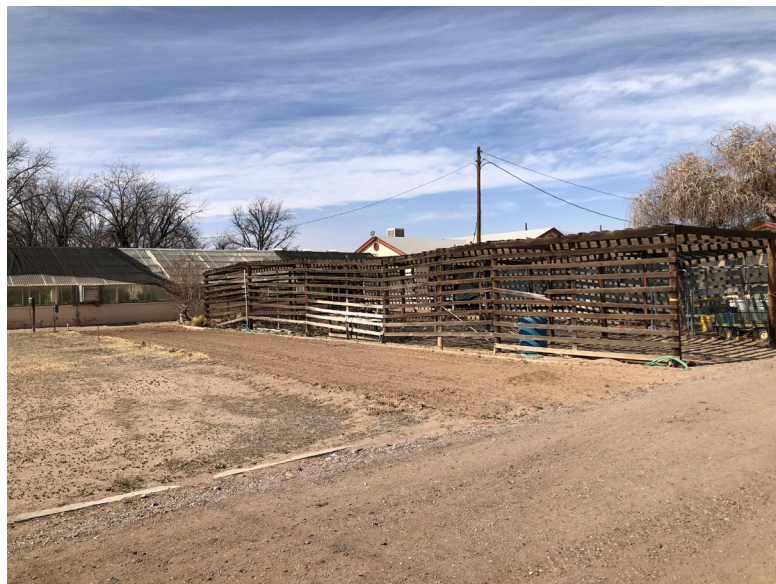
SHADEHOUSE 510

No work not considered a building

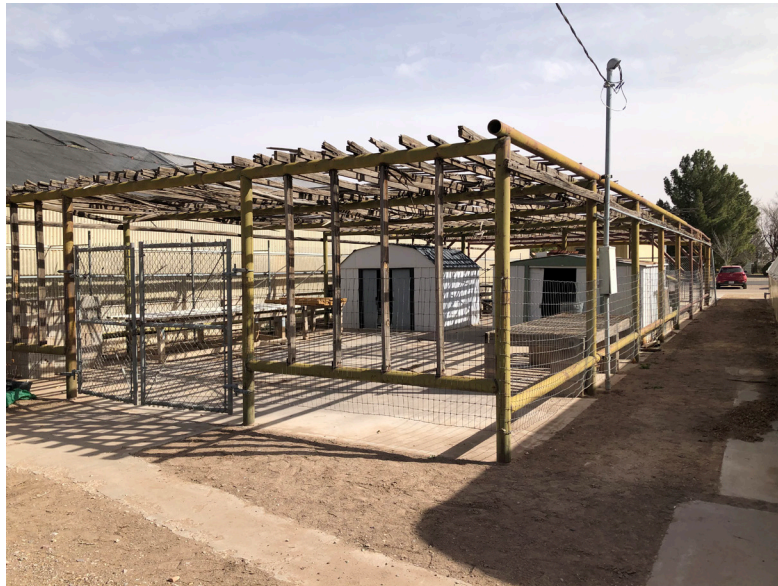
SHADEHOUSE C 511

No work not considered a building.

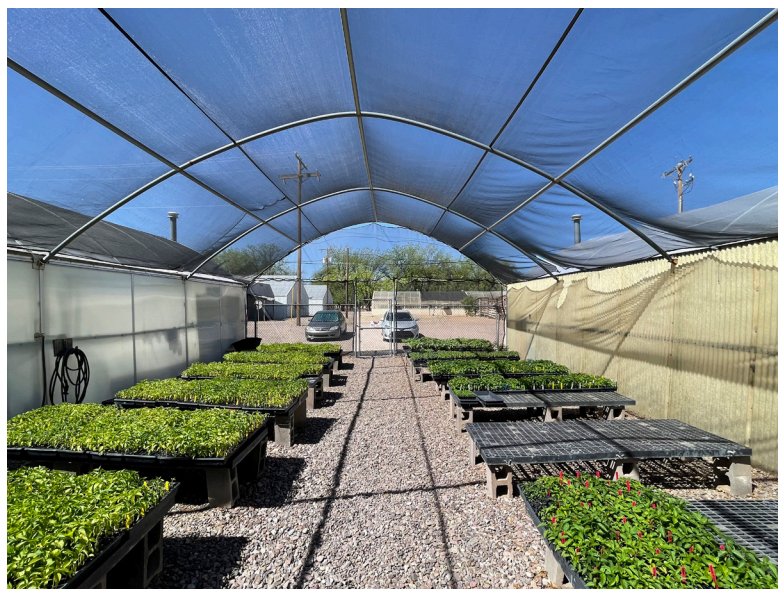
SHADEHOUSE A 509

No work

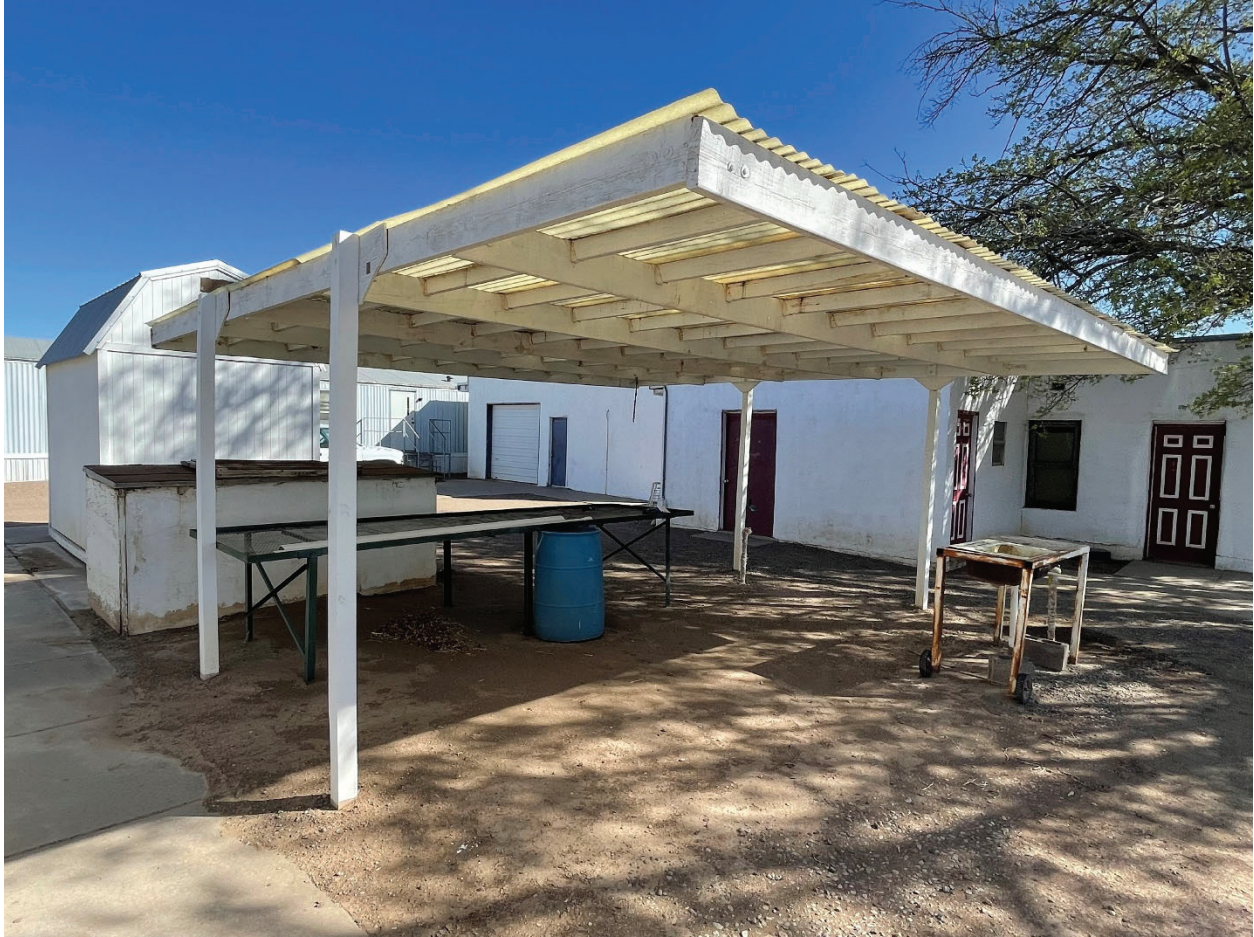
Weed research shade canopy:

- ☒ Wood column and connections to the shade structure are weak and allows structure to rock laterally. A steel structure is a better alternative to stabilizing structure.

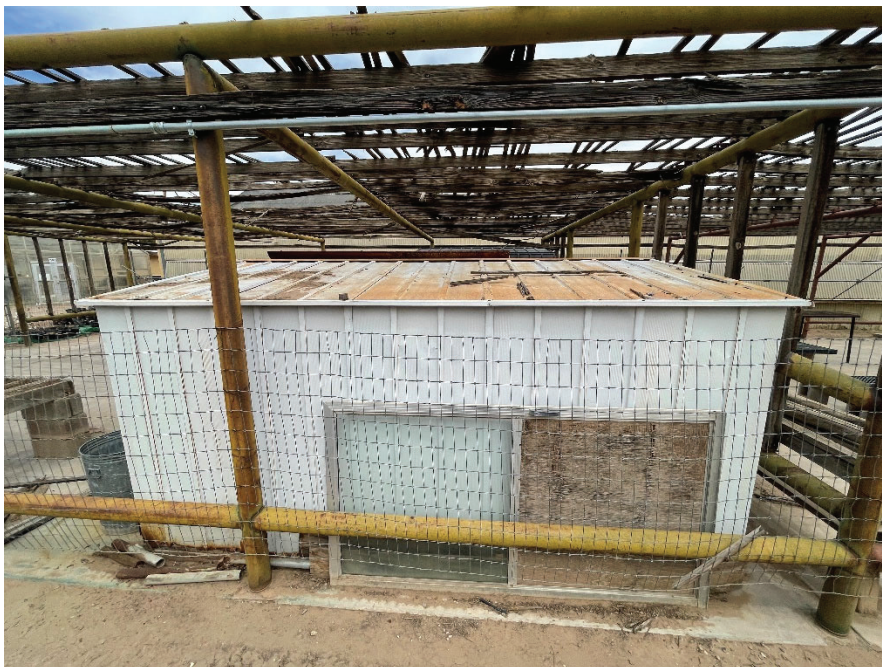
- ☒ Storage building has missing roof in sections. Building beyond feasible repair.

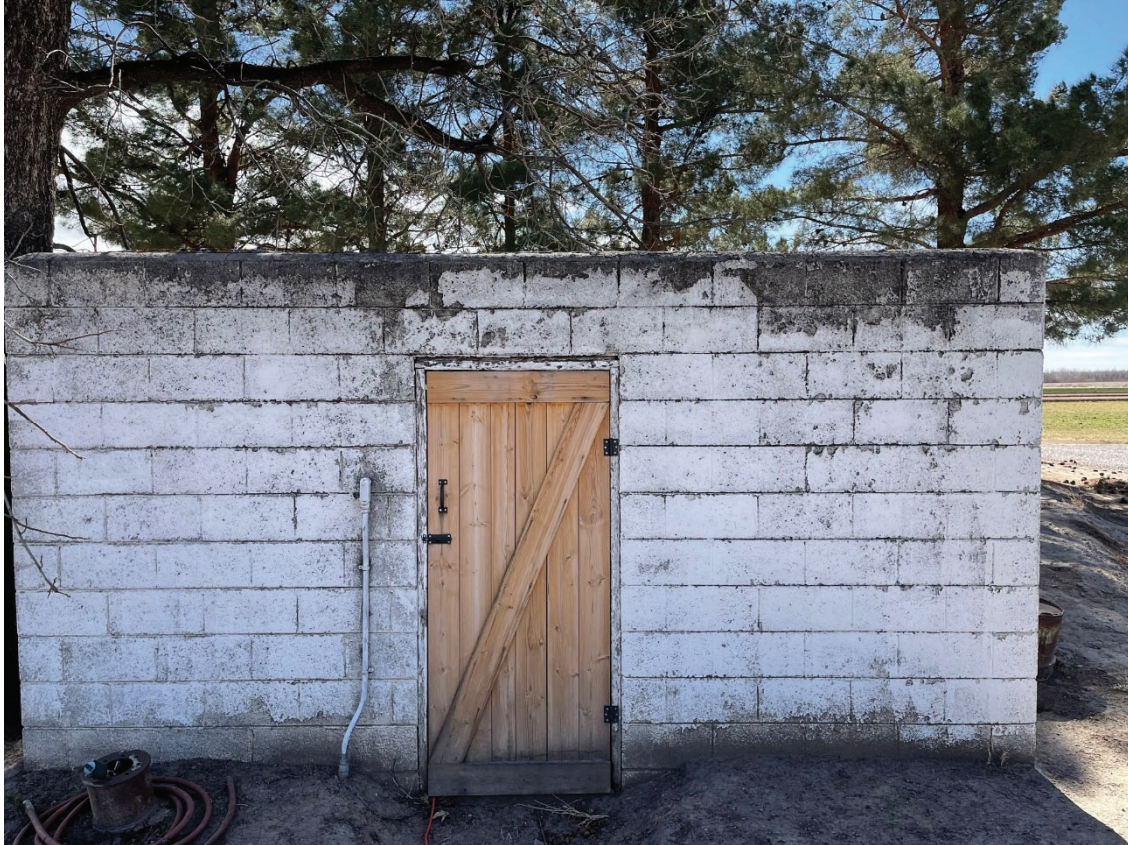
Pump house:

Needs: New roof, repaint all exterior wall faces, appropriate integrated heating unit, reinsulate interior, rain gutters and down leaders, concrete entry stoops, regrade for positive drainage.

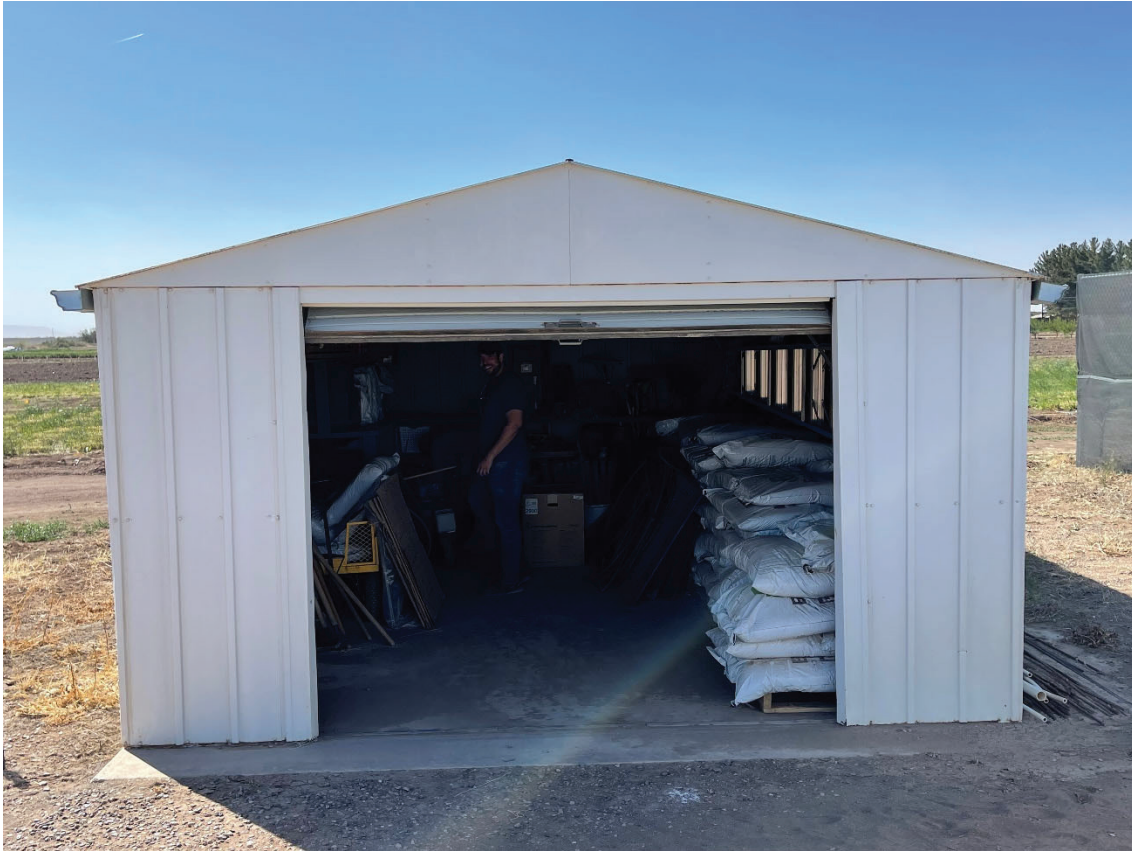
Weed research tool storage/ supply shed:
Needs: New metal roof panels.

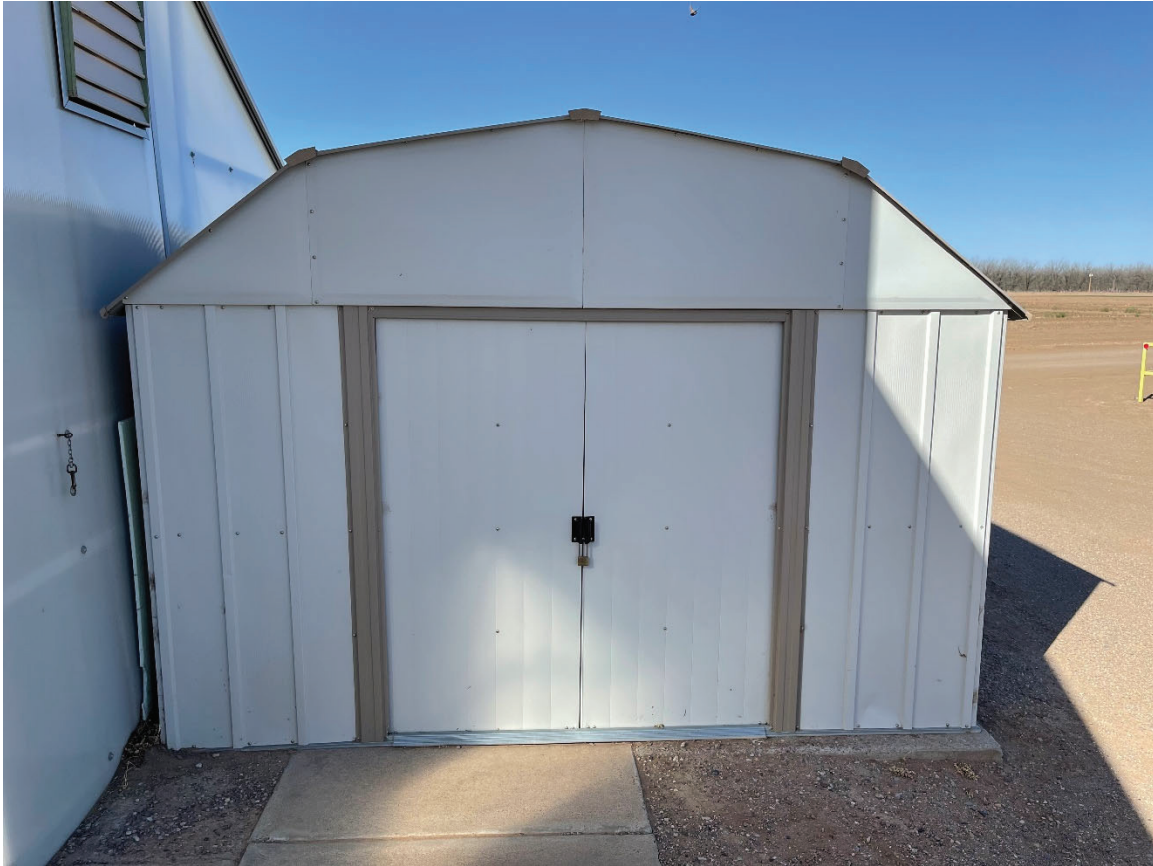
Metal storage shed:
Needs: Gutter and down leaders.

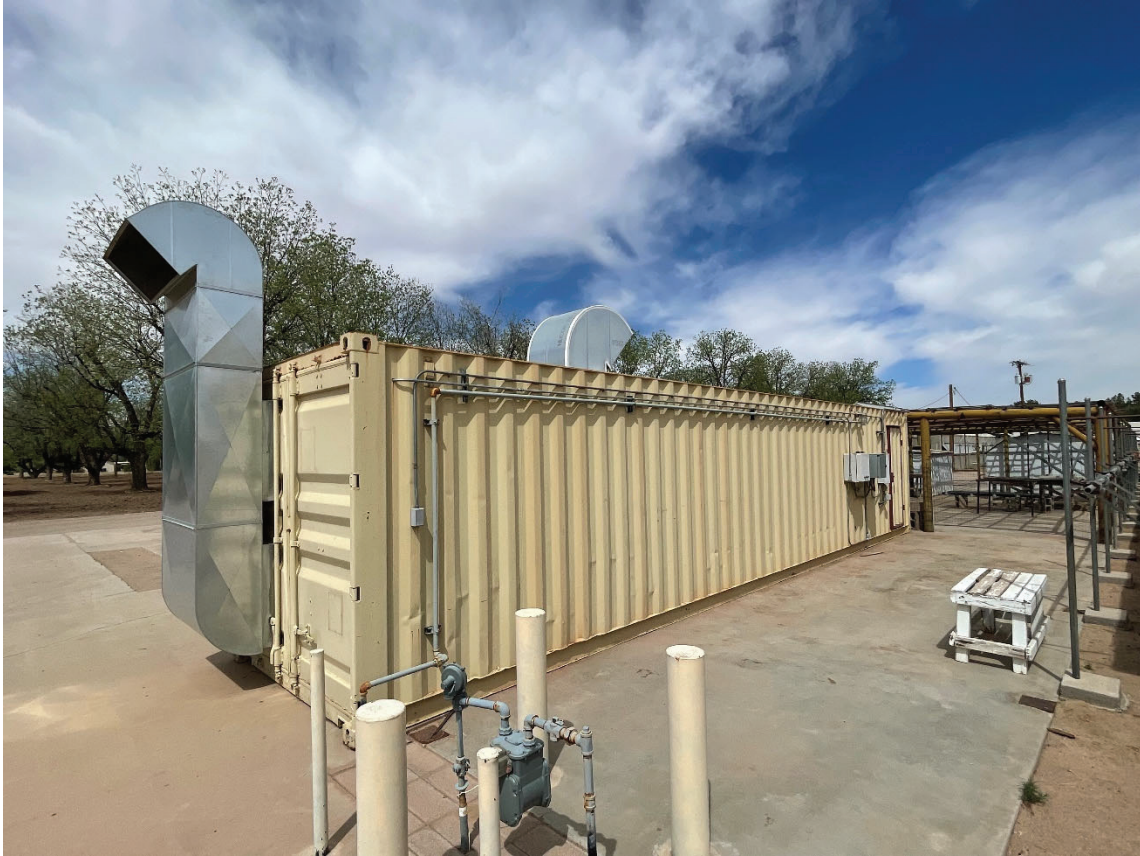
Boxcar mechanical room:
Needs: repainting.

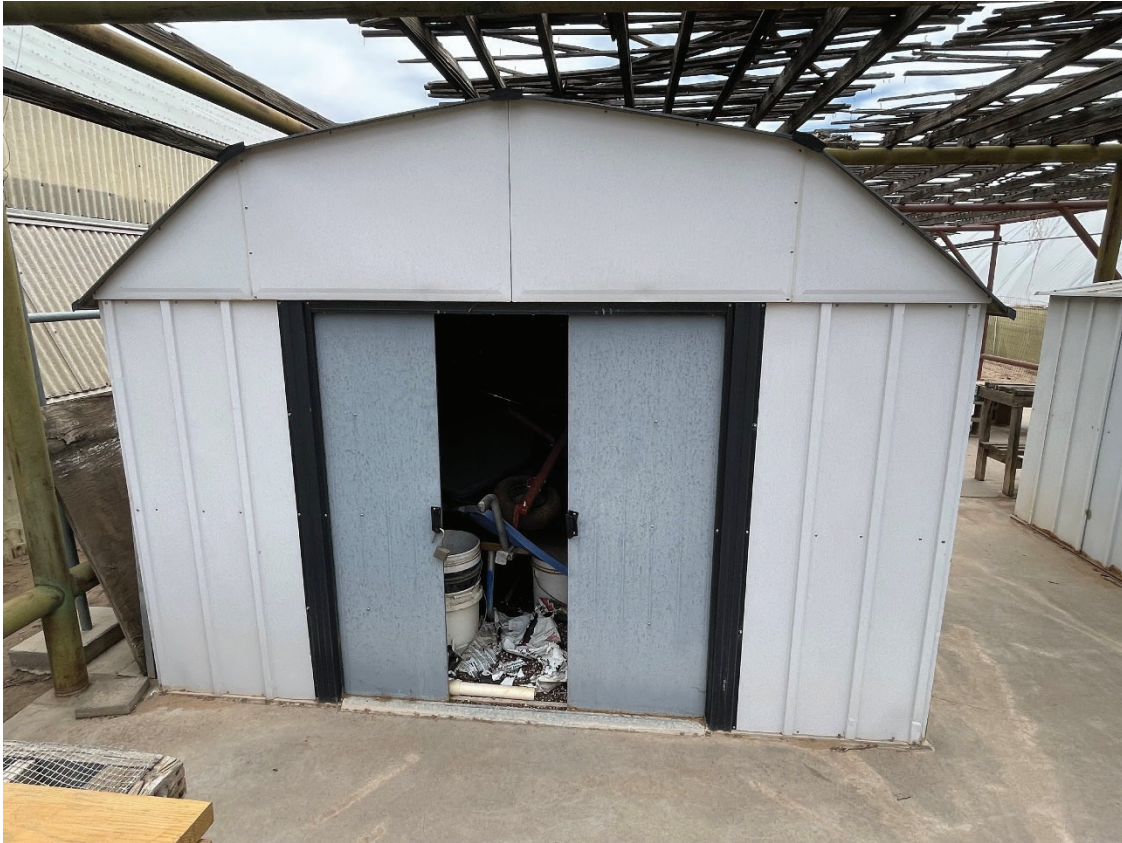
Metal storage shed:
Needs: none detected.

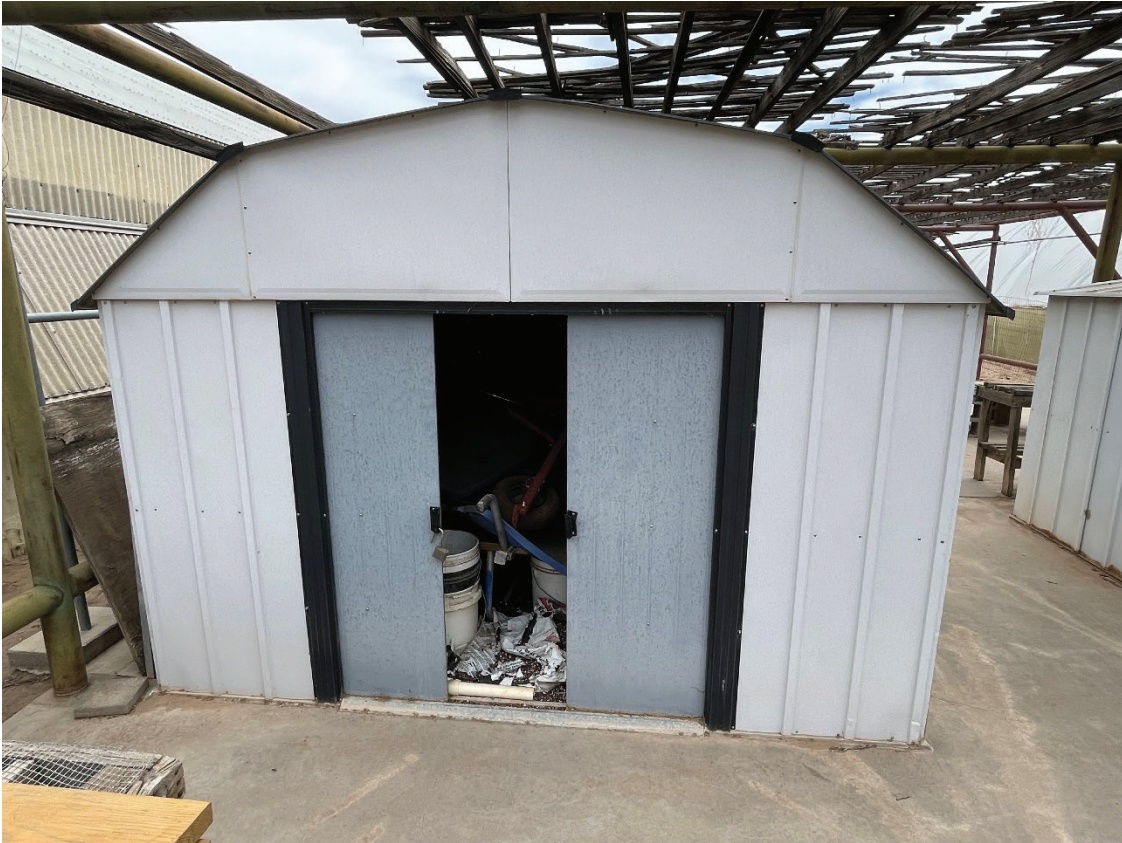
Metal storage shed:
Needs: none detected.

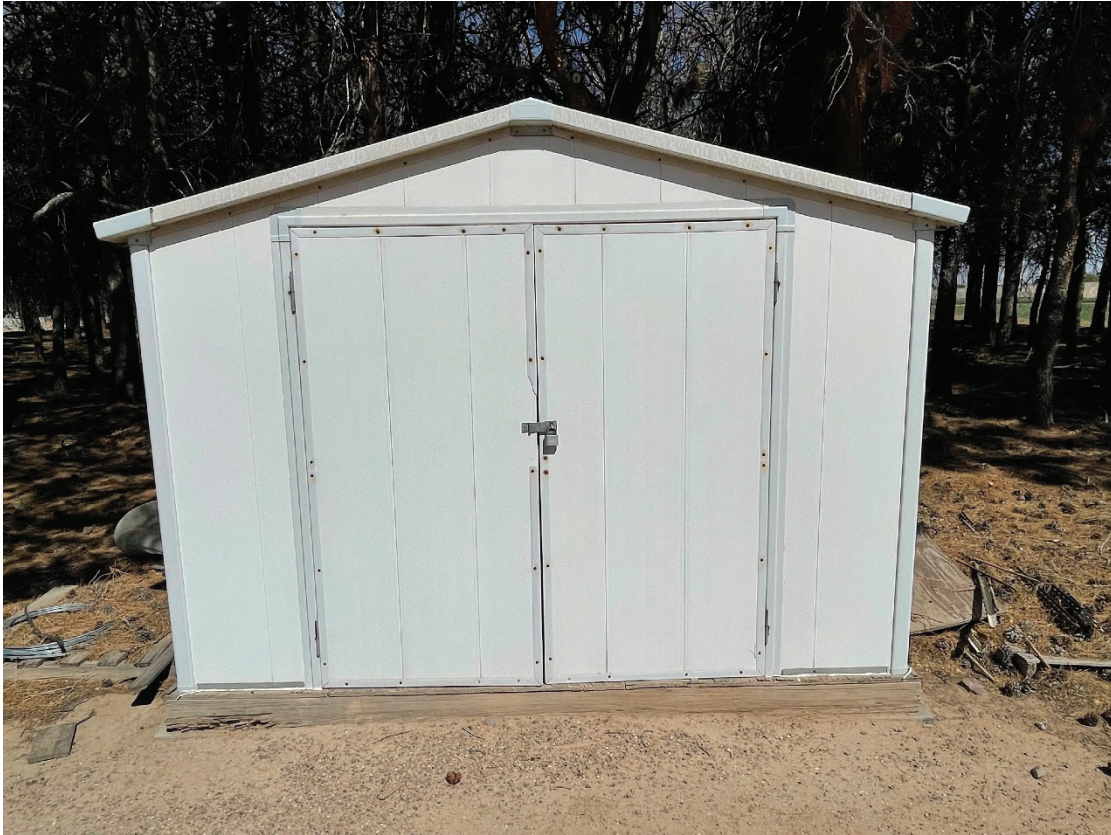
Storage shed East of Pump House:

Needs: Rain gutters and down leaders, regrade 3 sides for positive drainage, concrete entry stoop, metal cover plate protection for exposed platform faces all four sides.

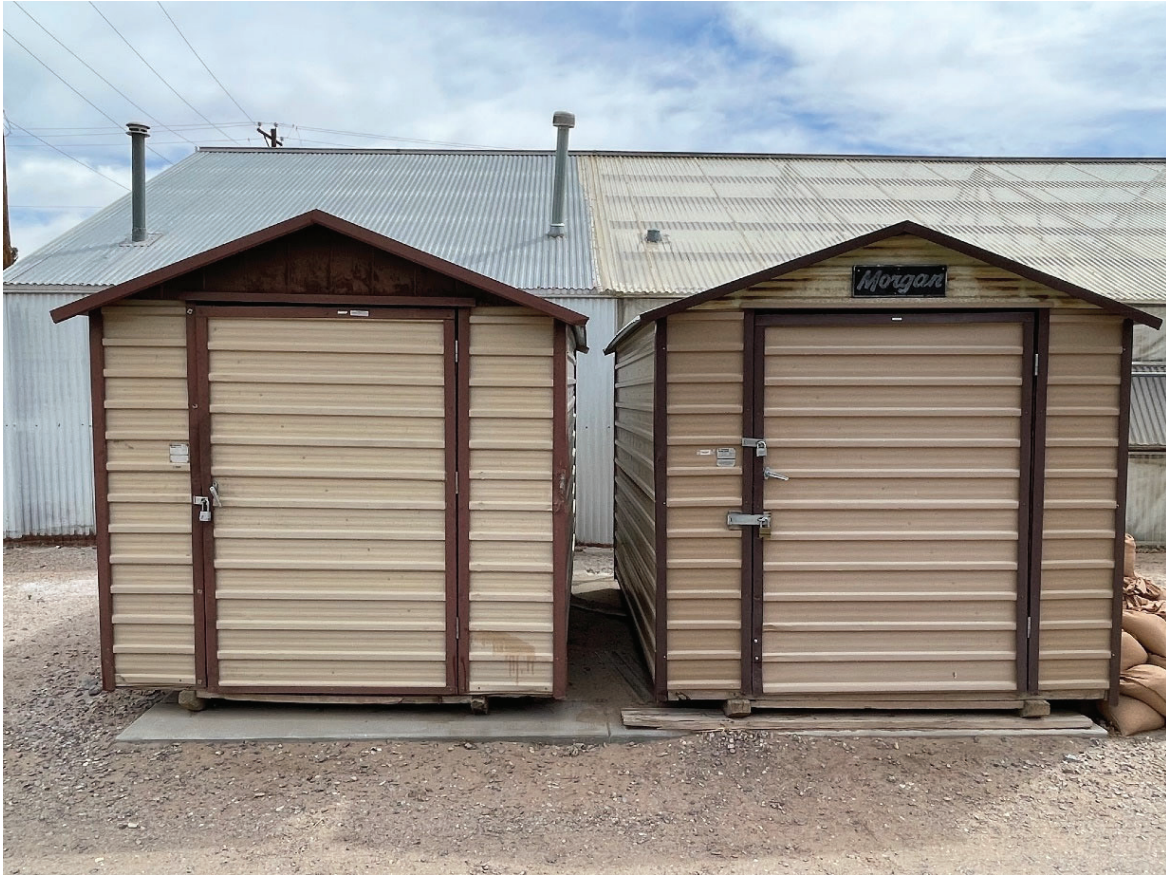
Dual Metal Storage Units:

Needs: Rain gutters and down leaders, concrete entry stoops, regrade for positive drainage.

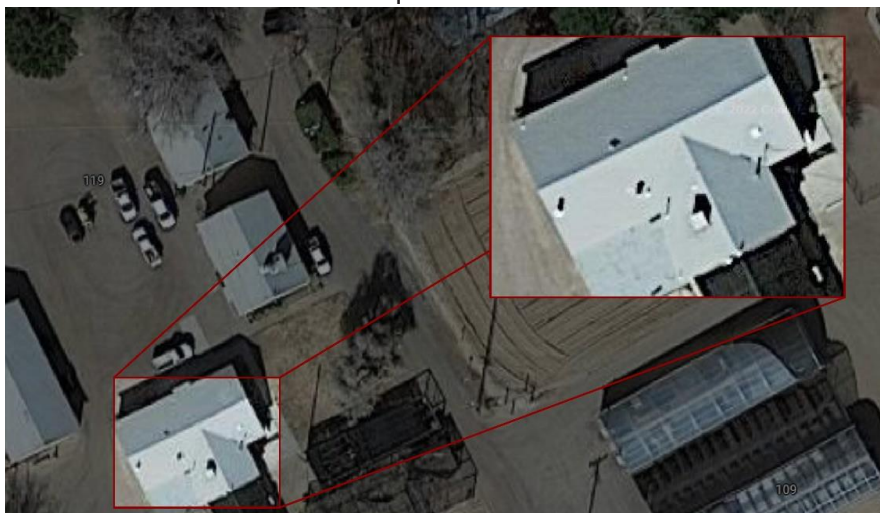
Fabian Garcia has a classroom on the site, multiple research buildings, multiple research areas, and a main office. There is a great deal of research that goes on at Fabian Garcia, and multiple IoT, INTERNET of things, devices and sensors that needs network connection to communicate with main campus servers. Some up-grades have been made, but better network equipment, cabling, network devices, wireless devices, and a dedicated network closet is required to fulfill the need at Fabian Garcia.

A dedicated network closet is needed for this site. Currently the network equipment is in the research building, and is on a wall above a door on a shelf. It is our recommendation to build out an IT/network space for this ASC. If there is no room that can be modified into this space, it is our recommendation to build a separate IT/network space outside, close to the existing DMARC, that is cooled, isolated only for IT needs, has proper lighting, floor loading, power, network racks and equipment, airflow, and meets standards.
